PEACE RIVER DEVELOPMENT SITE C PROJECT

REVIEW OF UPSTREAM AXES

Report No. 5032A01 02
May 2006

APPENDIX A
PHOTOGRAPHS AND NOTES
FROM THE
NOVEMBER 2005 SITE RECONNAISSANCE

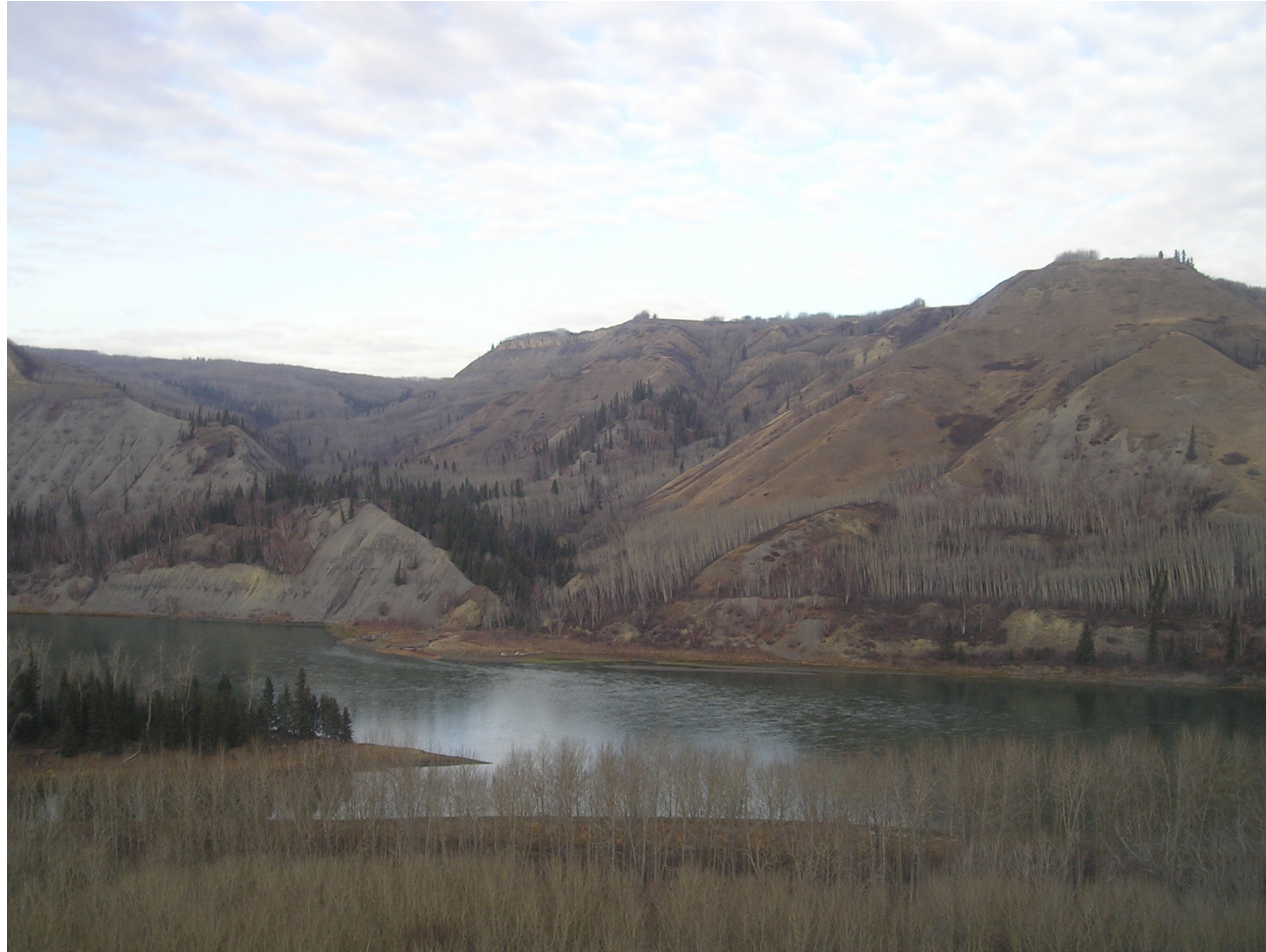
Site C1 – Over right bank looking towards the left. Note Tea Creek off to the left. Top of the Tea Creek at the terrace level is a sandstone outcropping.

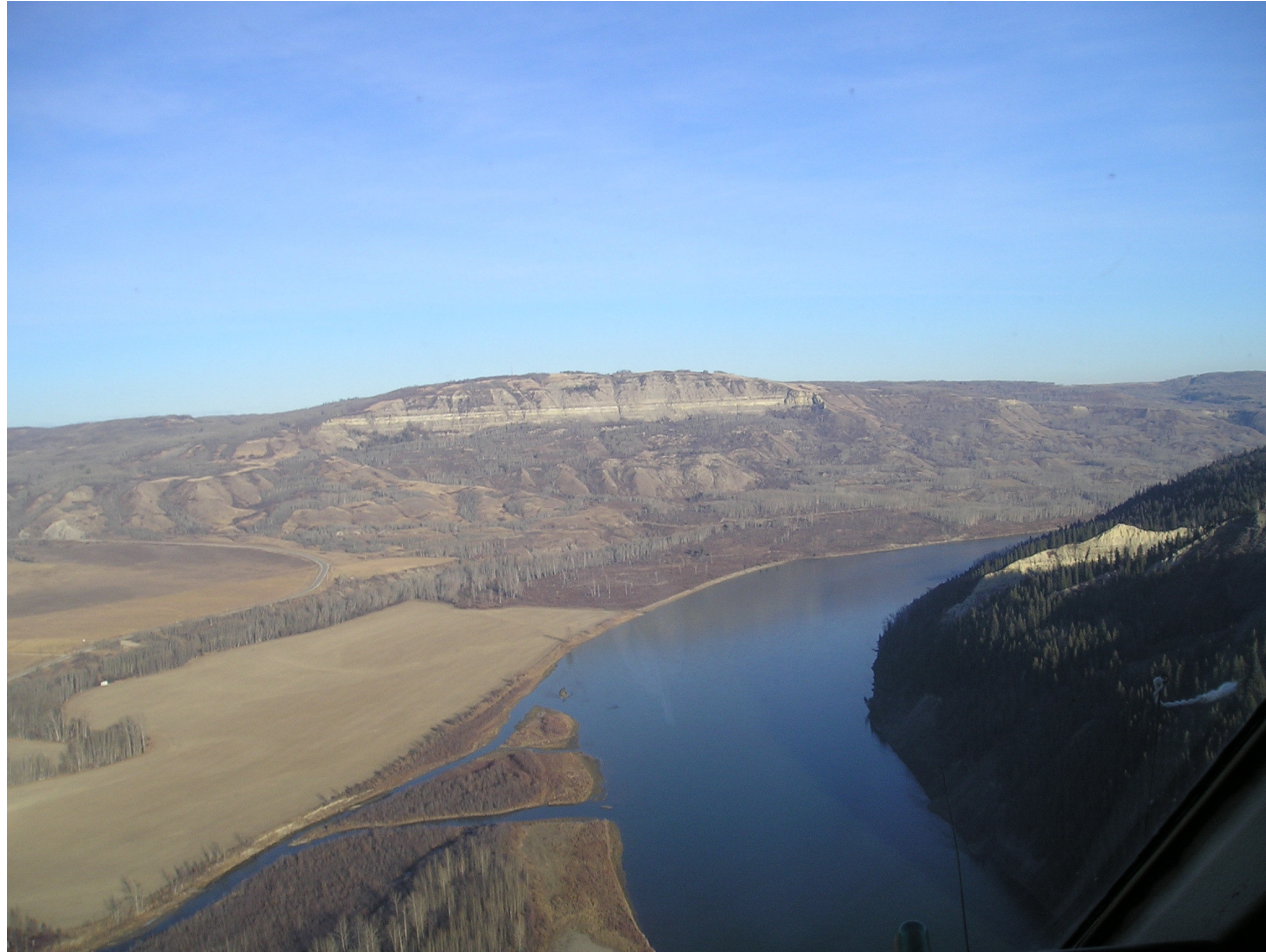
Looking downstream the Peace River with the Cache Landslide in the distance. Note the sandstone outcropping at the top of the landslide and all the slide debris at the bottom.

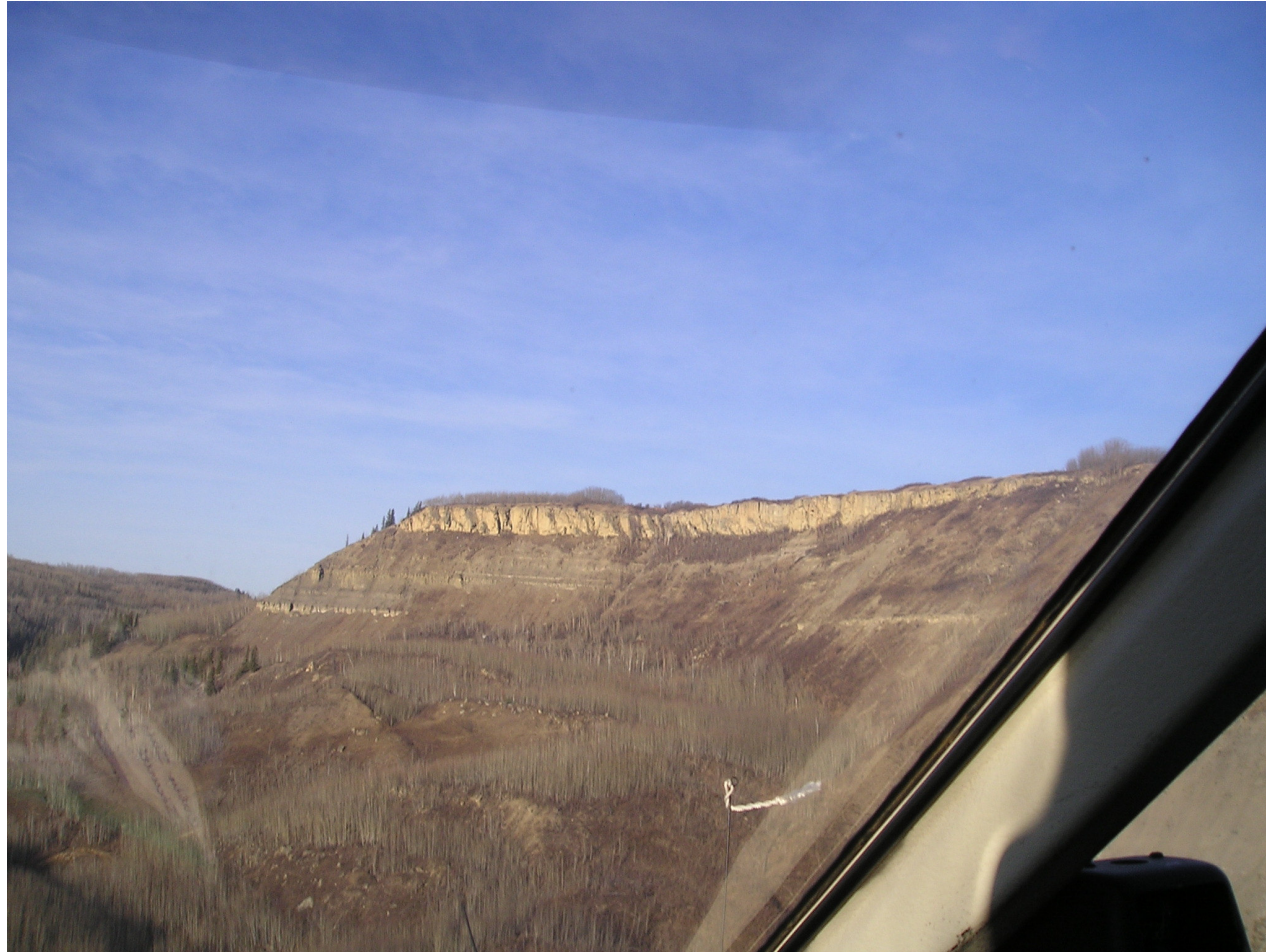
Flying up Tea Creek with the sandstone outcrop at the top. Appeared more competent than test showed.

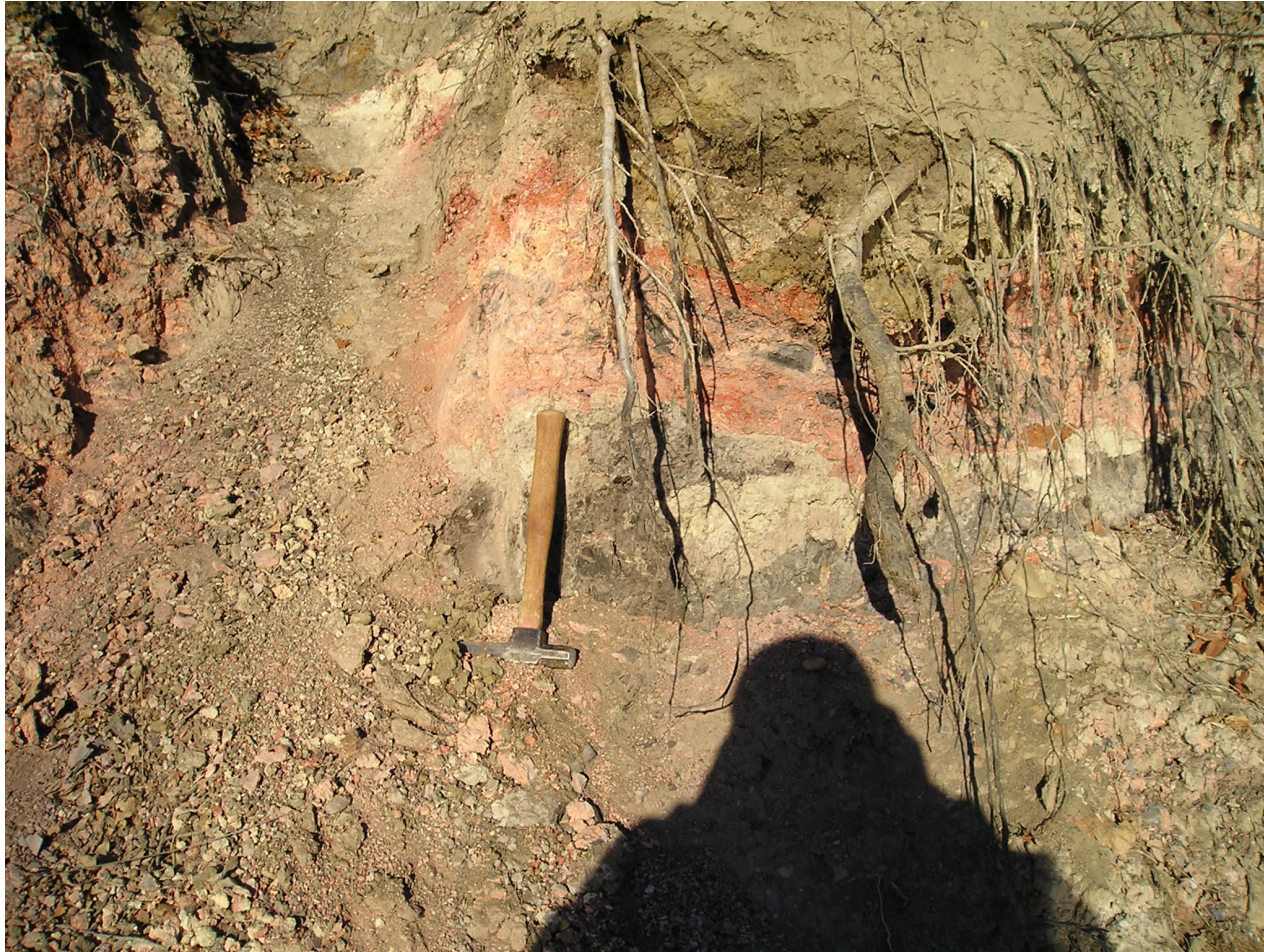
Site C1 – Shale outcropping at toe of the Left Bank. Note unusual colouration.

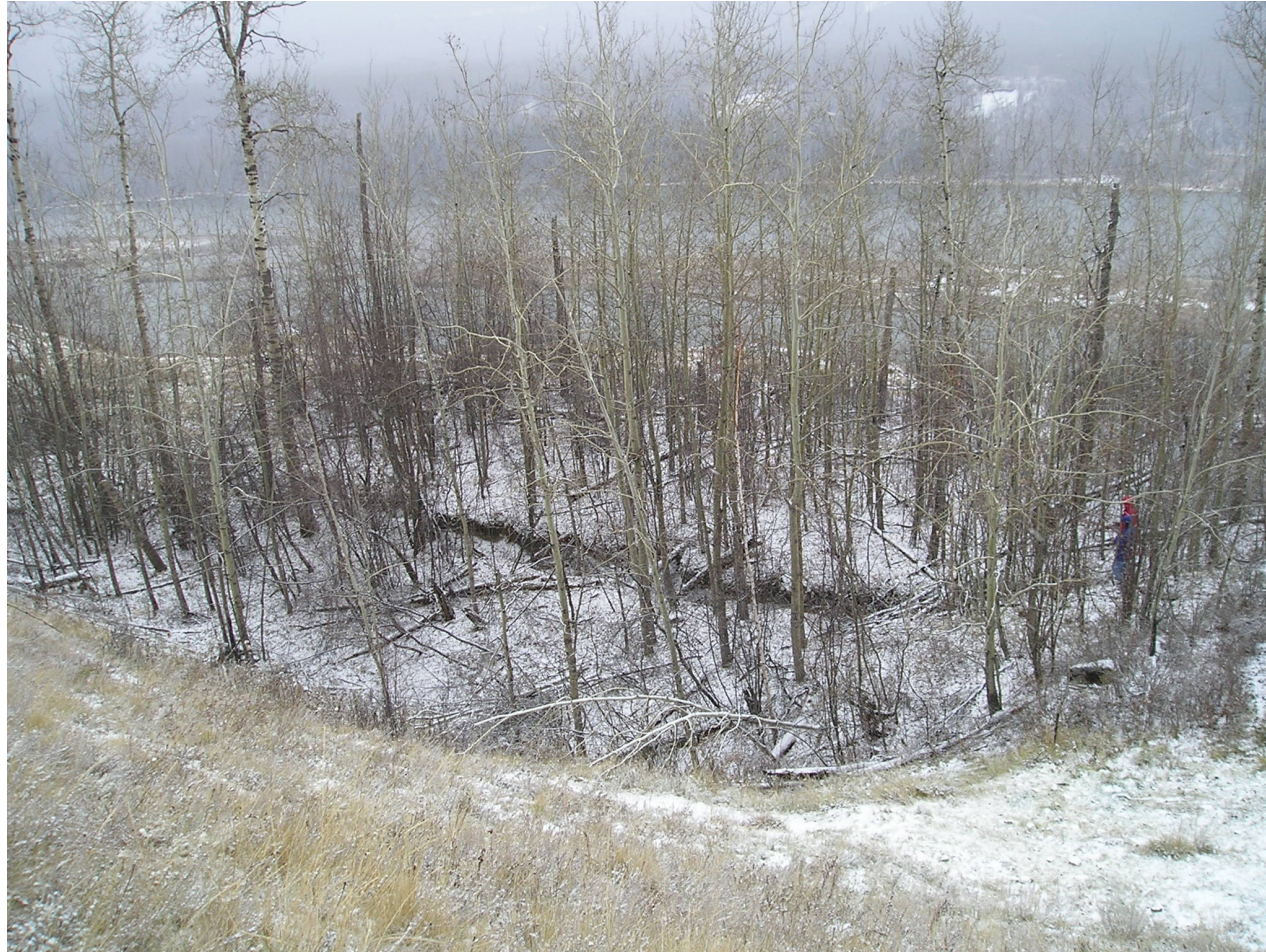
Site C3 - Walking down the Left bank. Note the ground subsidence high up on the slope (Elev. 580+/-).

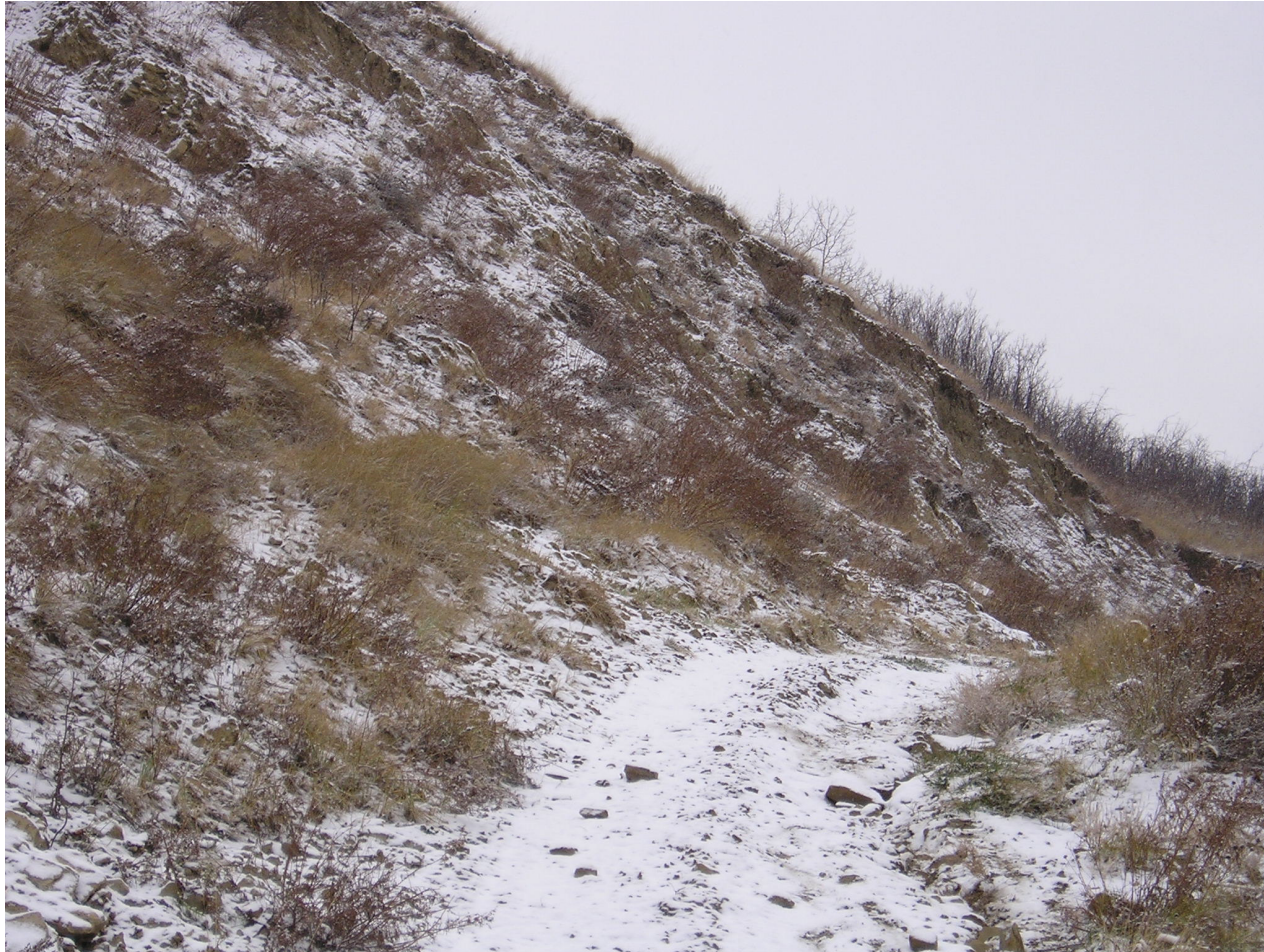
Site C3 – Looking up the access road. Note the unstable slopes and recent movements.

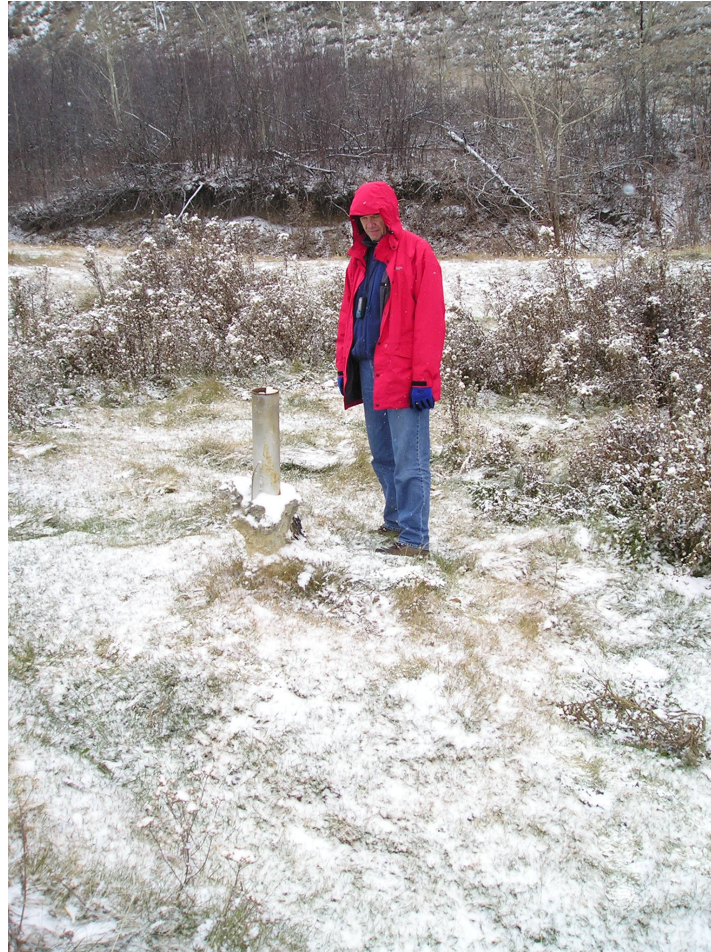
Site C3 – Ground around the drill hole has subsided approximately 0.5m.

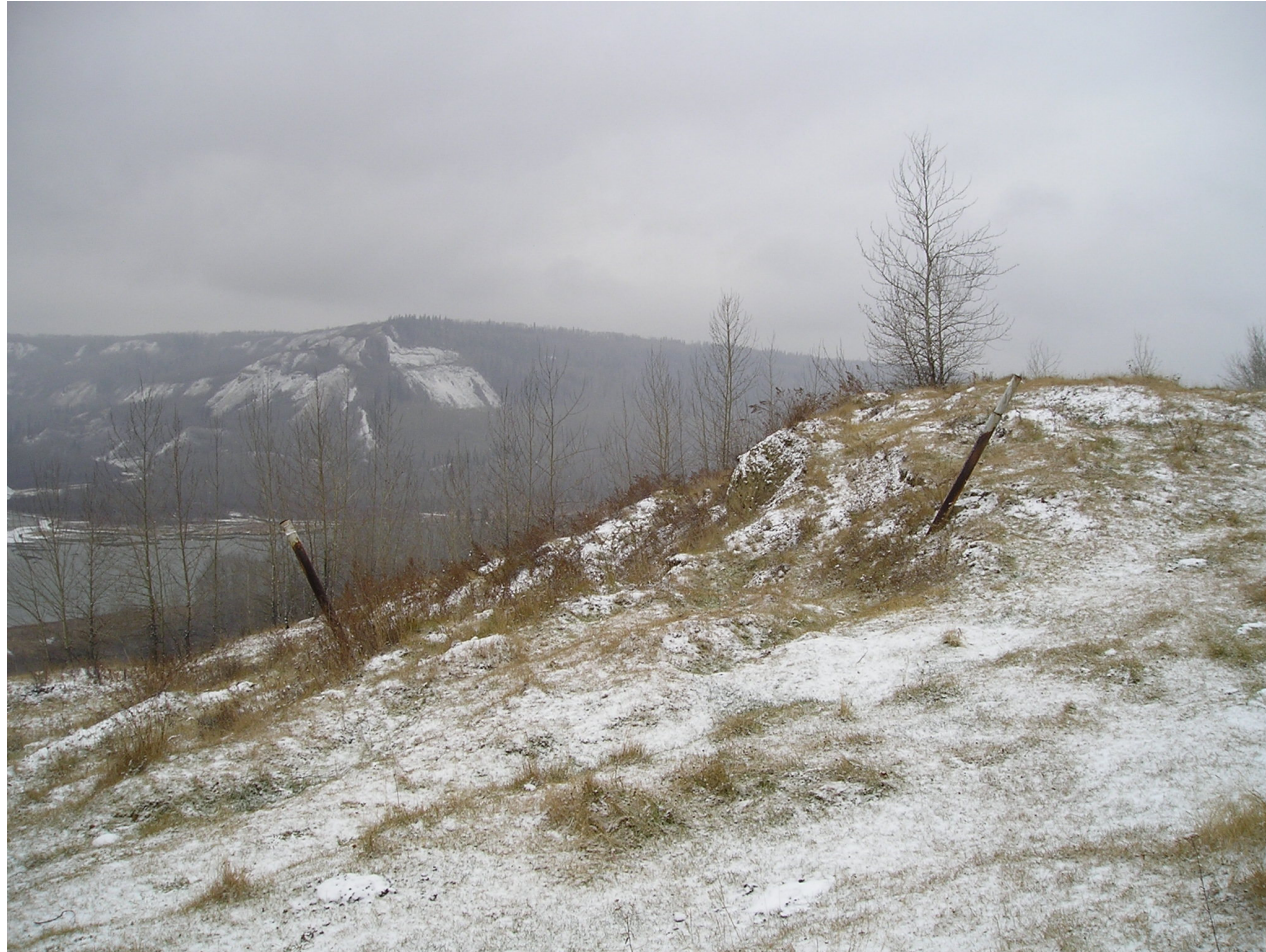
Site C3 – On the Left Bank where more drill hole casings have moved since they were installed due to ground movements.

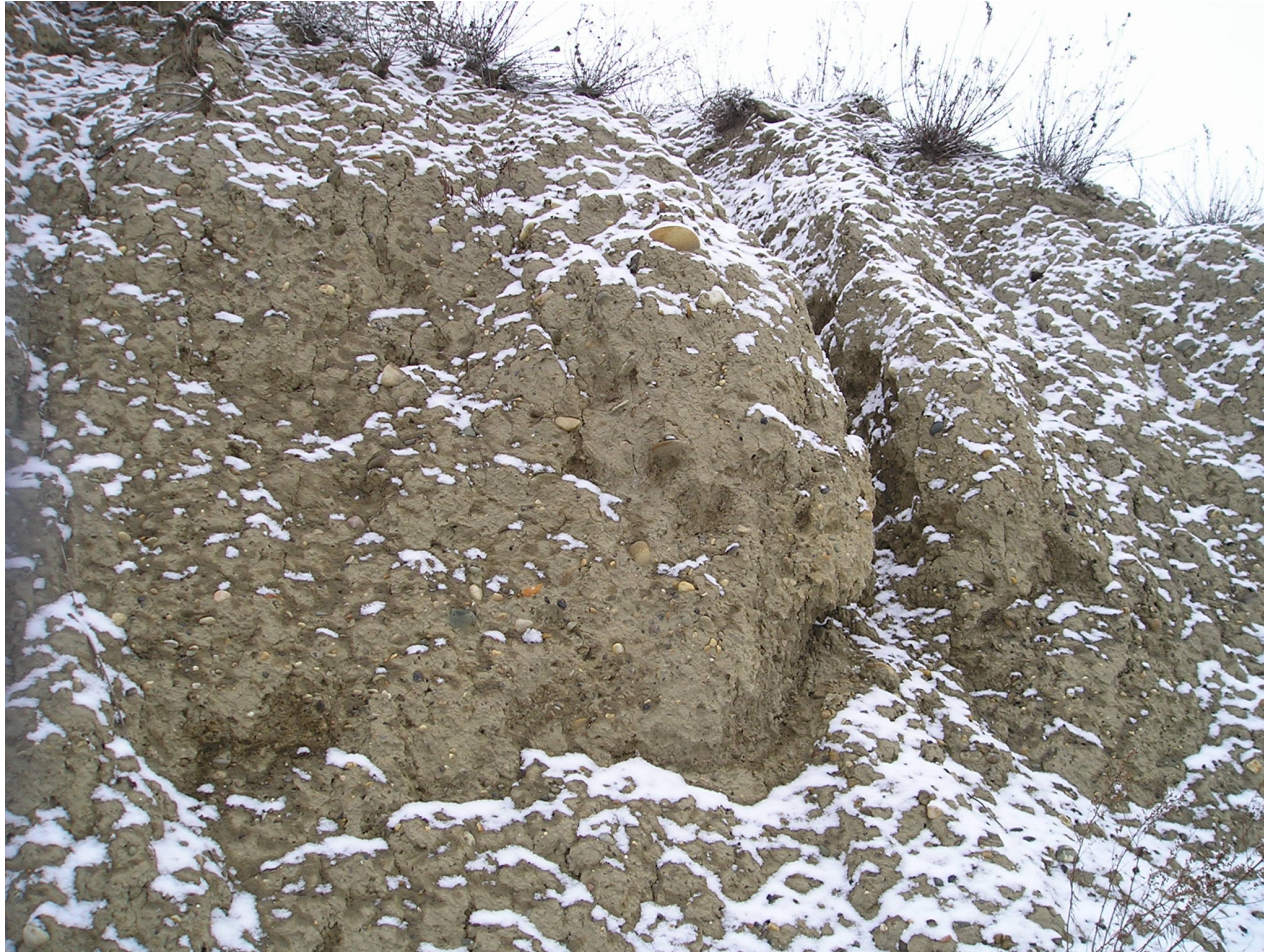
Site C – Typical overburden (Lacustrine) deposits on the Left Bank.

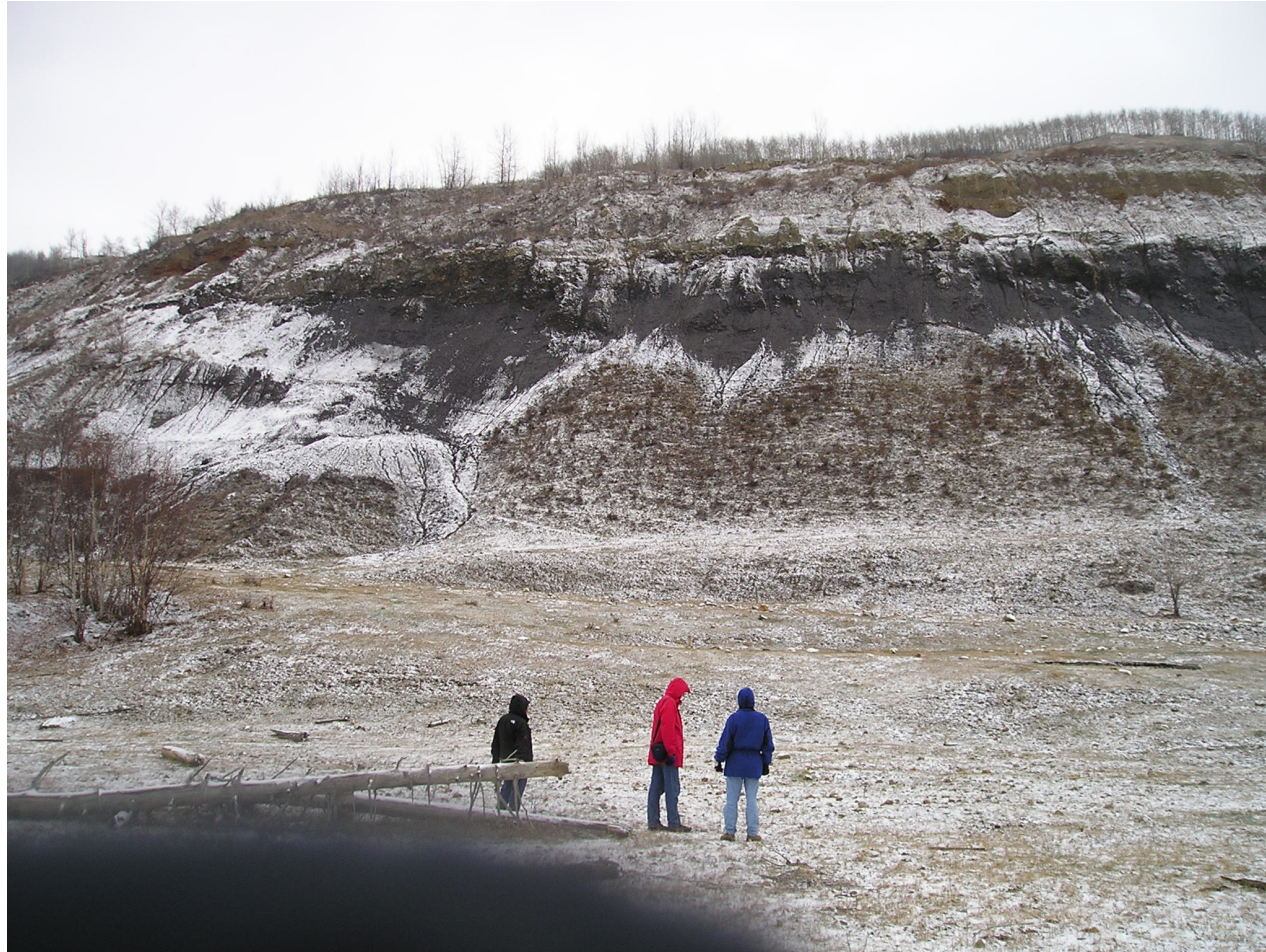
Site C3 – On the toe of the Left abutment looking at the shale outcropping (standing at about Elev.420+/-). Top of the shale is near the top of the proposed dam at Elev. 460+/-.

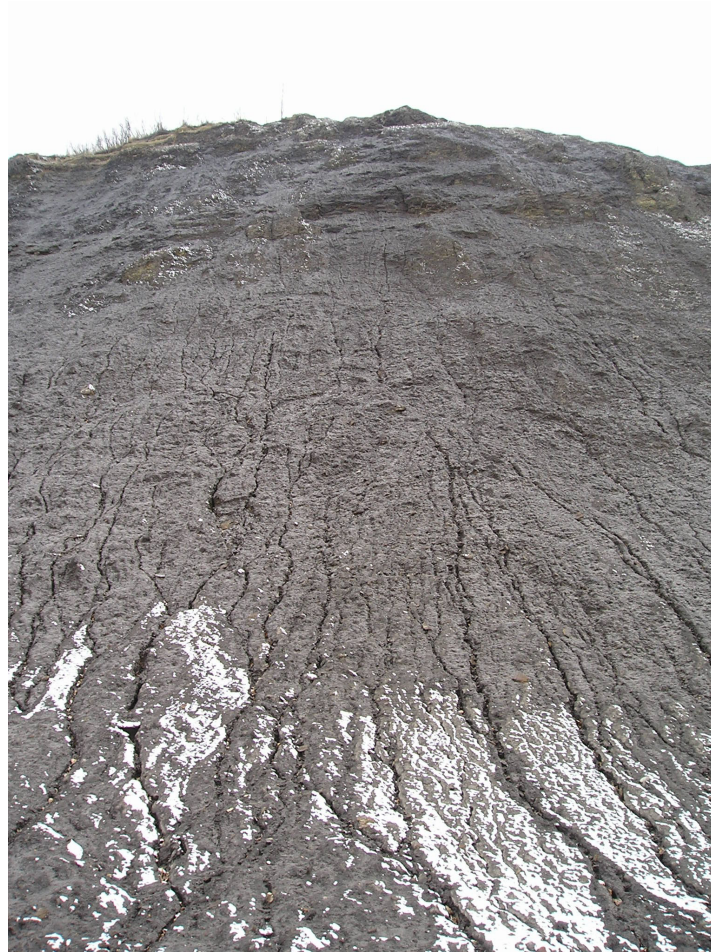
Site C3 – Shale face on the dam centre+/-.
