# Site C Wildlife Mitigation Structures

## *Snake Hibernacula Monitoring 2021*

18113590-010-R-Rev2

19 January 2022

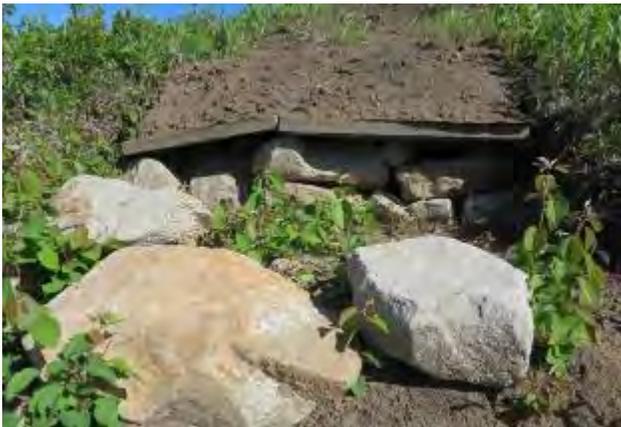
**Photo 9: Snake 21.4 (Dam View) entrance on 10 June 2021 prior to filling excess gaps.**

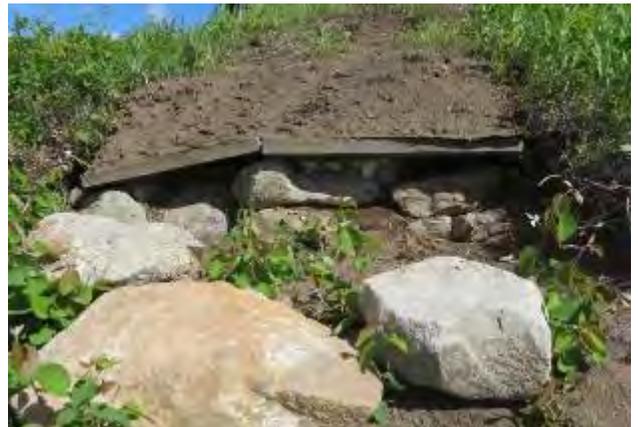
**Photo 10: Snake 21.4 (Dam View) entrance on 10 June 2021 after filling excess gaps.**

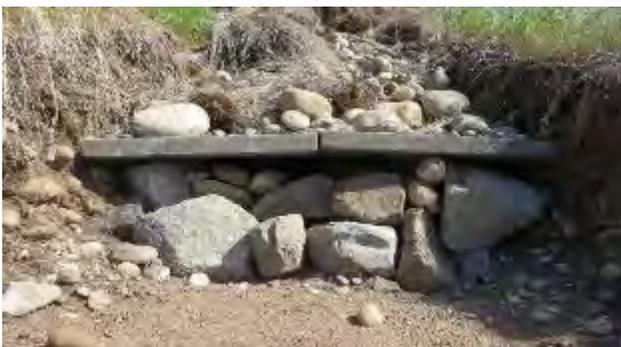
**Photo 11: Snake 48 (Wilder Creek) entrance on 10 June 2021 prior to filling excess gaps.**

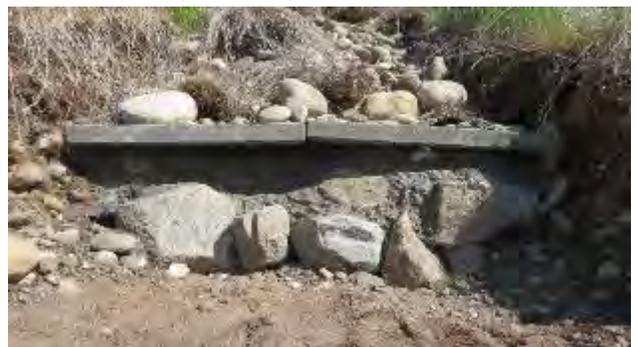
**Photo 12: Snake 48 (Wilder Creek) entrance on 10 June 2021 after filling excess gaps.**

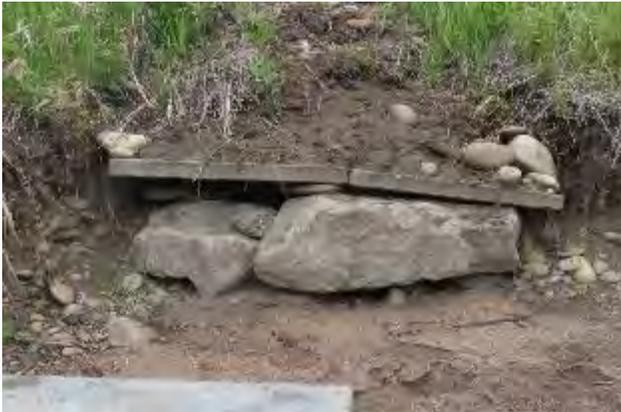
**Photo 13: Snake 134 (Watson Slough) entrance on 10 June 2021 prior to filling excess gaps.**

Hibernaculum Name	Date	Occupied	Snakes observed	Species	Comments
Snake 21.4 (Dam View)	12 May	No	No	-	Temperature logger data downloaded
	10 June	No	No	-	Gaps in hibernaculum entrance plugged using expanding insulating foam, rocks, and concrete/mortar/sand mixture (Appendix B, photos 9 and 10)
Snake 48 (Wilder Creek)	12 May	No	No	-	Temperature logger data downloaded
	11 June	No	No	-	Gaps in hibernaculum entrance plugged using expanding insulating foam, rocks, and concrete/mortar/sand mixture (Appendix B, photos 11 and 12)
Snake 134 (Watson Slough)	12 May	No	No	-	Temperature logger data downloaded
	10 June	No	No	-	Gaps in hibernaculum entrance plugged using expanding insulating foam, rocks, and concrete/mortar/sand mixture (Appendix B, photos 13-14)

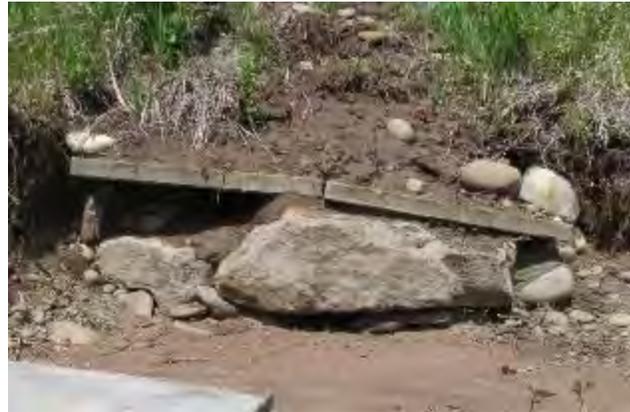
**Photo 14: Snake 134 (Watson Slough) entrance on 10 June 2021 after filling excess gaps.**

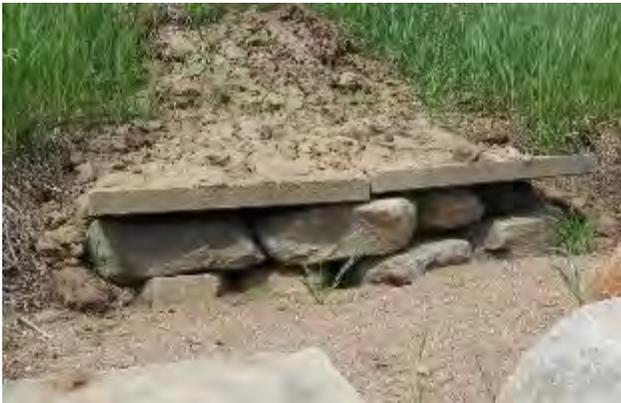
**Photo 15: Snake 153 (Halfway River) entrance on 11 June 2021 prior to filling excess gaps.**

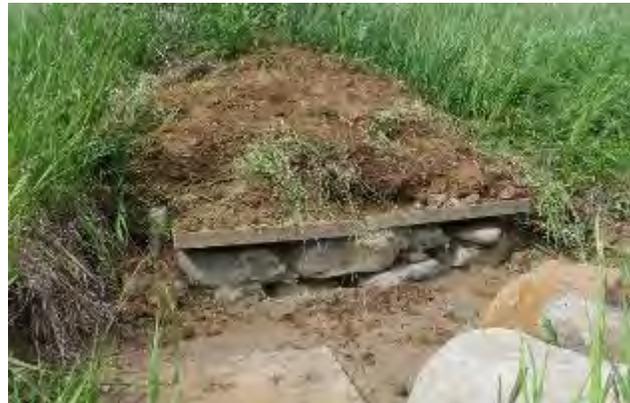
**Photo 16: Snake 153 (Halfway River) entrance on 11 June 2021 after filling excess gaps and adding additional soil.**

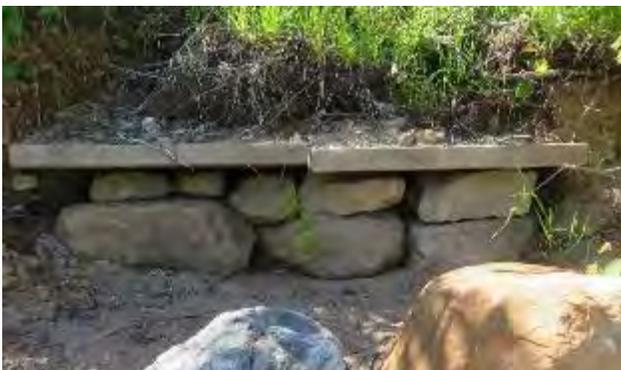
**Photo 17: Snake 272.2 (Peck's) entrance on 11 June 2021 prior to filling excess gaps.**

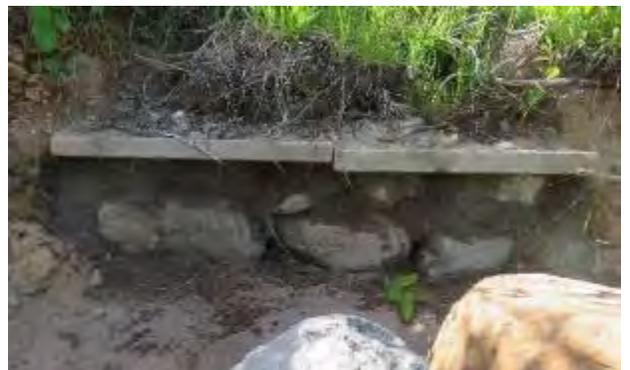
**Photo 18: Snake 272.02 (Peck's) entrance on 11 June 2021 after filling excess gaps.**

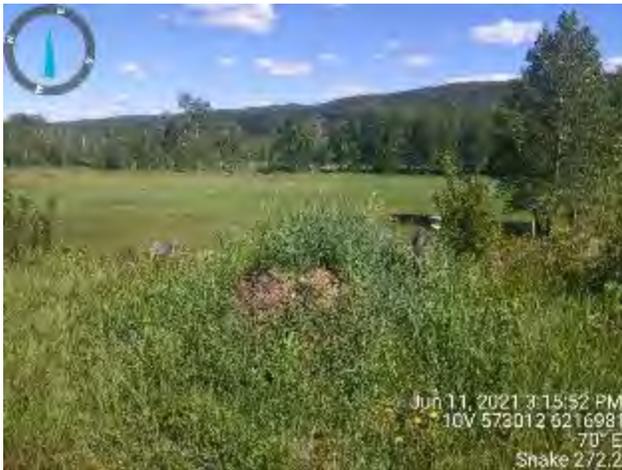
**Photo 19: Snake 272.2 (Peck's) prior to addition of extra soil.**

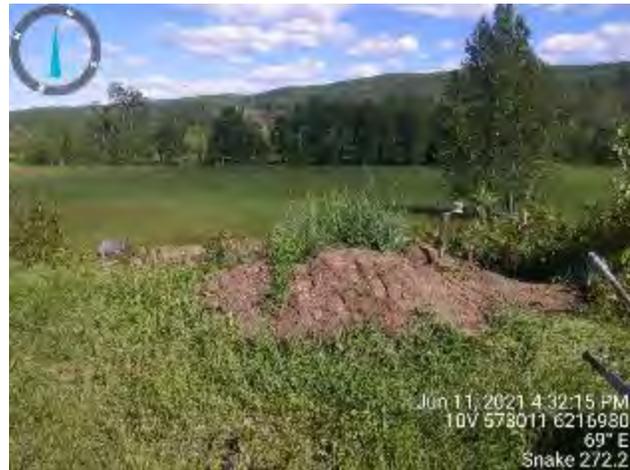
**Photo 20: Snake 272.2 (Peck's) after addition of extra soil.**

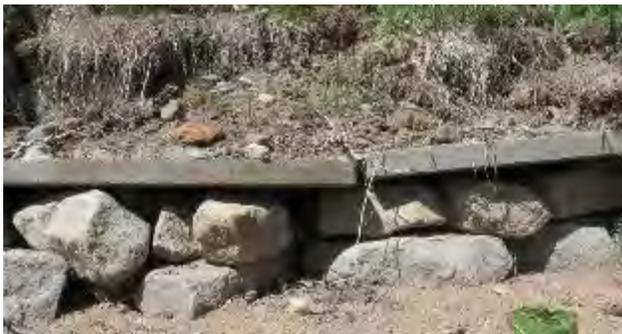
**Photo 21: Snake 326 (Lynx Creek) entrance on 11 June 2021 prior to filling excess gaps.**

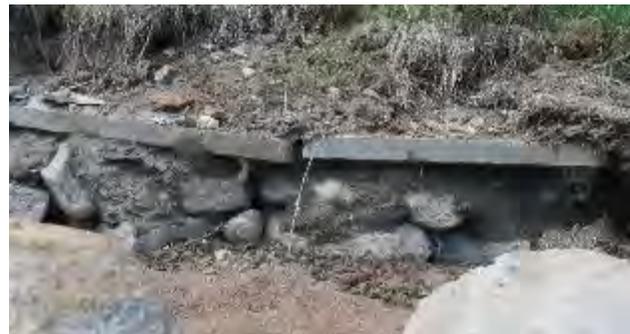
**Photo 22: Snake 326 (Lynx Creek) entrance on 11 June 2021 after filling excess gaps.**

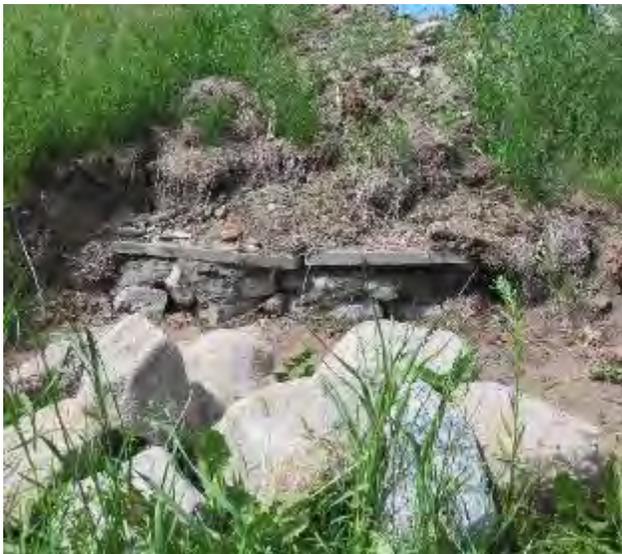
**Photo 23: Snake 326 (Lynx Creek) prior to addition of extra soil.**

11 June	No	Yes	Terrestrial gartersnake	A minimum of 2 individual snakes observed 4 times; additional soil placed on hibernaculum to attempt to improve its insulation (Appendix B, photos 23 and 24); gaps in hibernaculum entrance plugged using expanding insulating foam, rocks, and concrete/mortar/sand mixture (Appendix B, photos 21 and 22); adult western toad emerged from hibernaculum entrance (Appendix B, photo 30)

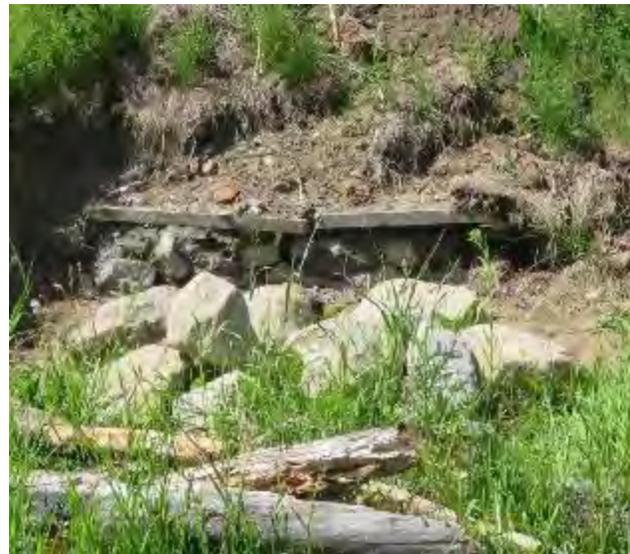
**Photo 24: Snake 326 (Lynx Creek) after addition of extra soil.**

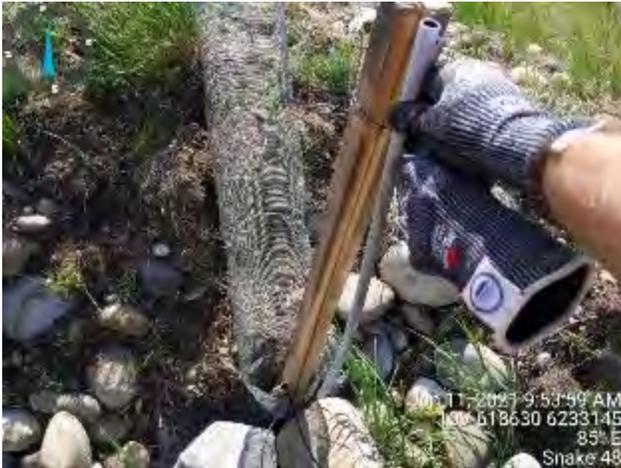
**Photo 25:** Example of procedure to install extra insulation to the tube housing hibernaculum temperature logger. Tube cut close to ground level (11 June).

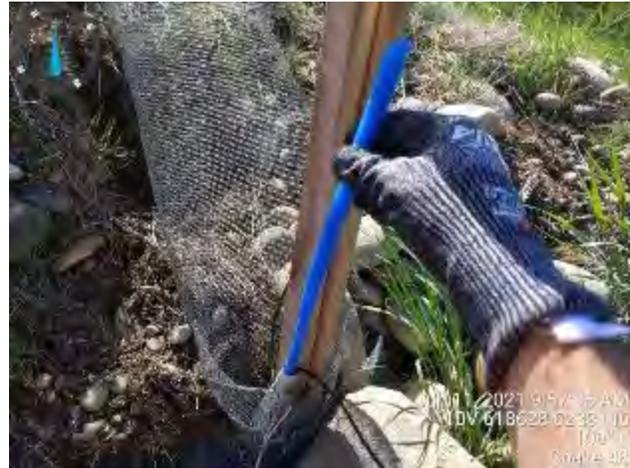
**Photo 26:** Example of procedure to install extra insulation to the tube housing hibernaculum temperature logger. Approximately 30 cm of foam added to top of tube (11 June).

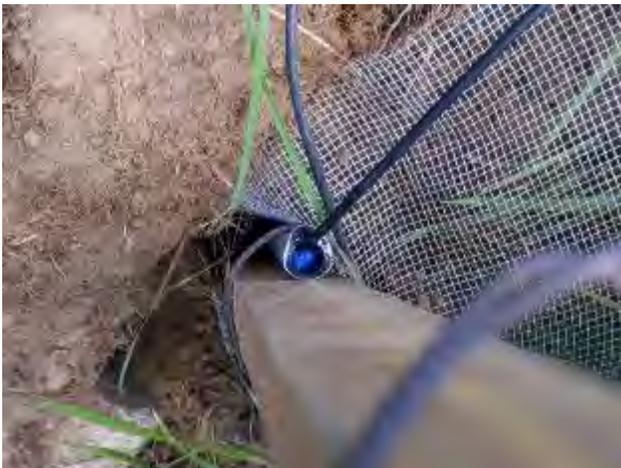
**Photo 27:** Installation of extra insulation into the tube housing hibernaculum temperature logger. Insulating foam inserted into tube (11 June).

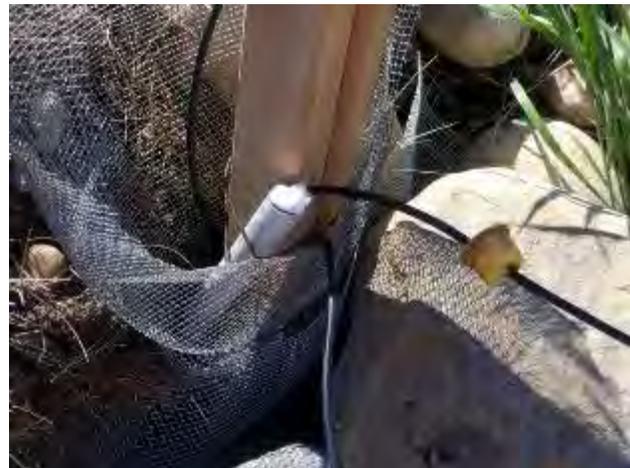
**Photo 28:** Installation of extra insulation to the tube housing hibernaculum temperature logger. Silicone sealant used to seal cap onto top of tube (11 June).
