Site C Clean Energy Project

Site C Fish Stranding Monitoring Program (Mon-12)

Construction Year 3 (2017)

Site C Fish Stranding Monitoring Program (Mon-12) Year 2 (2017) Data Report

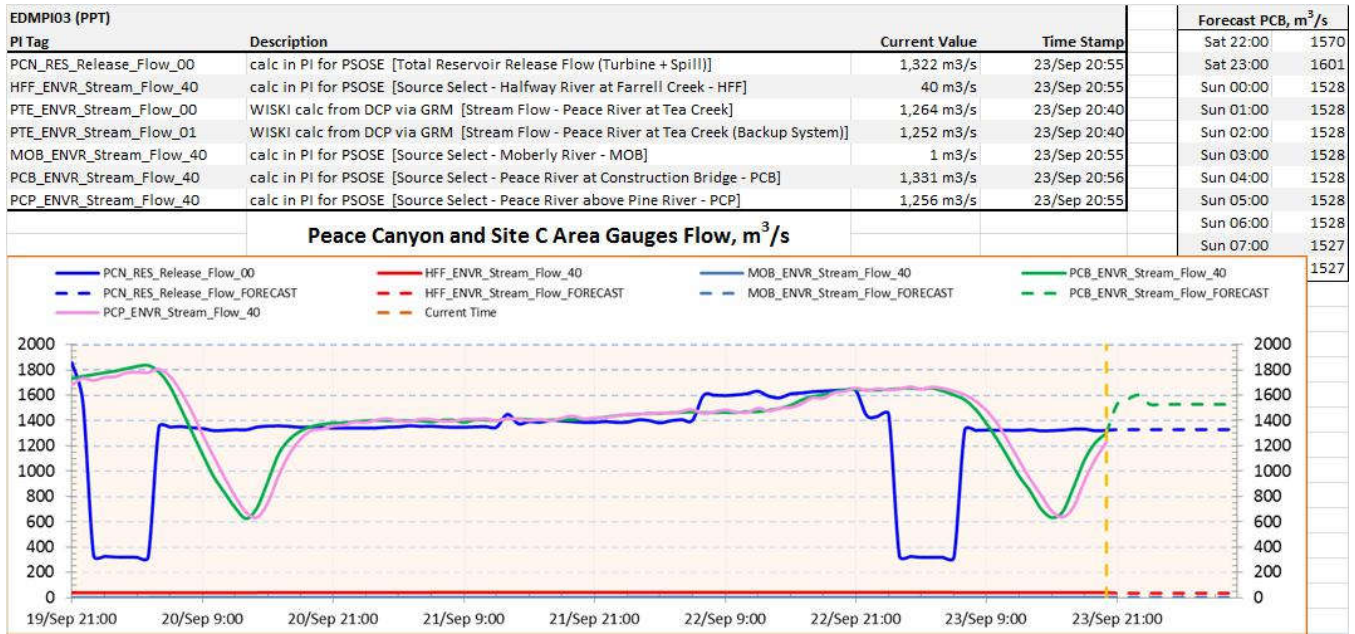
Figure 2.2 Example of flow report provided by BCH to help coordinate crew timing and effort

Figure 2.2 example above shows the reduction event at PCN prior to Trip 5 on September 23 and 24, 2017.

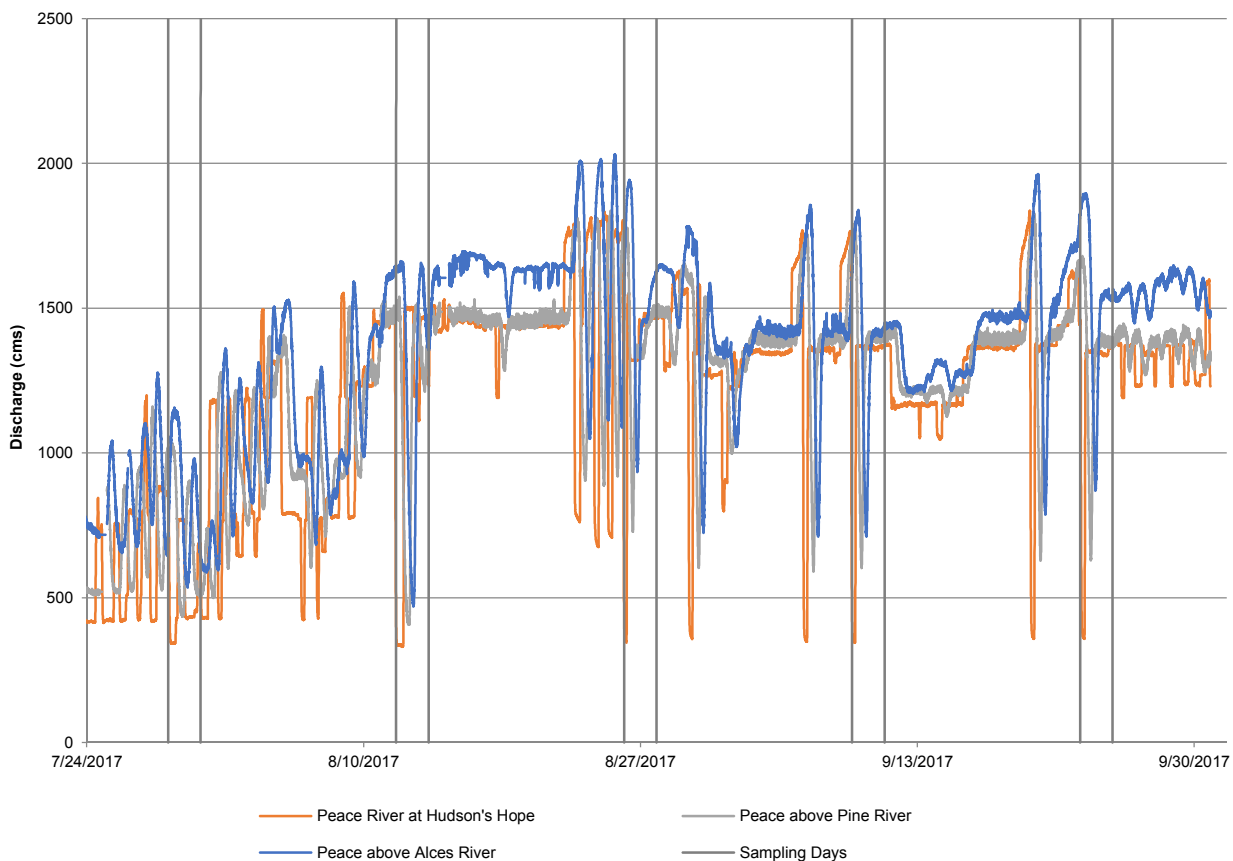
Figure 3.1 Summary of discharge recorded at the Peace River at Hudson’s Hope (07EF001), Peace River above Pine River (07FA004), and Peace River above Alces River (07FD010) Water Survey of Canada Hydrometric Stations and sampling days between July 24 and September 30, 2017

Mean daily discharge at the Peace River at Hudson’s Hope (07EF001) hydrometric station between July 29 and September 24, 2017 ranged from 1,180 cms on July 29 to 864 cms on September 3. The maximum discharge over that time period peaked on September 19 at 1,836.00 cms and again on August 24 at 1,833.00 cms. The minimum discharge (330.90 cms) was observed at the lowest point on both August 12 and 16.

At the Peace River above Pine River (07FA004) hydrometric station, the mean daily discharge ranged from 1,210 cms on July 29 to 947 cms on August 21. The maximum discharge over that time period peaked on August 25 at 1,836.60 cms. The minimum discharge was recorded on July 16, 2017 at 399.35 cms. At the Peace River above Alces River (07FD010) hydrometric station, the mean daily discharge ranged from 1,640 cms on July 29 to 1,070 cms on August 31. The maximum discharge over that time period peaked on August 25 at 2,031.10 cms. The minimum discharge was recorded as 469.79 cms on August 13. The data for each station is shown on Figure 3.1.

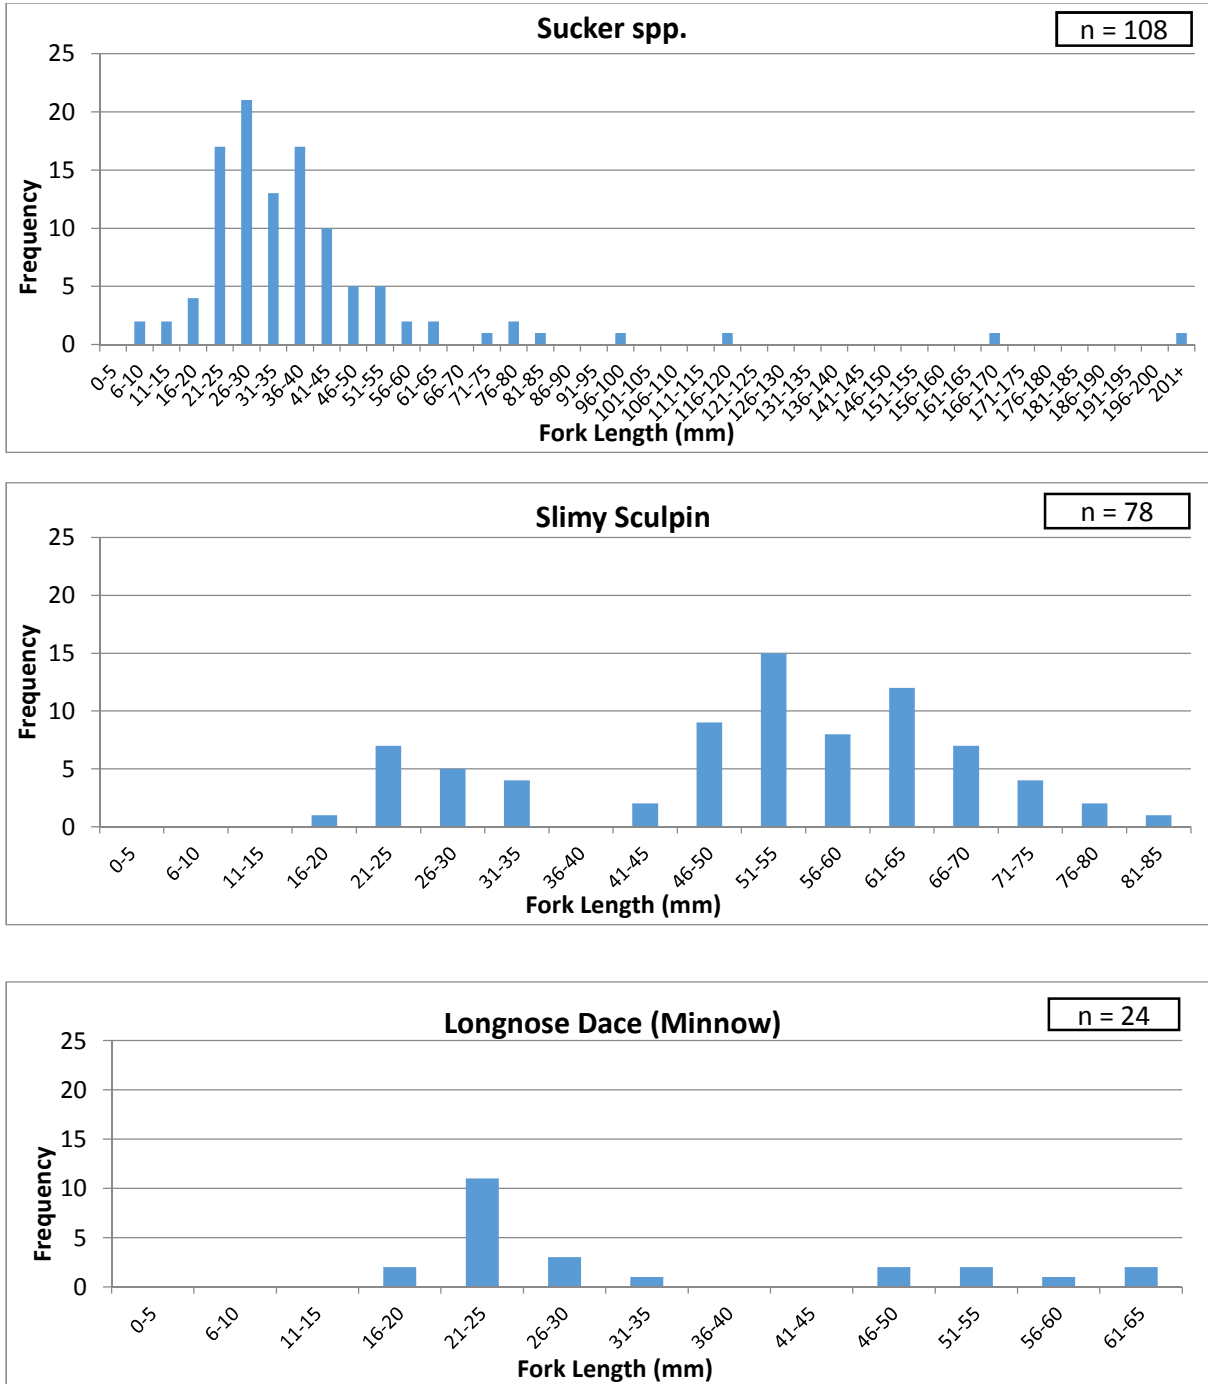
Figure 3.2 Fork length frequency results for Sucker spp., Slimy Sculpin, and Longnose Dace, collected during Year 2 (2017) stranding surveys

Fork length was measured for all fish collected during the sampling events. A summary of the fork length frequency data for the three most commonly observed species groups (sucker, slimy sculpin, and longnose dace) is provided below.

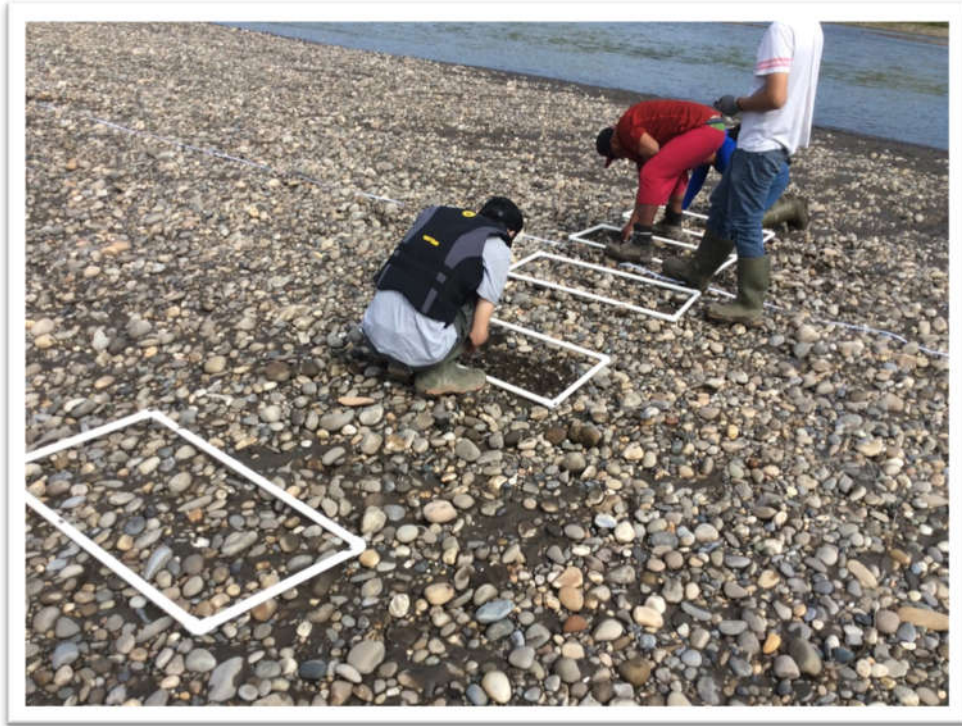
Plate 1 Interstitial sampling on Trip 1, Day 1 using 0.5 m² frames. This method was used on Trip 1 and Trip 2 only.

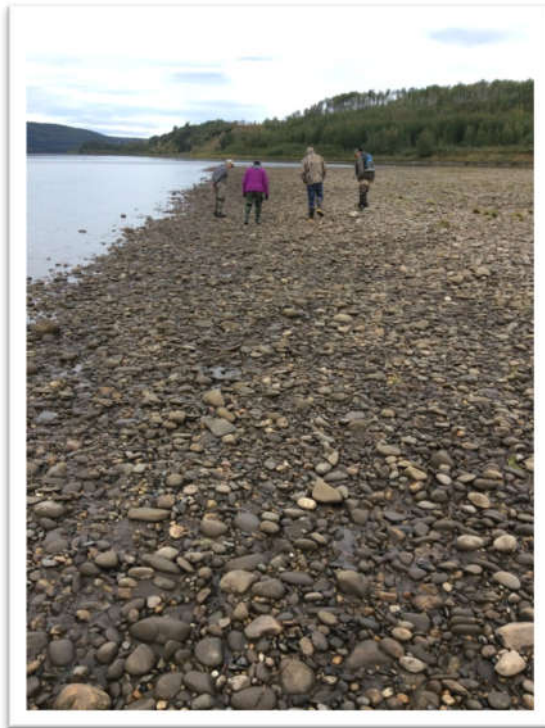
Plate 2 Crew conducting broad-based interstitial sample, with a group of four walking together along the recently de-watered substrate within the Diversion Headpond on Day 5 (August 26, 2017).

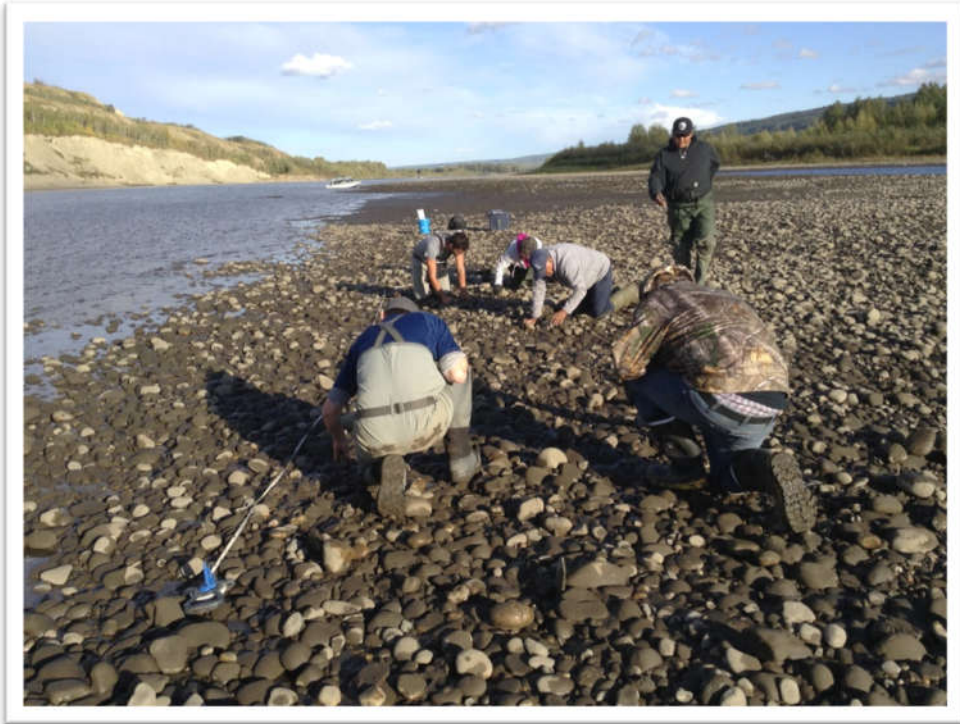
Plate 3 View of hot-spot interstitial sampling within a Multi-thread Unclassified Risk site within Reach 2 (17-02-07-04) on Trip 4, Day 7 (September 9, 2017).

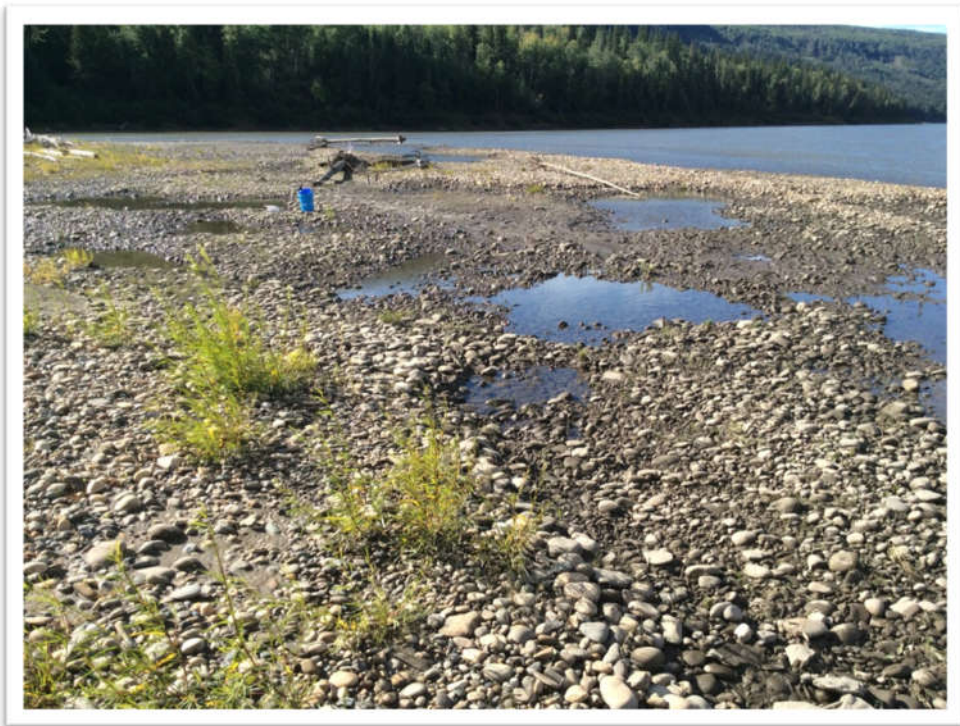
Plate 4 View of isolated pools within a Multi-thread Low Risk site within Reach 3 (17-04-06-02) on Trip 3, Day 6 (August 27, 2017).

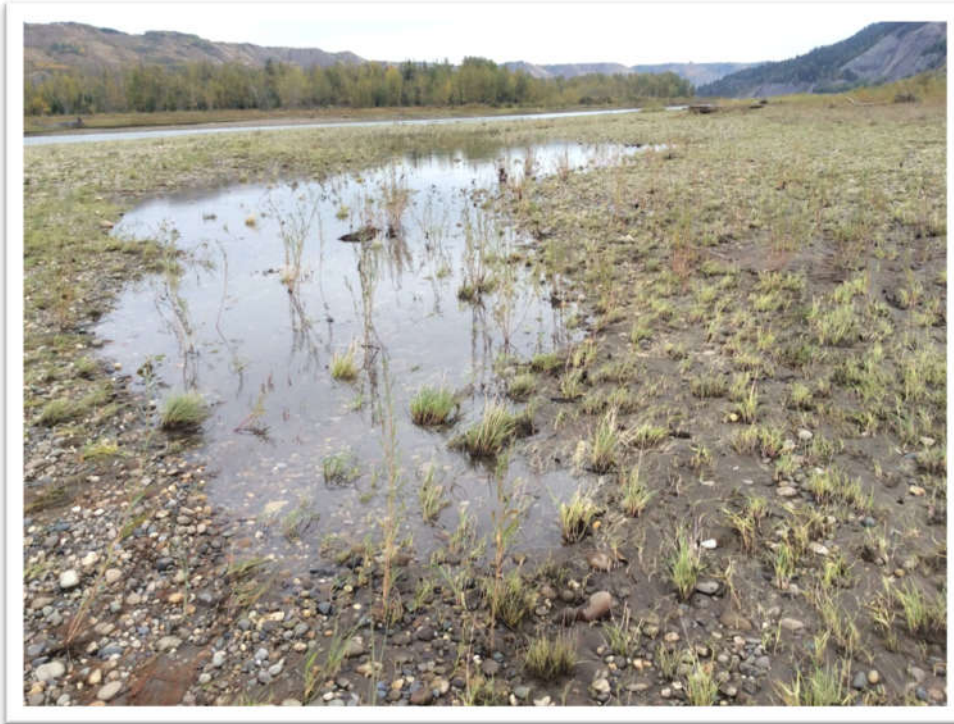
Plate 5 View of isolated pool on a mid-stream gravel bar (island) within a Multi-thread High Risk site within the Diversion Headpond (17-04-07-02) on Trip 4, Day 7 (September 9, 2017).

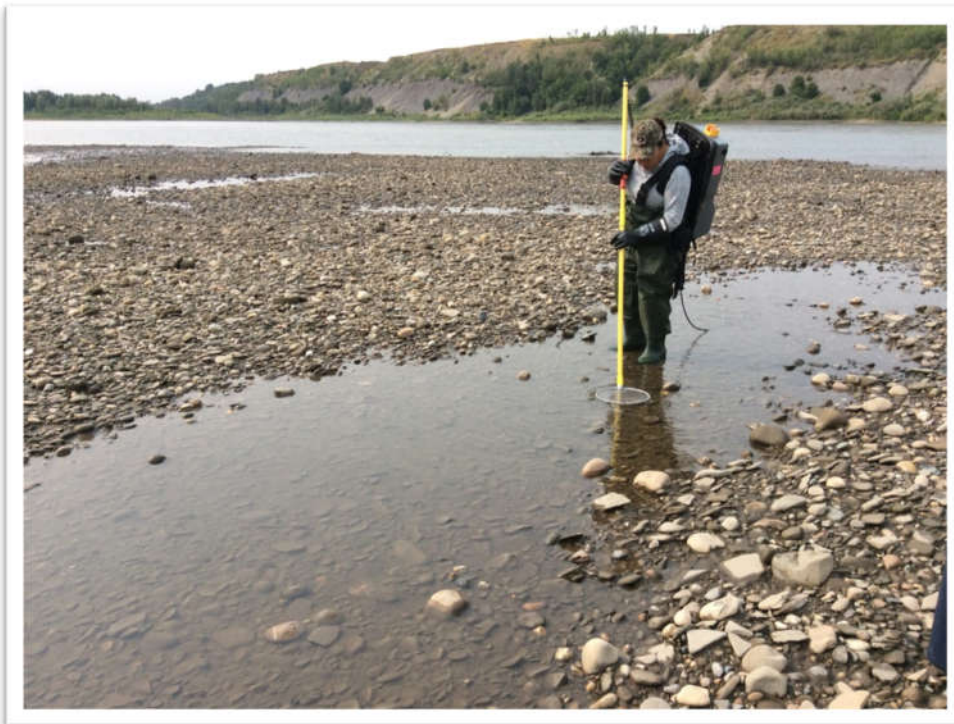
Plate 6 View of electrofishing sampling of isolated pools within a Multi-thread Unclassified Risk site within Reach 2 (17-08-03-04) on Trip 2, Day 3 (August 12, 2017).

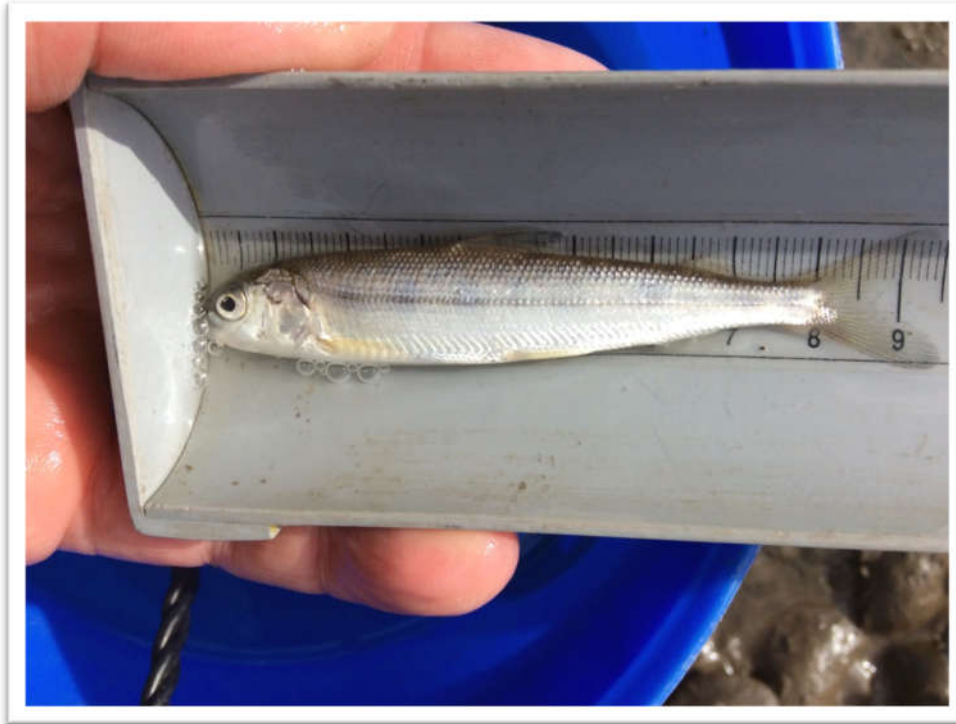
Plate 7 View of juvenile Mountain Whitefish collected during interstitial sampling within a Multi-thread High Risk site within Reach 3 (17-08-06-01) on Trip 3, Day 6 (August 27, 2017).

All captured fish (live or dead) were released into the mainstem of the Peace River following the sampling event. Crews were equipped with fish species keys and a hand lens for identification. In cases where fish identification was difficult or there were time constraints, photos were taken of the fish on the measuring board or in hand for confirmation of identification (Plate 7). As per previous Project discussions, collection of voucher specimens is not within the scope.

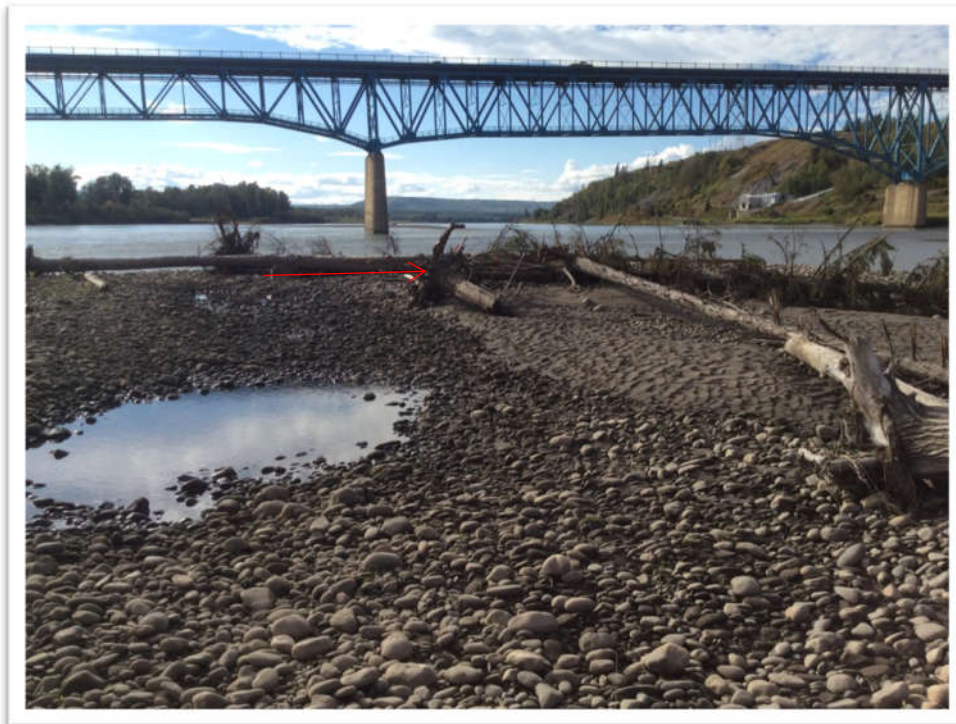
Plate 8 View of Camera 1 setup (indicated by red arrow) on a mid-island bar (island) downstream from the Taylor Bridge within a Multi-thread High Risk site at the upper end of Reach 2 associated with sampling site 17-07-07-05 conducted on Trip 4, Day 7 (September 9, 2017).

Camera 1 recorded conditions on a mid-stream (island) gravel bar, immediately downstream of the Taylor Bridge. The camera was secured to the root wad of a piece of large woody debris within a larger pile of debris. During the high water period of the ramping event on September 19, the woody debris shifted and the angle of the camera was altered. As such, the imagery from September 20 onward does not show the subject gravel bar. However, the rising and lowering of the river level is apparent throughout the recording period and shows the formation of pool during reduction events. The camera was re-positioned during a sampling event on September 23, where two fish were collected during the electrofishing of three pools (17-04-09-03). Following the sampling event, the images show one of the pools continue to dewater, although the camera stops recording images prior to the complete dewatering due to low light. A series of the time-lapse images is shown on Plate 11.

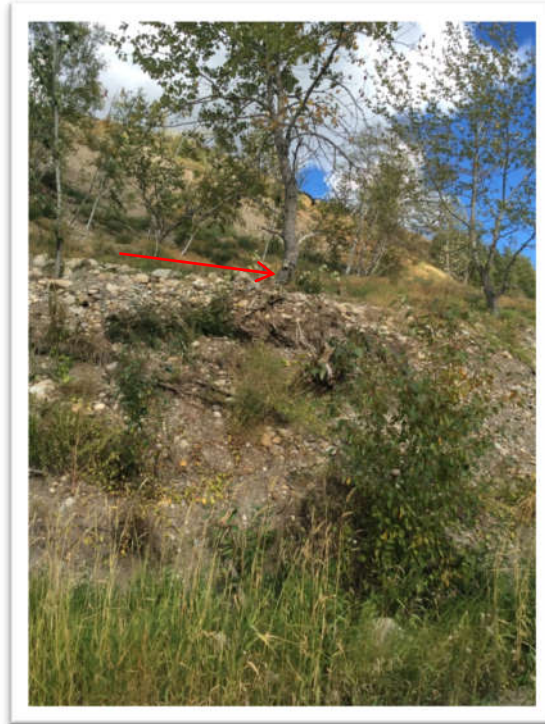
Plate 9 View of Camera 2 setup (indicated by red arrow) along the left bank of the Peace River within a Multi-thread High Risk site at the upper end of Reach 2 associated with sampling site 17-08-07-04 conducted on Trip 4, Day 7 (September 9, 2017).

Camera 2 recorded conditions along a side channel bar across from the Pine River fan. The camera was secured to the base of a tree on the left bank and oriented towards the river channel. This camera shows the same ramping activities and the formation of pools along the side channel. In some cases, the pools appear to dewater completely prior to becoming re-connected the mainstem flows (see images on Plate 12).

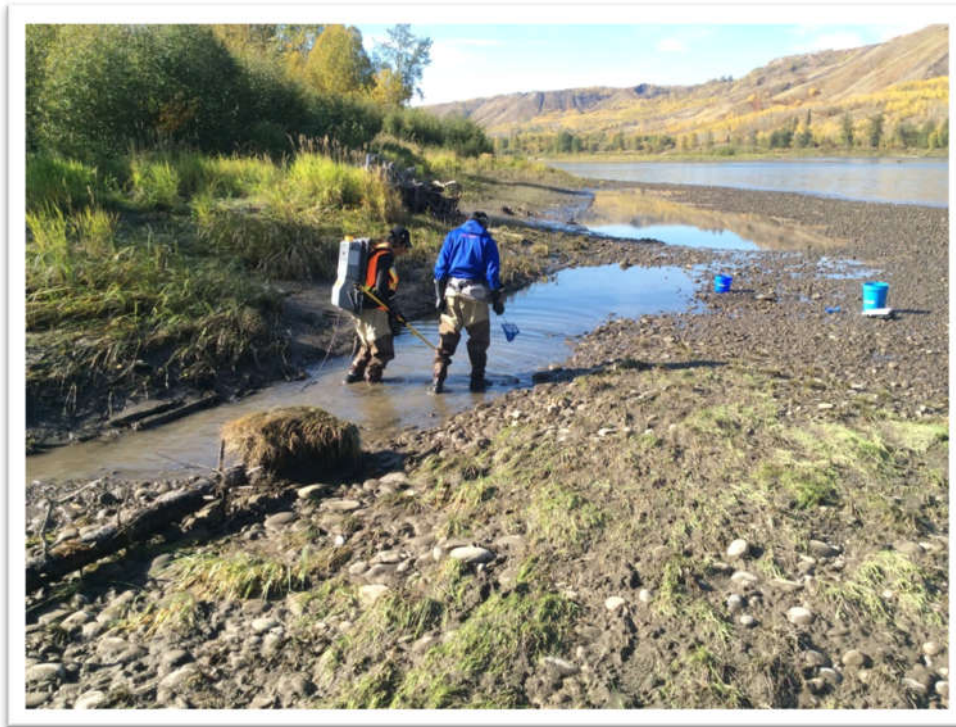
Plate 10 View of electrofishing sampling of isolated pools where temperature data loggers were installed at a Single-thread High Risk site within Reach 1 (17-04-09-02) on Trip 5, Day 9 (September 23, 2017).

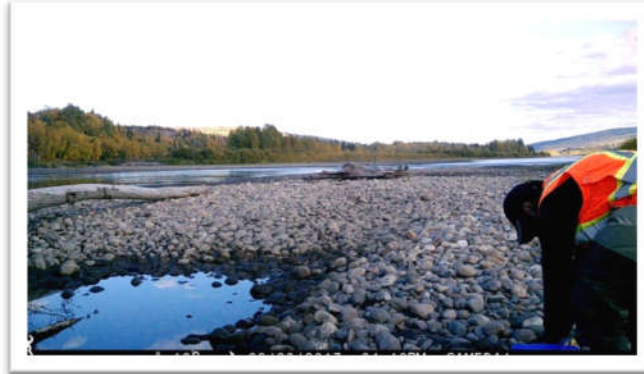
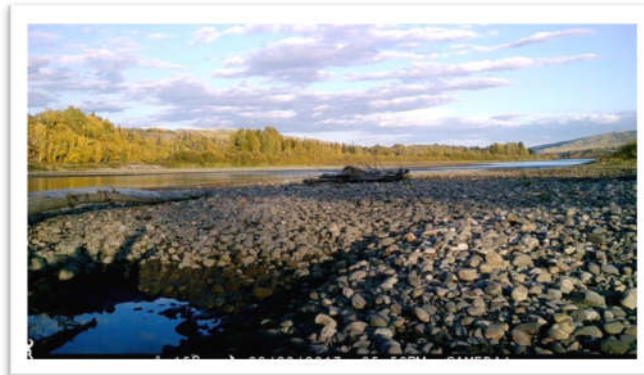
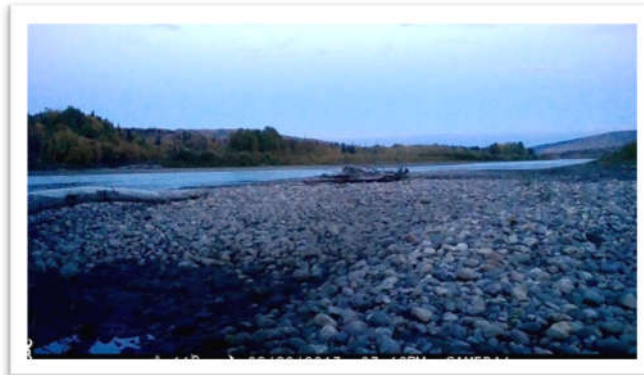
Image 01: Taken prior to sampling (16:19).

Image 02: Taken approximately one hour following sampling (17:42)

Image 03: Taken at 19:12

Plate 11 View of time lapse images from Camera 1 at Site 1, within Reach 2 during the sampling event 17-04-09-03 on September 23, 2017. The sampled pool in the foreground can be seen shrinking prior to sunset at which point it is no longer visible.

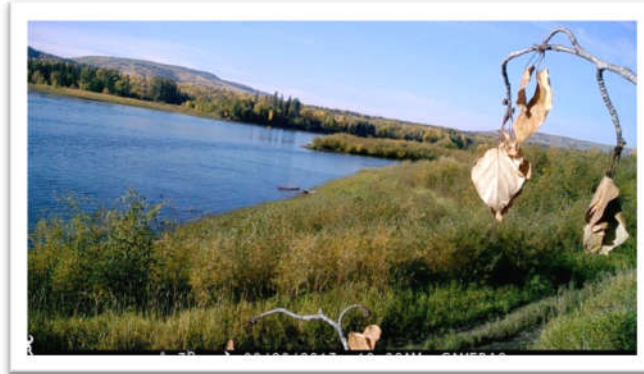
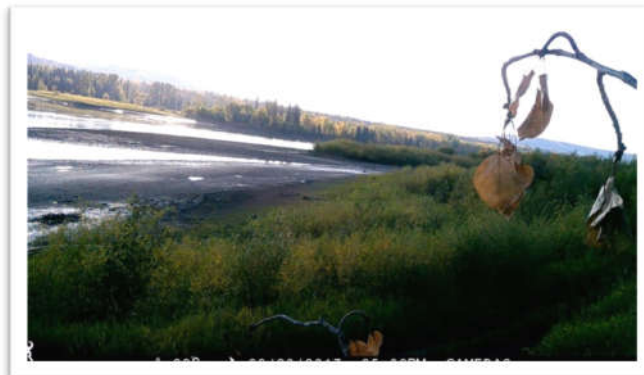
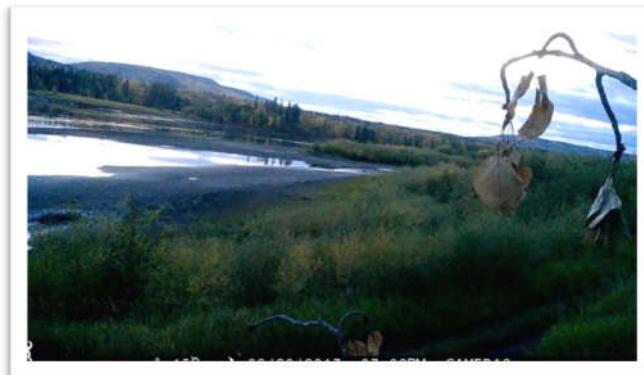
Image 01: High water level prior to the initiation of the reduction event (10:02)

Image 02: Low water level prior to flows rising (17:02). Pools can be seen forming along the dewatered substrates.

Image 03: Mainstem flows rising and pools have mostly dewatered. One pool is visible although the low light prevents the confirmation of whether it dried out completely prior to becoming reconnected to the mainstem.

Plate 12 View of time lapse images from Camera 2, within Reach 1 on September 23, 2017. Images show the reduction event from high water to low water levels and the drying out of residual pools.
