Site C Clean Energy Project

Site C Fish Stranding Monitoring Program (Mon-12)

Construction Year 4 (2018)

Site C Fish Stranding Monitoring Program (Mon-12) 2018 Data Report

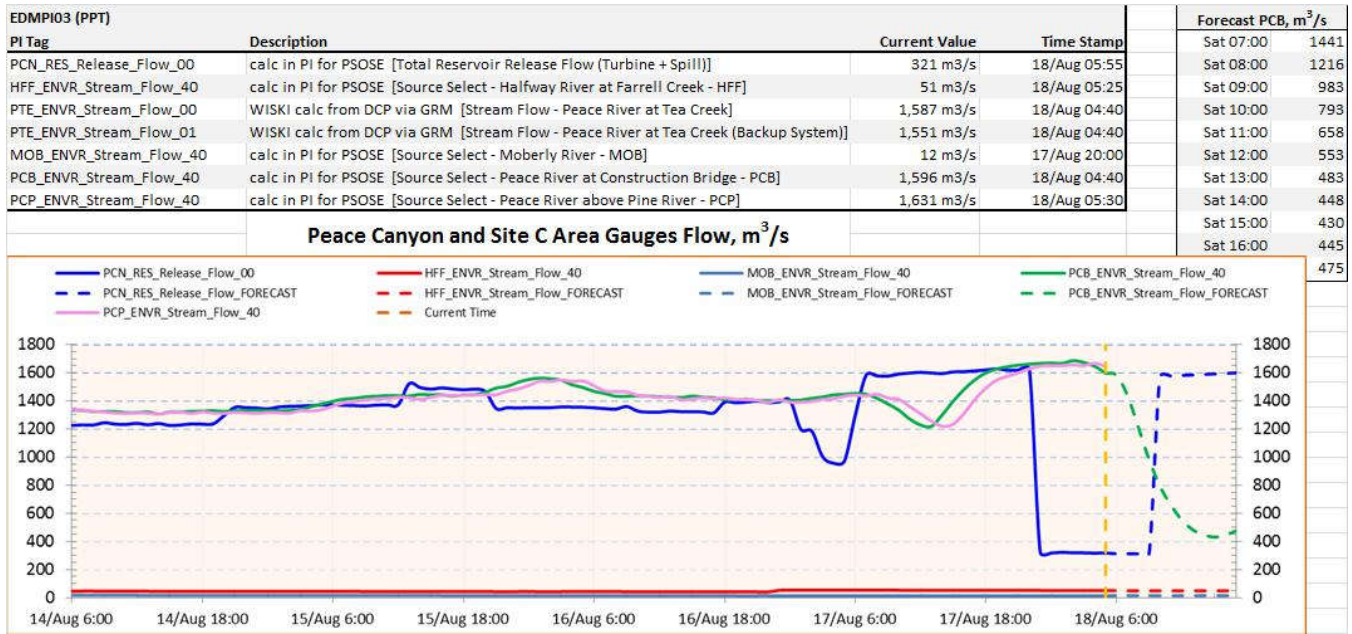
Figure 2.2 Example of typical flow report provided by BCH showing the forecasted reduction event (dashed lines) at PCN prior to Trip 2 on August 18, 2018.

To help coordinate the timing of crew arrival at each reach, BCH provided Ecora with a Peace River flow report via email every six hours which showed discharge rates over the previous four days and a twelve-hour forecast. An example of a typical report is provided in Figure 2.2.

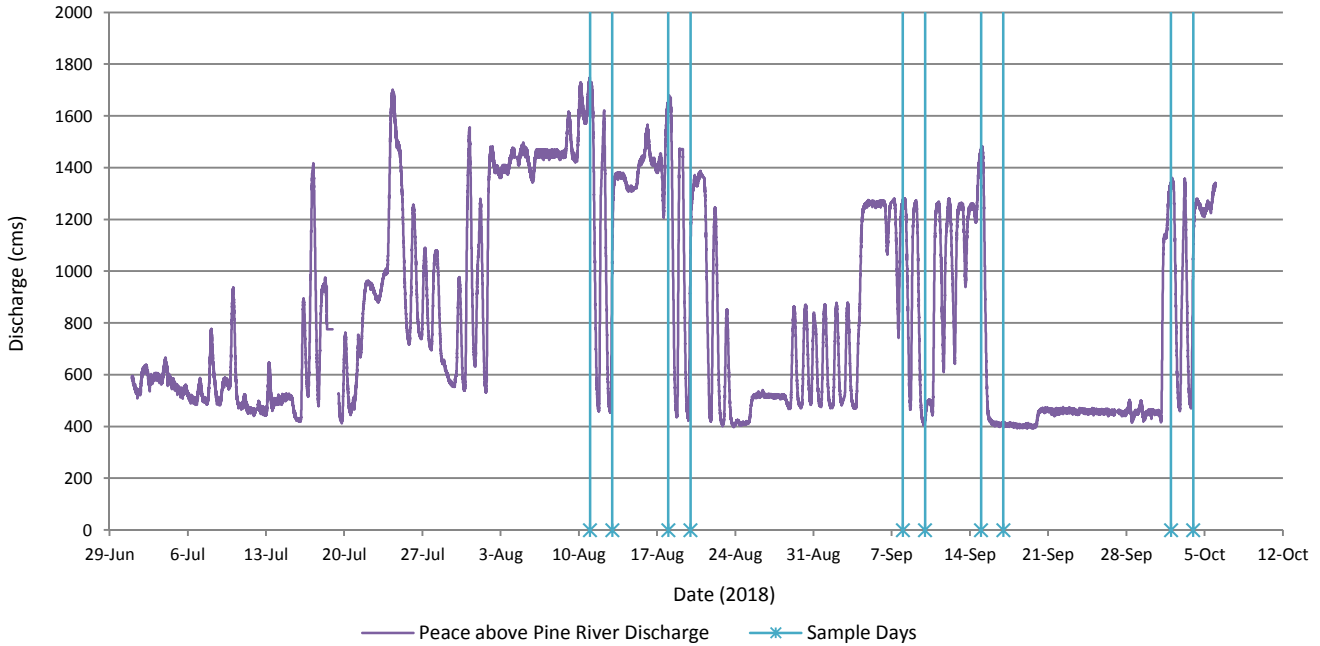
Figure 3.1 Summary of discharge recorded at the Peace River above Pine River (07FA004) Water Survey of Canada Hydrometric Station (purple) and sampling days (blue) between June 29 and October 7, 2018

The Peace River above Pine River [07FA004] Water Survey of Canada hydrometric station (PRPR) data shows that maximum discharge of 1,749 cms occurred on August 10, prior to Trip 1. Minimum discharge of 392 cms occurred on September 19 (Figure 3.1). Sampling days are shown in Figure 3.1 as vertical blue lines.

Sampling was not planned in June or July as PCN discharge was kept low, near the water licence minimum, and there were no ramping events planned. The site reconnaissance trip completed by Ecora and Ecofish was on July 9, 2018 during a period of low flow. Freshet flows and rainfall attenuated the effects of ramping from PCN in July and peak discharge rates (e.g., July 16 and 24) associated with rain events were relatively short in duration (i.e., preceded by low flows and therefore short period of wetted history which reduces the risk of stranding).

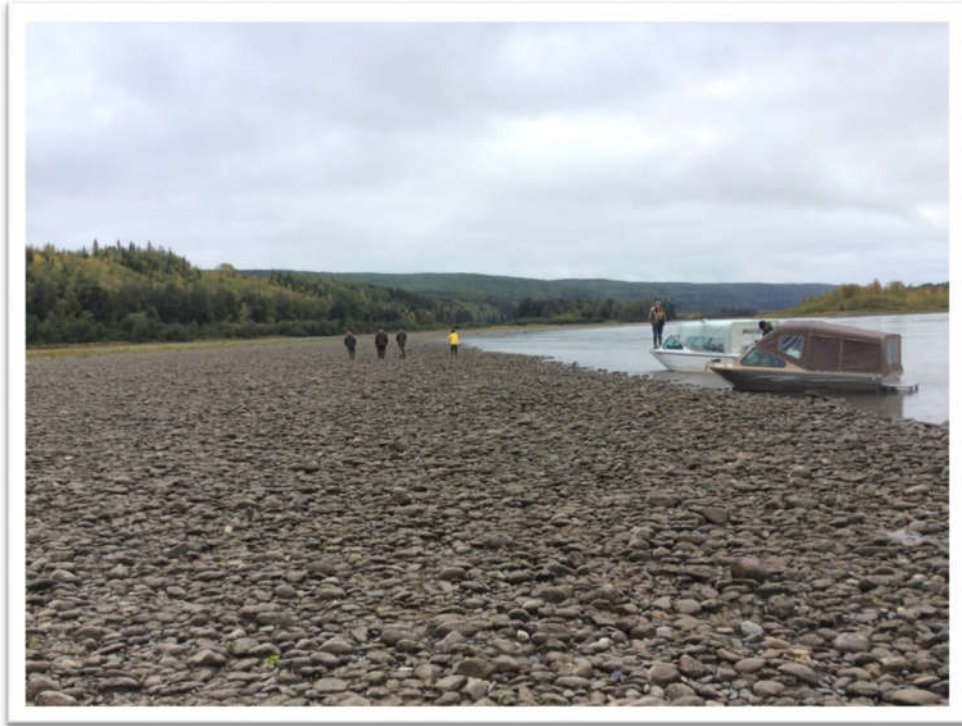
Plate 1 View of interstitial sampling crew conducting Broad-based survey at site HP-M-H-238 on Trip 3 – Day 6 (September 9, 2018)

- An overview ('Broad-based') search was completed by the crew over a portion of the site to search for obvious fish presence (i.e., readily observable without overturning substrates). The crew searched at least 100 m length (i.e., transect) along the shoreline in an upstream direction or as the available sampling area allowed. Crews completed the overview sampling by walking side by side over the entire area (Plate 1).

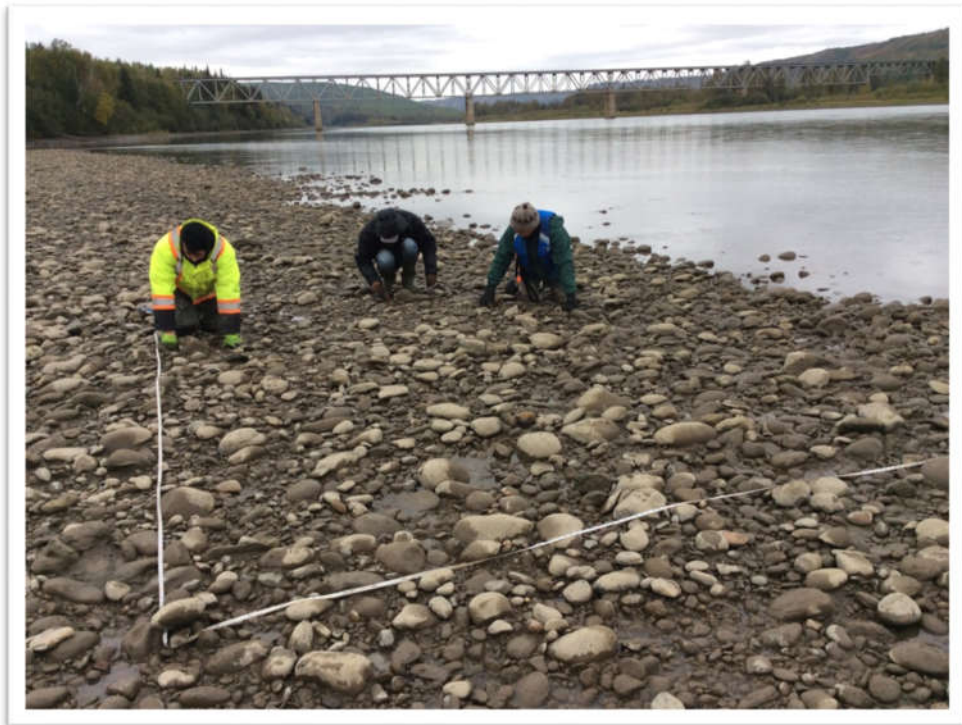
Plate 2 View of crew conducting Hot-spot interstitial sample at site 1-S-H-399 on Trip 4 – Day 8 (September 16, 2018)

- At each Hot-spot, a measuring tape was laid out to delineate two sides of a sampling area, typically 4-m by 5-m or 10-m by 2-m for a total of 20 m² of sampling area per Hot-spot (with a target of 100 m² of total Hot-spot sampling per site). Within each Hot-spot, crews overturned all rock substrates and other cover (e.g., vegetation, woody debris) to search for fish (Plate 2).

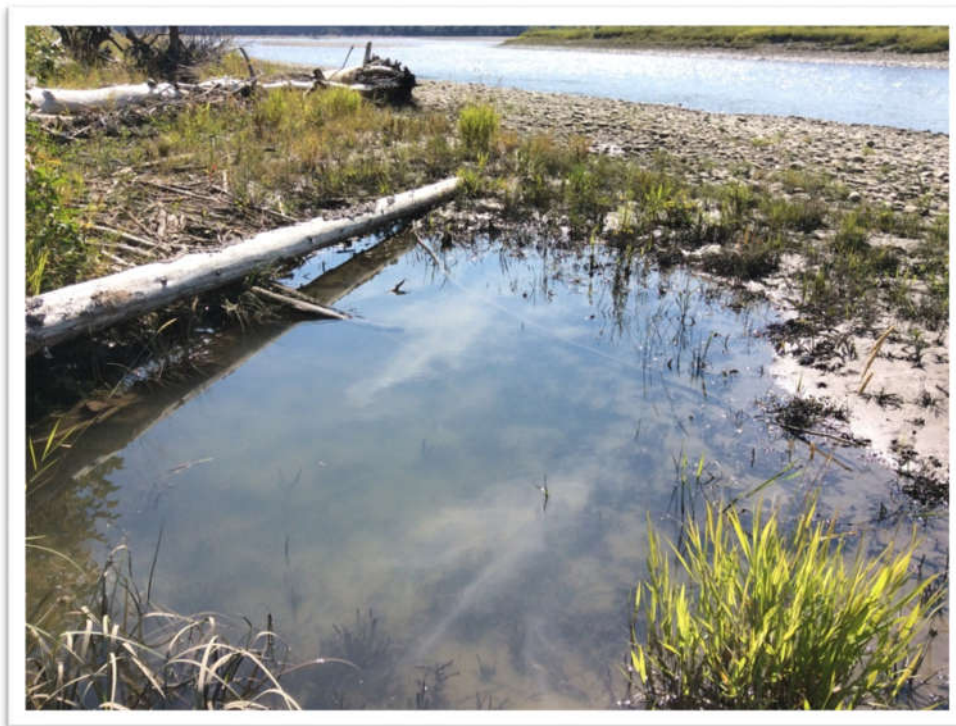
Plate 3 View of typical pool sampling location at site HP-M-H-411 on Trip 1 – Day 1 (August 11, 2018)

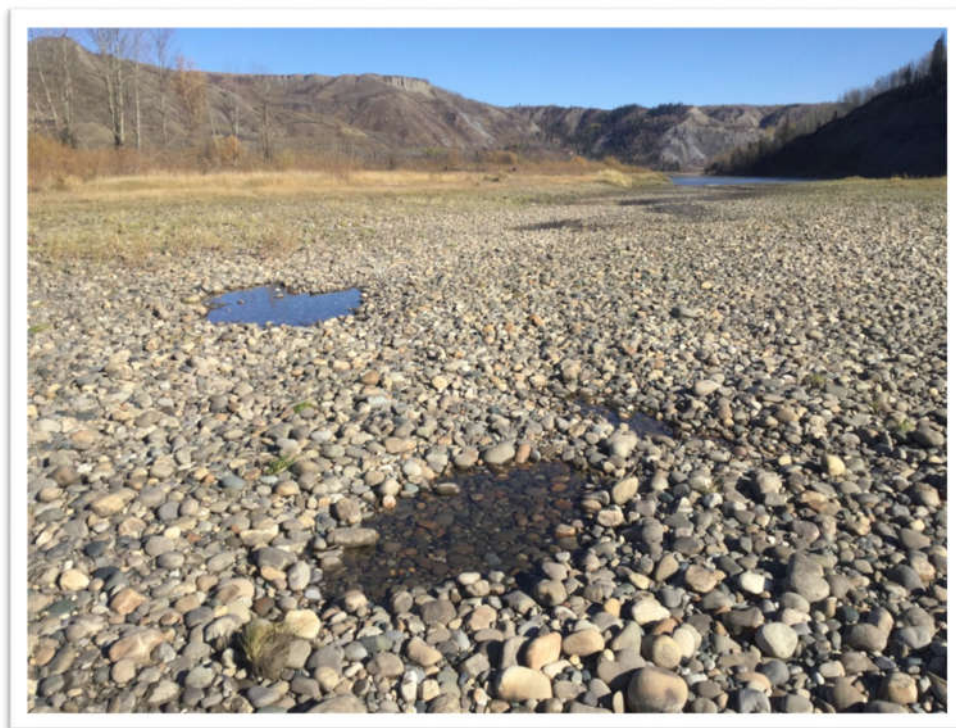
Plate 4 View of pool sampling site 1-M-H-251 on Trip 5 – Day 9 with multiple small pools occurring throughout (October 2, 2018).

- If one to three pools were observed at a site, each pool was sampled. At sites where more than three pools suitable for sampling had formed, a subset of three pools was selected for sampling (Plate 4). Pools with the greatest likelihood of containing fish were selected for sampling, based on habitat suitability, including relative size and depth, coarse substrates, and low embeddedness.

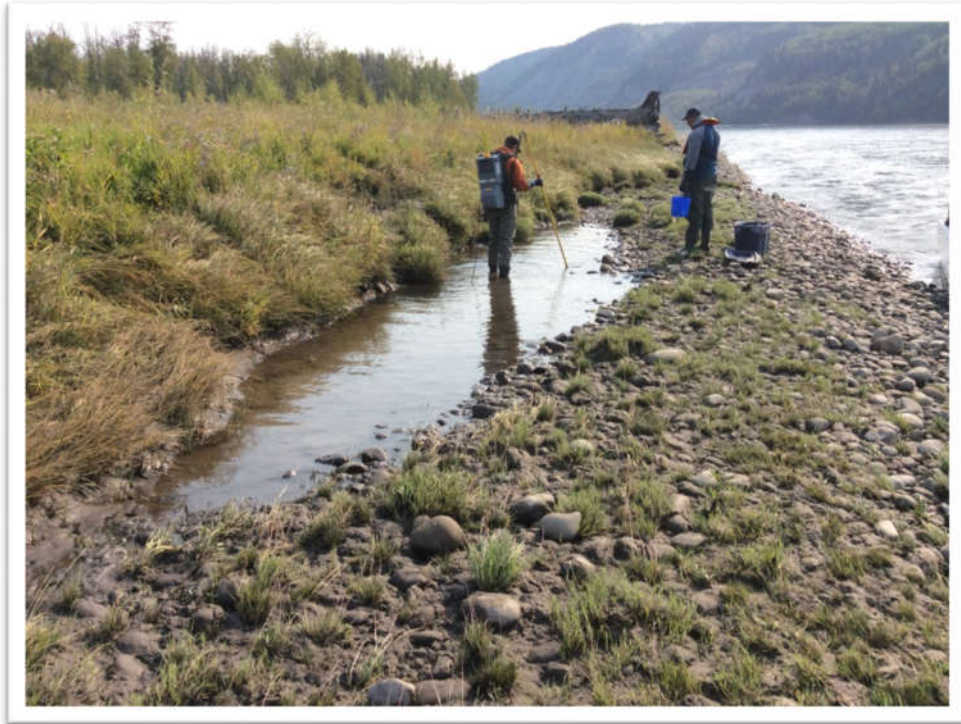
Plate 5 View of electrofishing sampling at an isolated pool at site HP-M-H-67 on Trip 2 – Day 4 (August 19, 2018)

- Sampled pools were searched visually and backpack electrofishing was used to confirm fish presence and collect fish, where possible (Plate 5). Multi-pass electrofishing techniques (i.e., minimum two passes per pool; typically, three were conducted) were used to collect all fish present within each pool. The LR-24 quick setup was used to determine initial settings with manual changes made to optimize capture success.

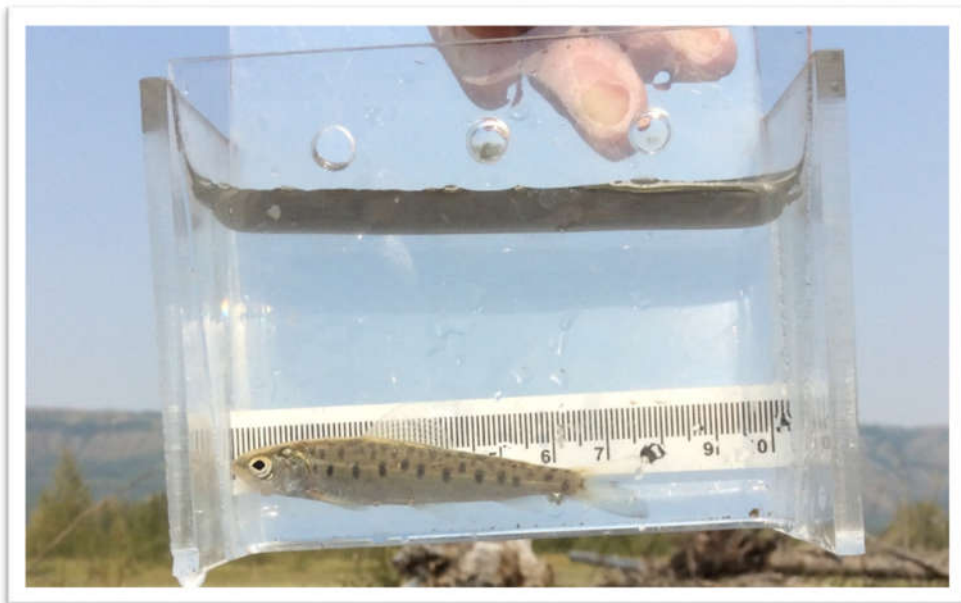
Plate 6 Fish viewer used to measure and photograph Arctic Grayling collected from a pool at site 1-M-H-251 on Trip 2 – Day 4 (August 19, 2018)

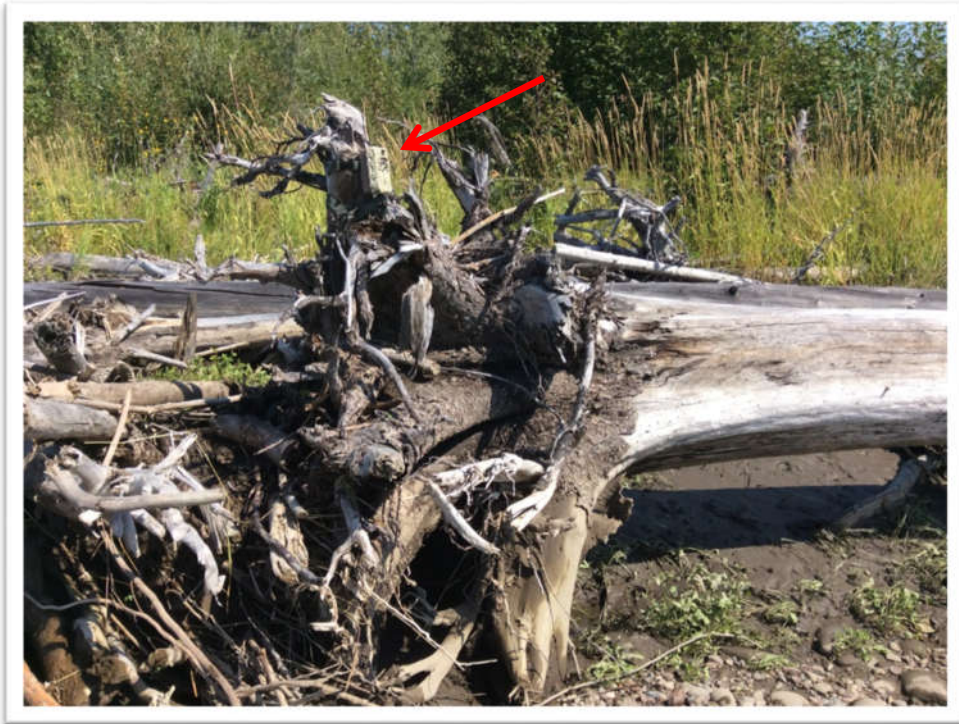
Plate 7 View of Camera 07 (indicated by red arrow) attached to the root wad of a piece of large woody debris at site HP-M-H-411 on Trip 1 – Day 1 (August 11, 2018)

To further our understanding about the risk of fish isolated in pools becoming stranded, time-lapse cameras (Browning Command Ops Model BTC-4) were set up at ten sites throughout the 2018 study area (Plate 7). The intended use of the images from the remote cameras was to address uncertainty associated with the time fish remain isolated in pools and the risk of isolated fish becoming stranded (as pools dry out). Where possible, each sampling event where isolated fish were observed during pool sampling at a camera location was cross-referenced to estimate the time the pool became isolated until the time the pool became inundated (i.e., until the river level ramped up and re-connected the pool to the mainstem) or the time until the pool dried out.

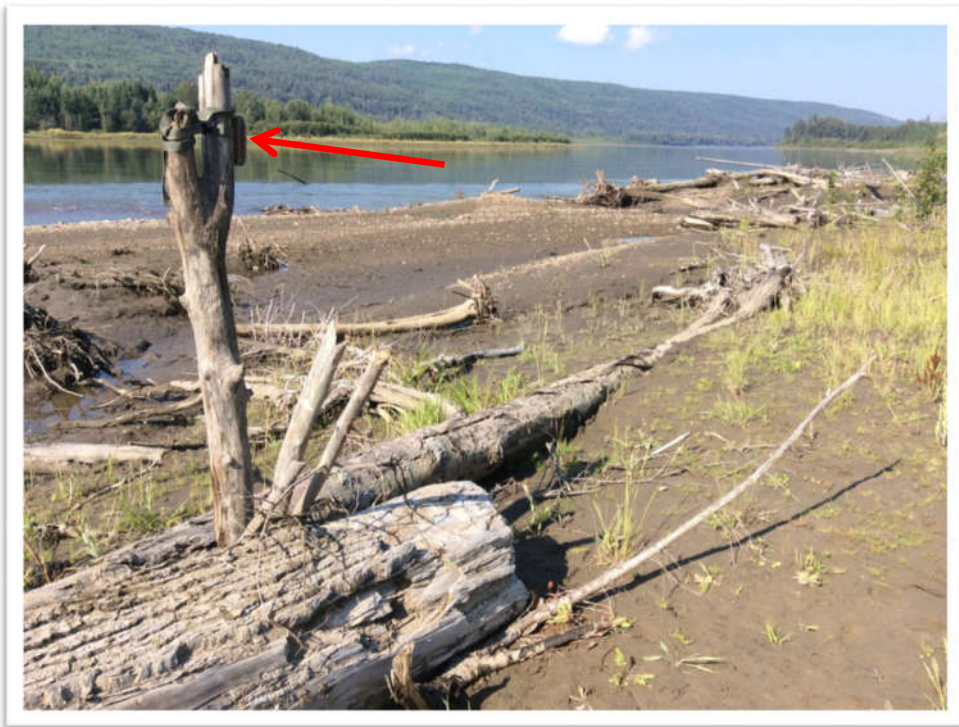
Plate 8 View of Camera 04 (indicated by red arrow) attached to a log propped up amongst large woody debris at site HP-M-H-82 on Trip 1 – Day 2 (August 12, 2018)

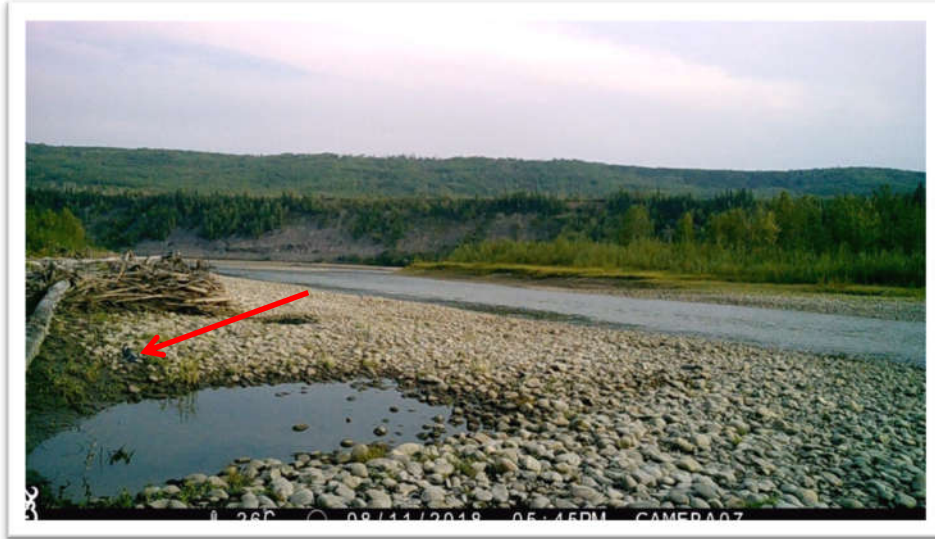
1. Sample Event 18-08-01-02 – Evidence of potential predation from diving piscivorous bird (see Plate 9);
2. Sample Event 18-08-02-01 – Pools dried out after four hours;
3. Sample Event 18-08-02-02 – Pools dried out after four hours (second sampling event at same site as above); and
4. Sample Event 18-01-06-05 – Pools appear to dry out after approximately 12 hours and remain dry for another approximately 18 hours.

Plate 9 Time-lapse image from Camera 07 showing a Belted Kingfisher (indicated by red arrow) diving into Pool 1 at site HP-M-H-411 on Trip 1 – Day 1 (August 11, 2018)

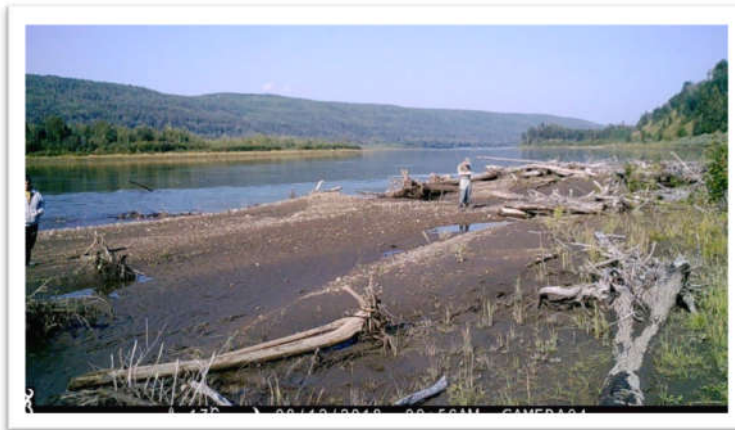
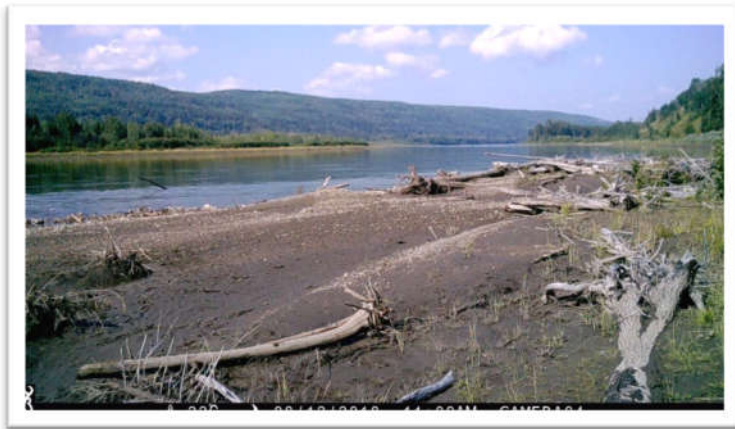
Plate 10 Time-lapse images from Camera 04 showing (upper photo) pools at time of sampling (09:45) and (lower photo) pools dried out (11:00) at site HP-M-H-82 on Trip 1 – Day 2 (August 12, 2018).

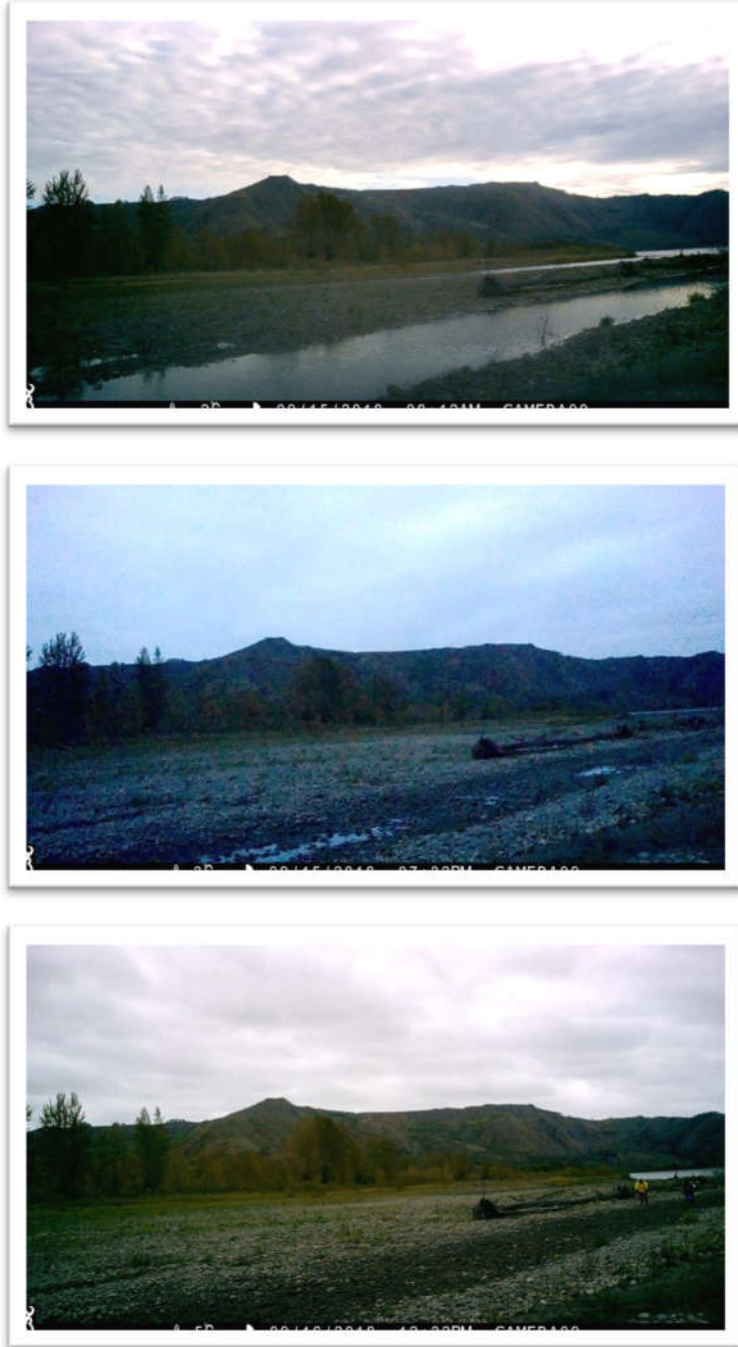
Plate 12 Time-lapse images from Camera 09 at site 1-M-H-251 showing (upper photo) pool at time of isolation (September 15 08:12), (middle photo) pool at time of drying out (September 15 19:32), and (lower photo) crew conducting interstitial sample event 18-01-08-04 on Trip 4 – Day 8 (September 16 12:32). There were 21 stranded fish collected, 17 of which were dead.

Interstitial sampling event 18-01-08-04 was conducted at a site that usually contains a large pool following a reduction event but had dried out on Day 8 and 21 stranded fish were observed, 17 of which were dead (Plate 12). The sites where fish were collected on Day 7 were not monitored by cameras so the imagery cannot be used to confirm. Similarly, sample events at sites monitored by cameras did not result in fish collection so an estimate of stranding cannot be made.

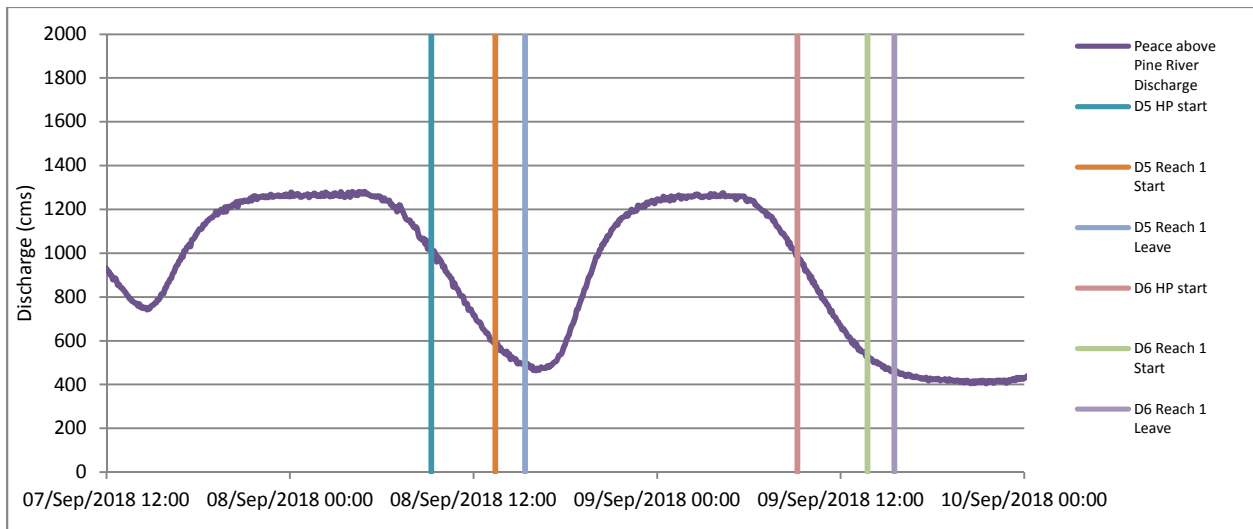
Figure C-3. Trip 3 (Day 5 and 6) on September 8 and 9, 2018

Summary of discharge recorded at the Peace River above Pine River (07FA004) Water Survey of Canada Hydrometric Station during each of the five sampling trips between August 11 and October 3, 2018 and the approximate survey start time at the Diversion Headpond (HP) and the survey start/finish time at Reach 1 (hydrometric data provided by operations staff at Peace Canyon Dam on October 9, 2018).

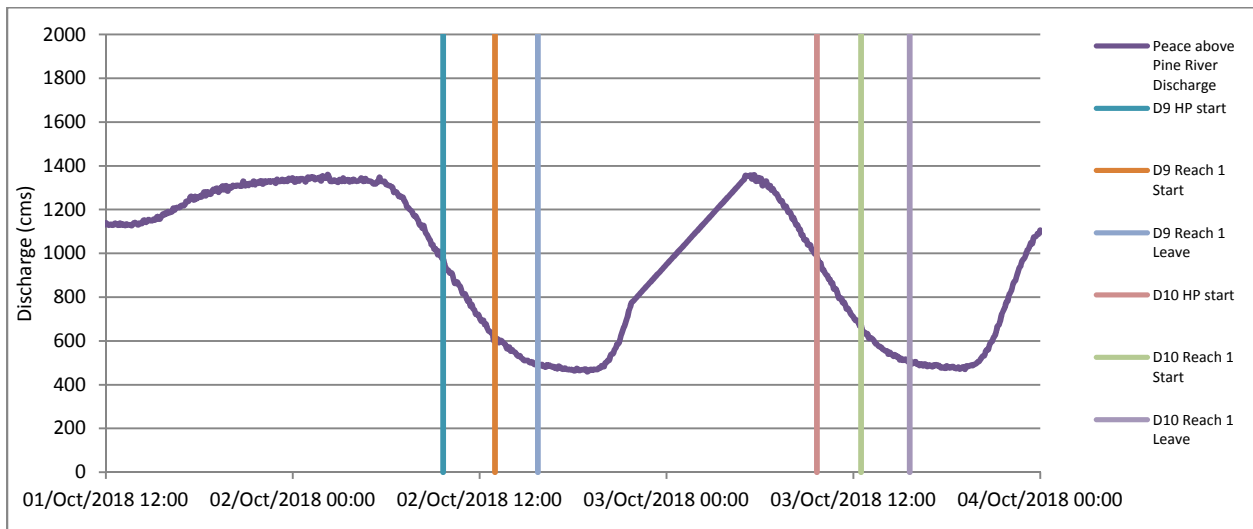
Figure C-5. Trip 5 (Day 9 and 10) on October 2 and 3, 2018
