Site C Clean Energy Project

Quarterly Progress Report No. 29

F2023 Fourth Quarter

January 1, 2023 to March 31, 2023

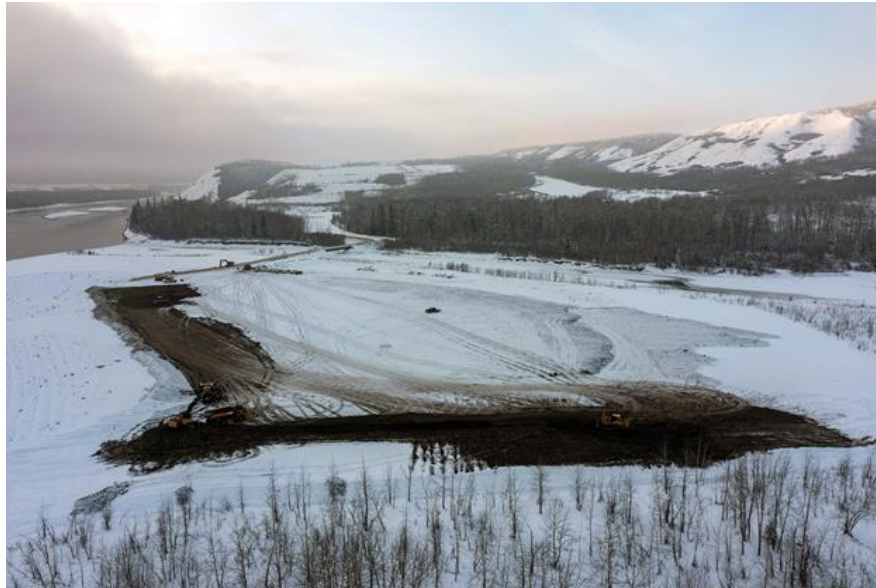
Figure A-1 Phase 1 of the P6 island (an island in the Peace River near Old Fort) reclamation work was completed in mid-January 2023. The island's original soil has been spread over the disturbed areas to allow for growth of seedlings which will be planted in spring 2024 | January 2023

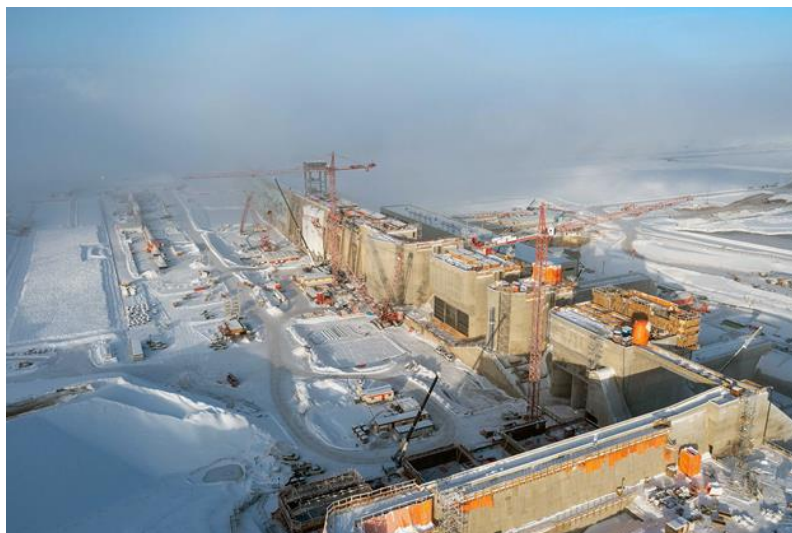
Figure A-2 The upstream wall of the passive spillway (foreground) where water enters the spillway | January 2023

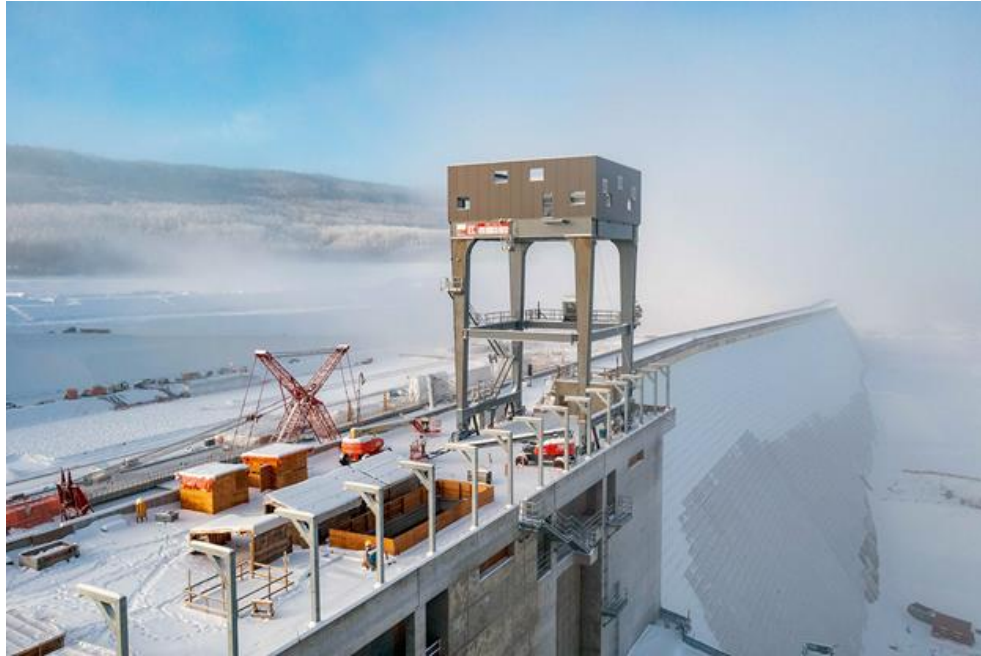
Figure A-3 Assembly of the permanent gantry crane, used for heavy lifts, located above the intakes for the generating units | January 2023

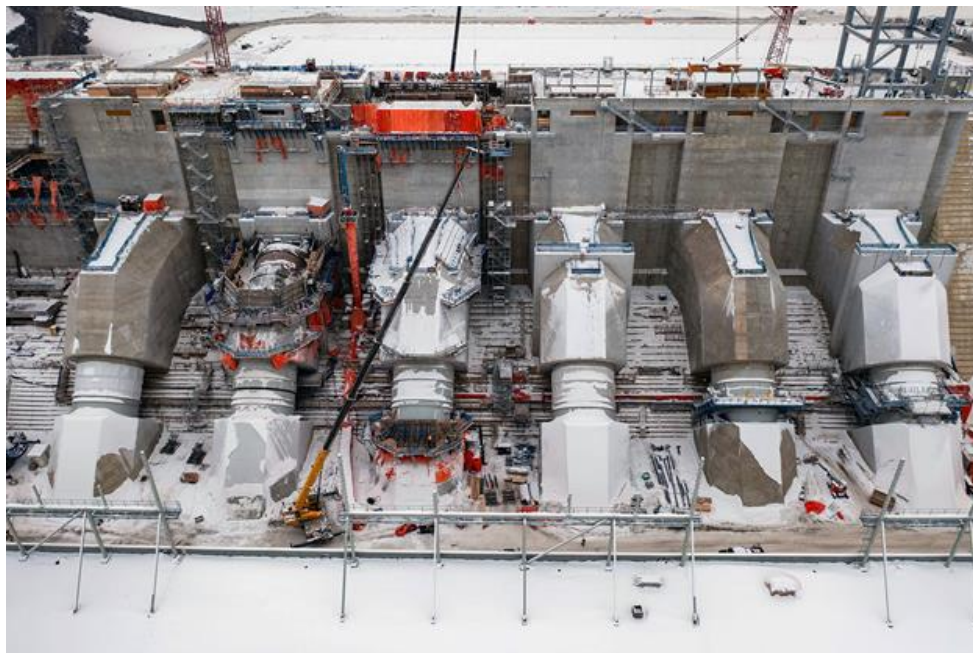
Figure A-4 Formwork being built to encase the unit 5 penstock in concrete | January 2023

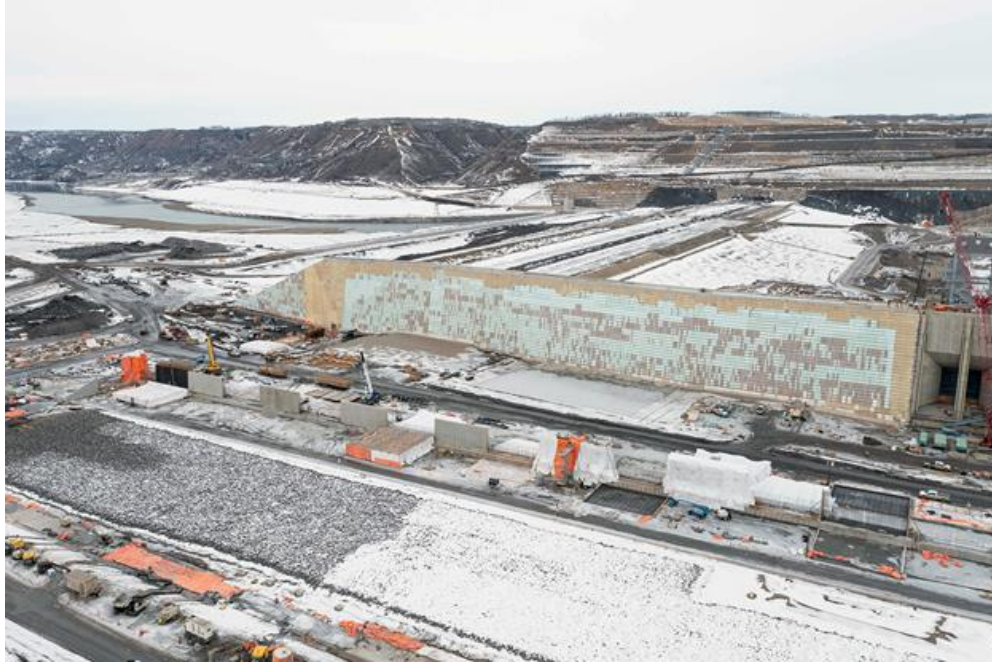
Figure A-5 Construction of the approach channel wall | February 2023

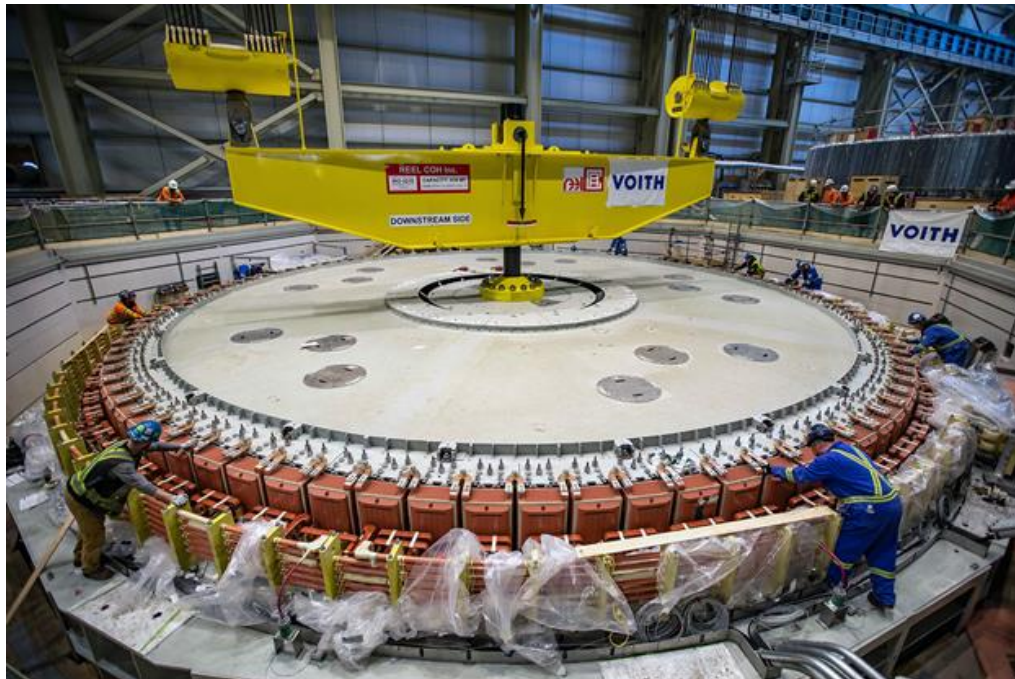
Figure A-6 Unit 1 rotor is lowered into position inside the unit 1 stator | February 2023

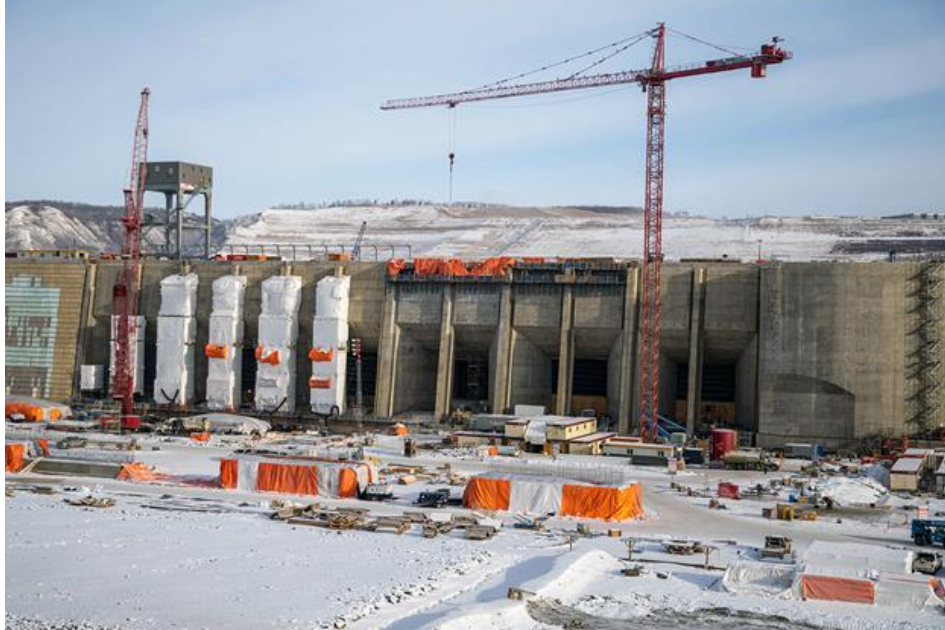
Figure A-7 The unit 2 and 3 trash rack guides are under the winter hoardings and work continues to complete the intakes for units 4 and 5 | March 2023

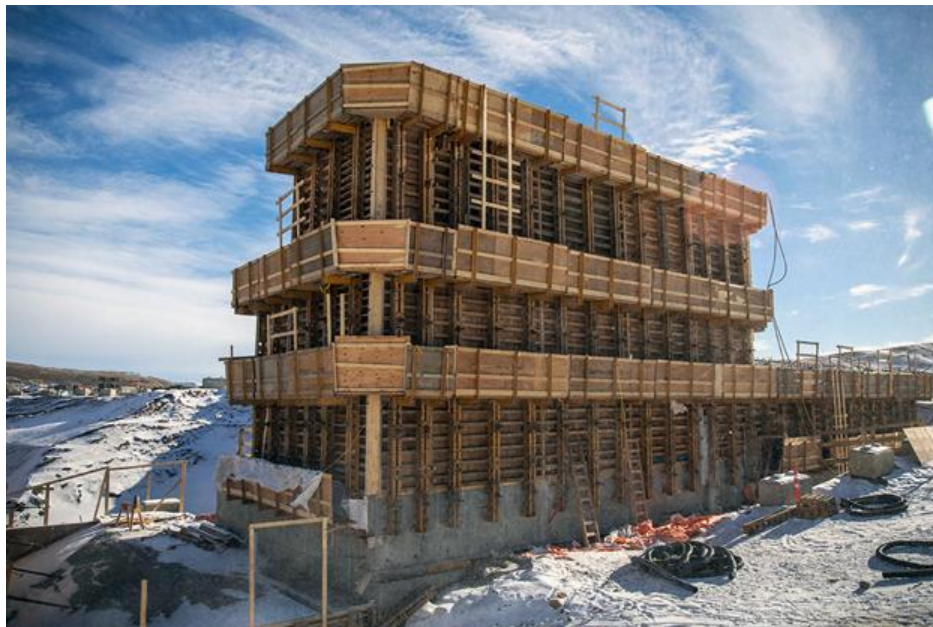
Figure A-8 The end wall of the auxiliary spillway as it transitions into the slurry wall. This is a trench filled with a concrete mix and rebar (slurry) down to bedrock to prevent water seepage | March 2023

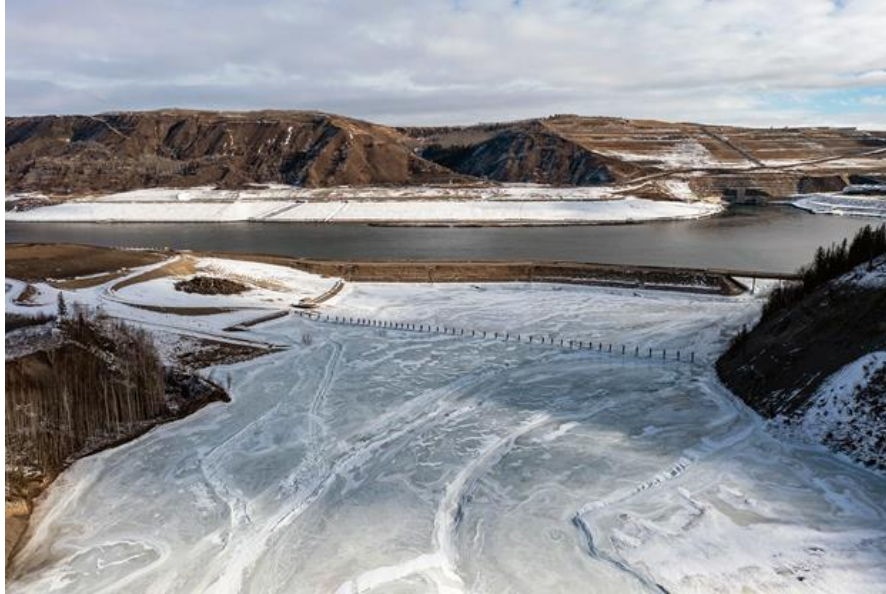
Figure A-9 Where the Moberly and Peace rivers meet upstream of the dam (foreground), the debris boom can be seen, along with the inlet portals for the diversion tunnels (top right) where the river flows around the dam | March 2023

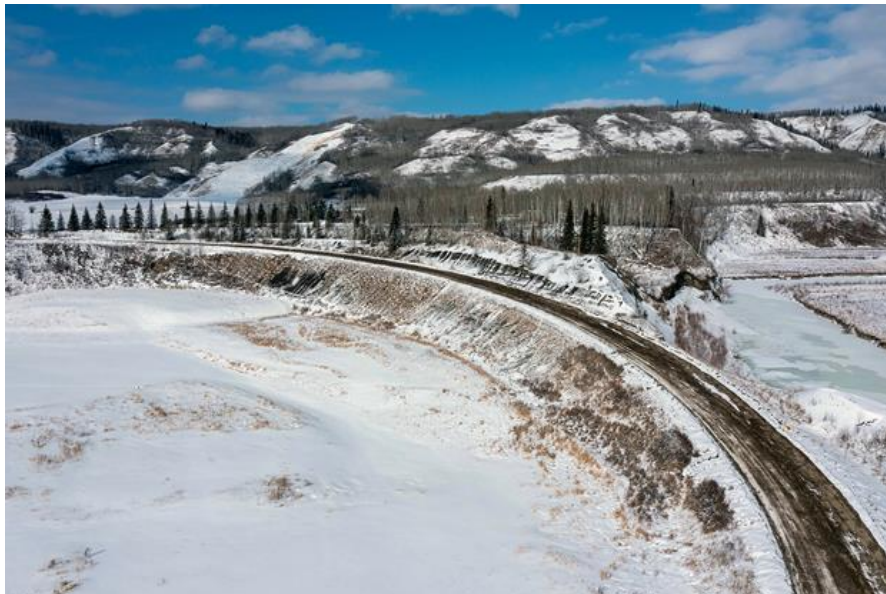
Figure A-10 The asphalt and sub-base gravel from the original Farrell Creek section of Highway 29 has been broken and hauled away to be ground and re-used in future road construction | March 2023
