**Site C Clean Energy Project**

PUBLIC Quarterly Progress Report No. 13 – July to September 2018 (Report)

**Quarterly Progress Report No. 13**

July 2018 to September 2018

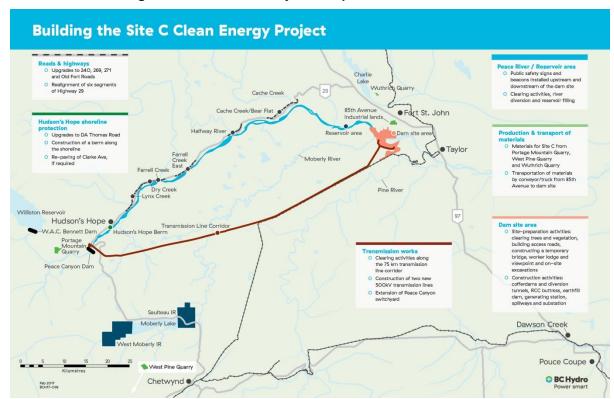
Figure 1 Site C Project Components

The Project includes the following key components (refer to Figure 1 and Figure 2):

- Access roads in the vicinity of the site and a temporary construction access bridge across the Peace River at the dam site;
- Construction of two temporary cofferdams across the main river channel to allow for construction of the earthfill dam;
- Worker accommodation at the dam site, with other workers being housed off site and in the region;
- The realignment of segments of Highway 29;
- Shoreline protection at Hudson's Hope;
- Two new 500 kilovolt AC transmission lines that will connect the Site C facilities to the existing Peace Canyon Substation, along an existing right-of-way;
- An 800-metre-long roller-compacted concrete buttress to enhance seismic protection;

- An earthfill dam, approximately 1,050 metres long and 60 metres high above the riverbed;
- A generating station with six 183 MW generating units; and
- An 83-kilometre-long reservoir that will be, on average, two to three times the width of the current river.

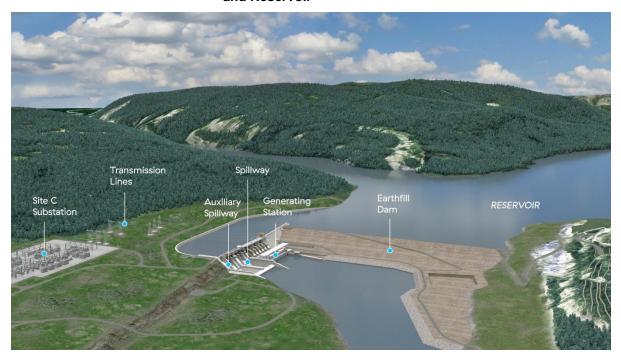
Figure 2 An Artist's Rendering Depicts the Site C
Earthfill Dam, Generating Station and
Spillways, Substation, Transmission Lines
and Reservoir

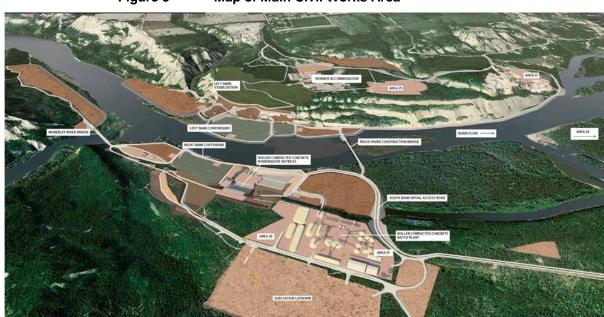
Figure 3 Map of Main Civil Works Area

The scope of the contract includes the construction of the following major components:

- Diversion works (including two approximately 11-metre diameter concrete-lined tunnels approximately 750 m in length);
- Excavation and bank stabilization (approximately 26 million cubic metres of overburden and rock excavation);
- Relocation of surplus excavated material (including management of discharges);
- Dams and cofferdams (including a zoned earth embankment 1,050 metres long and 60 metres above the present riverbed and stage 1 and 2 cofferdams);

- Roller-compacted concrete (including a buttress approximately 800 metres long with 2 million cubic metres of concrete);
- Haul roads; and
- Inlet and outlet portals.

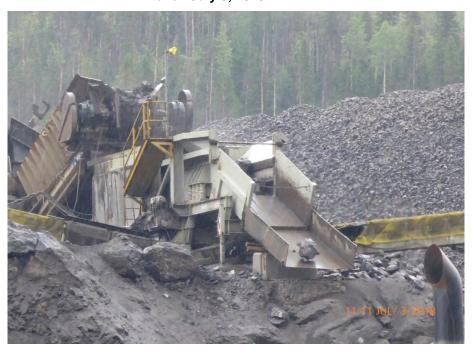
Figure A-1 West Pine Quarry Facing North. Photo taken July 3, 2018.

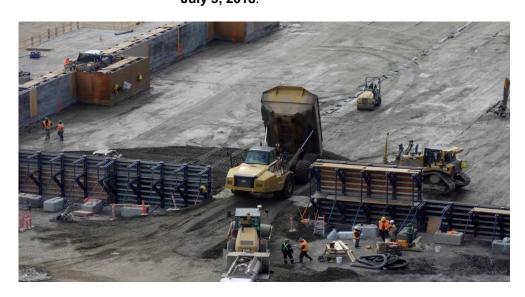
Figure A-2

Roller-compacted Concrete Delivered by Truck to the West Side of the Powerhouse Buttress. Photo taken July 5, 2018.

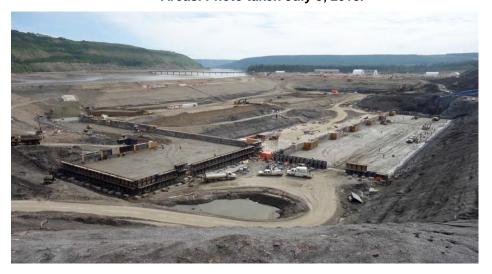
Figure A-3

Overview of the Powerhouse Buttress,
Service Bay Pad, Tailrace Wall, and
Generating Station & Spillways Laydown
Areas. Photo taken July 5, 2018.

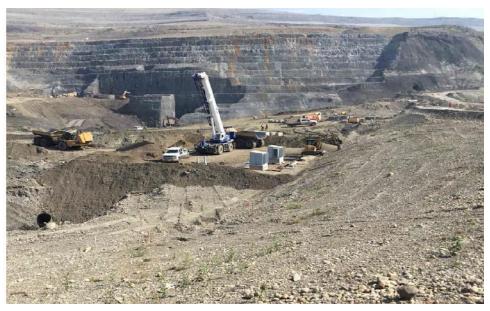
Figure A-4 Inlet Cofferdam Facing North; Crane Placing Transformers for the Diversion Tunnel Operations. Photo taken August 2018.

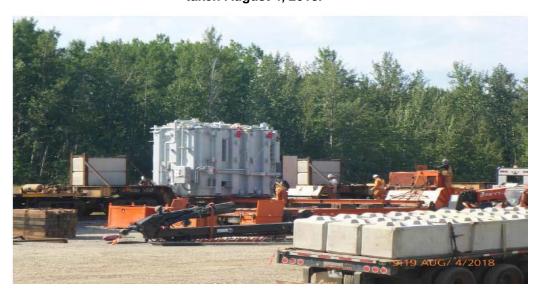
Figure A-5 Transformers Being Winched onto Flat Deck for Deliver to the Substation. Photo taken August 4, 2018.

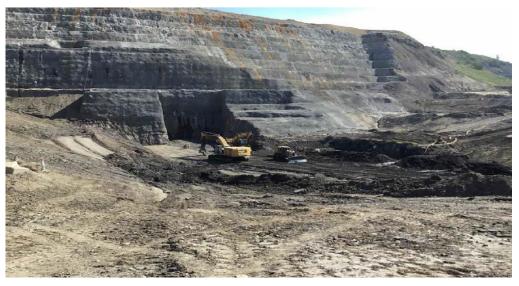
Figure A-6 Facing North; Equipment Working on Bench 13. Photo taken August 2018.

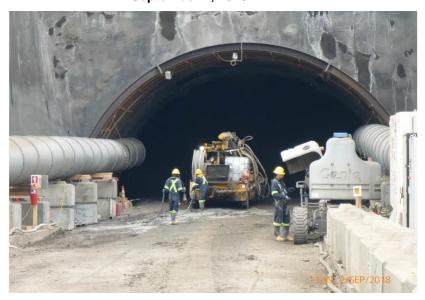
Figure A-7 Shotcrete Work in Tunnel 1. Photo taken September 2, 2018.

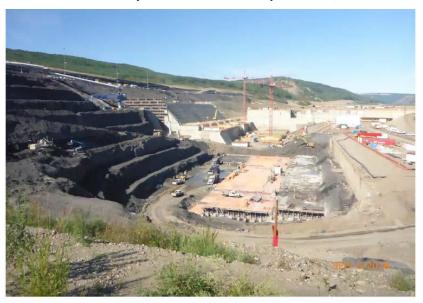
Figure A-8 Hydrovac Trucks Supporting Foundation Preparation for the Spillway Buttress Apron. Photo taken September 5, 2018.

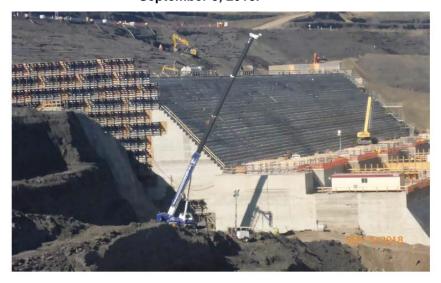
Figure A-9 Removal of Formwork from the East Face of the Powerhouse Buttress. Photo taken September 5, 2018.

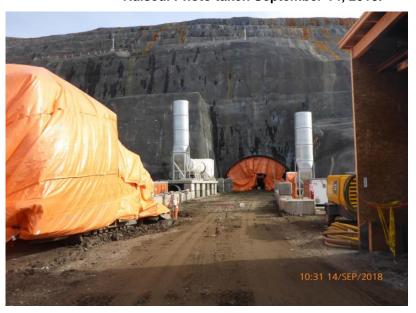
Figure A-10 Road Header and Tunnel Entrance Hoarded; Dust Suppression System Raised. Photo taken September 14, 2018.
