Site C Clean Energy Project

Quarterly Progress Report No. 26

F2023 First Quarter

April 1, 2022 to June 30, 2022

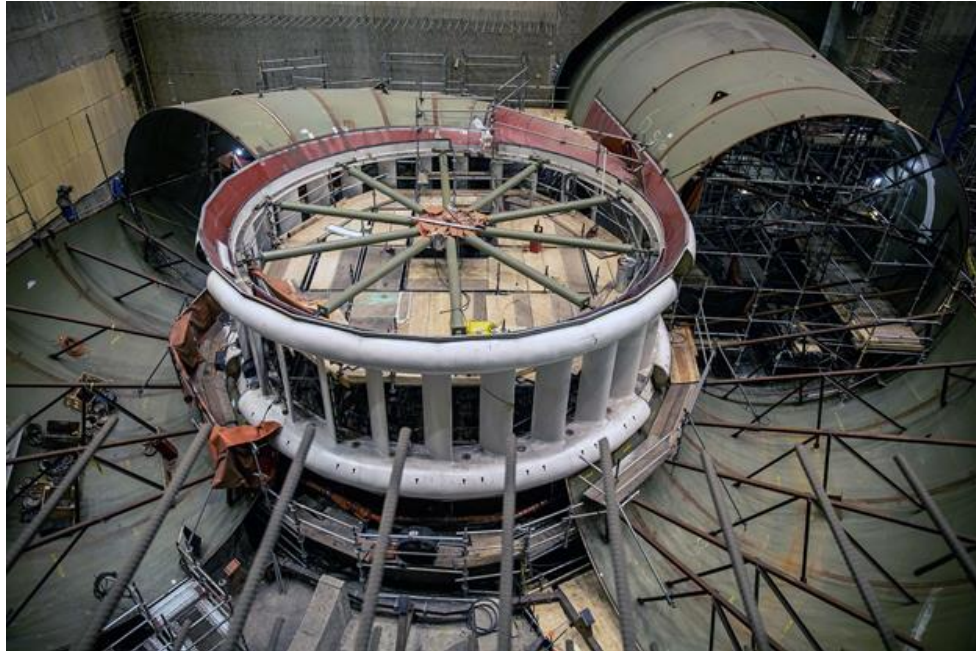
Figure A-1 Ongoing assembly of the Unit 6 Spiral Case and Stay Ring (April 2022)

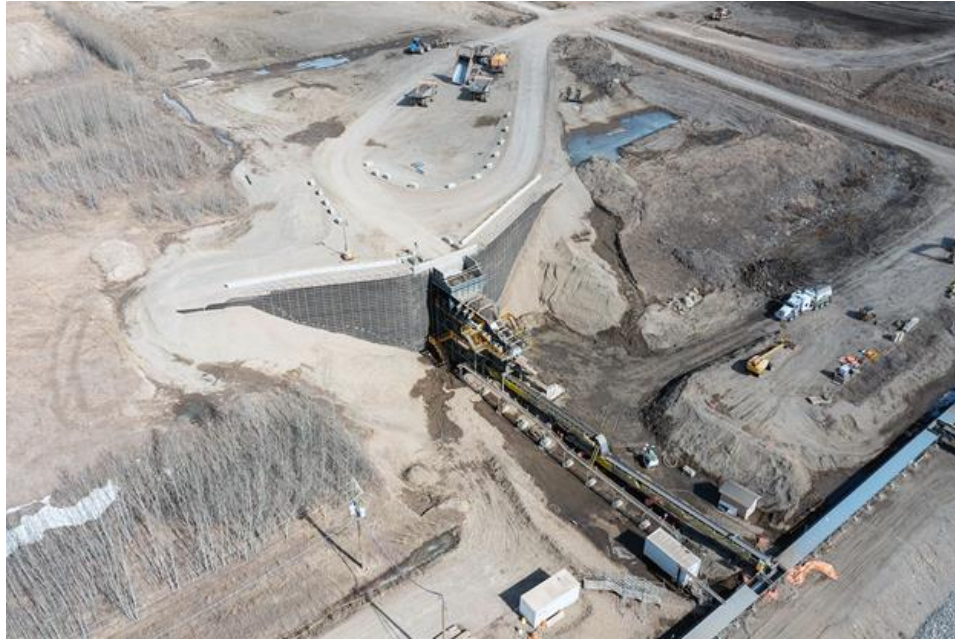
Figure A-3 The Hopper and Feeder are The Primary Supply Loading Point for the Conveyor that Transports Glacial Till from the 85th Ave Industrial Lands to Site C (April 2022)

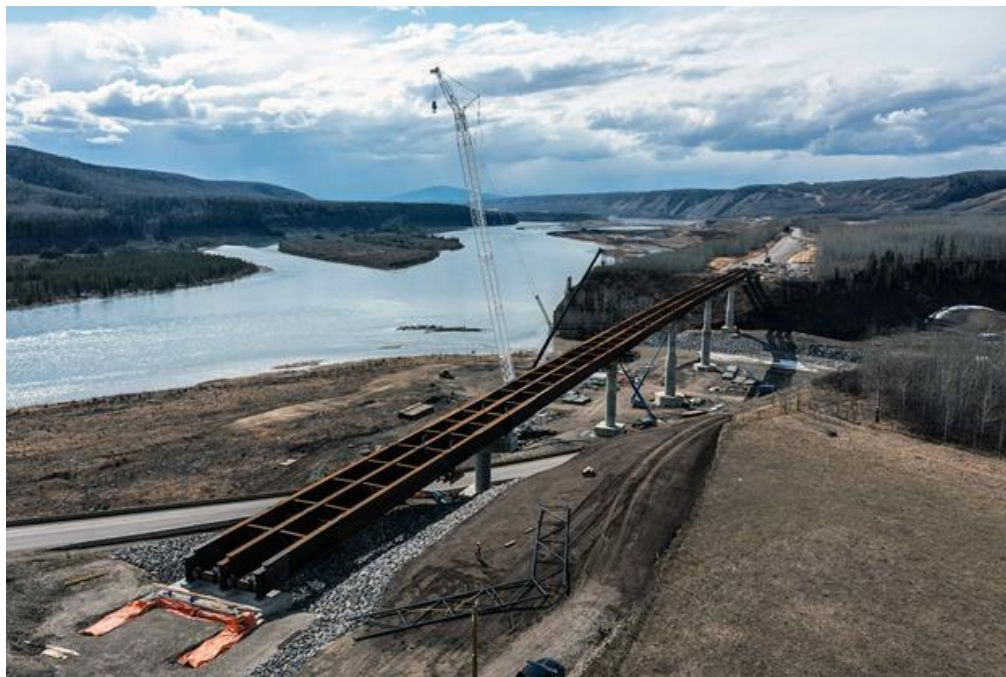
Figure A-4 Steel Installation is Complete on the Farrell Creek Bridge Deck (April 2022)

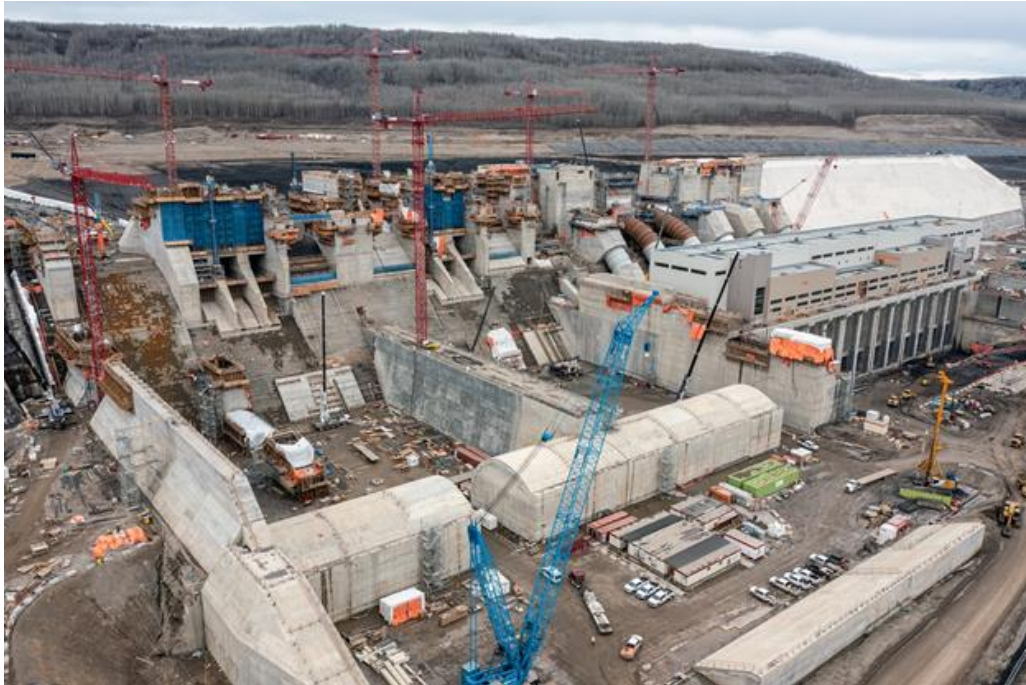
Figure A-5 Spillways, Penstocks, Powerhouse and Operations Building (May 2022)

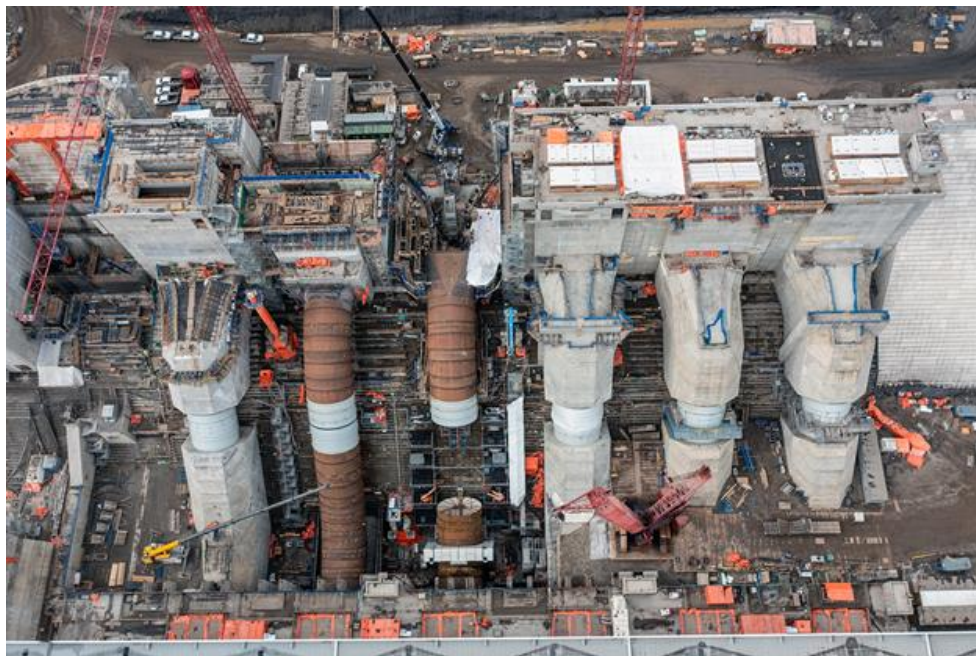
Figure A-6 Penstock Units 1 Through 6 (Unit 1 on the Right) in Varying Stages of Construction (May 2022)

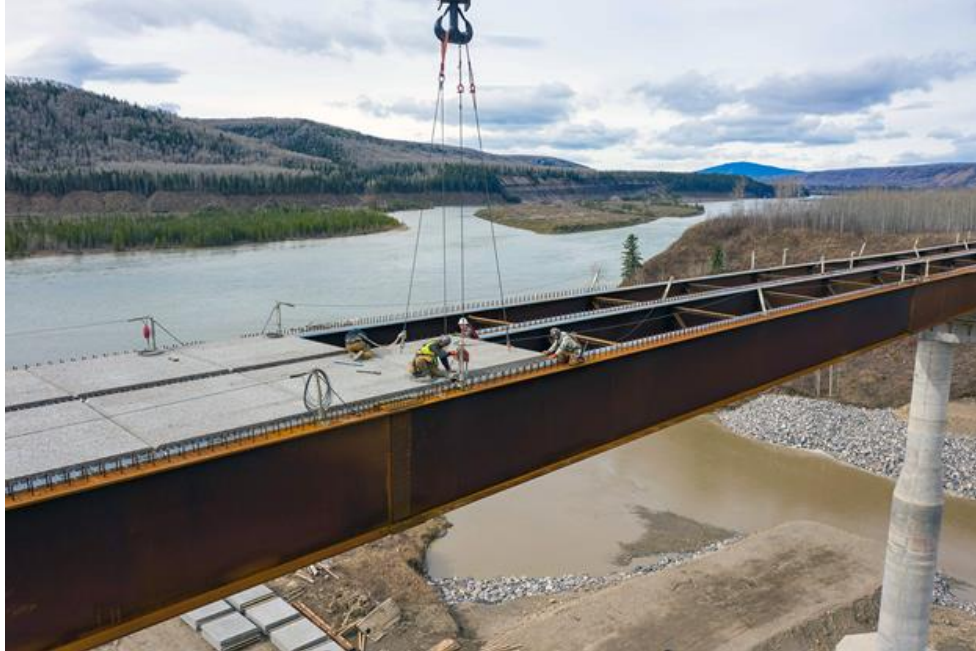
Figure A-7 Pre-Cast Concrete Panels are Moved into Position on the Farrell Creek Bridge at The Highway 29 Realignment (May 2022)

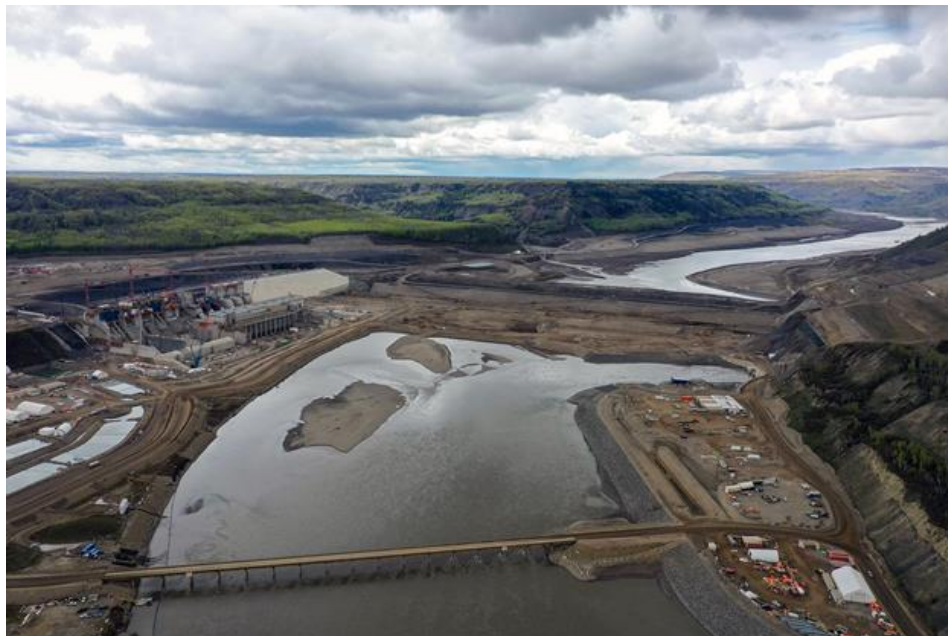
Figure A-8 An Upstream View of the Powerhouse and Generating Station, with Laydown Areas, Temporary Fishway and Outlet Portals (May 2022)

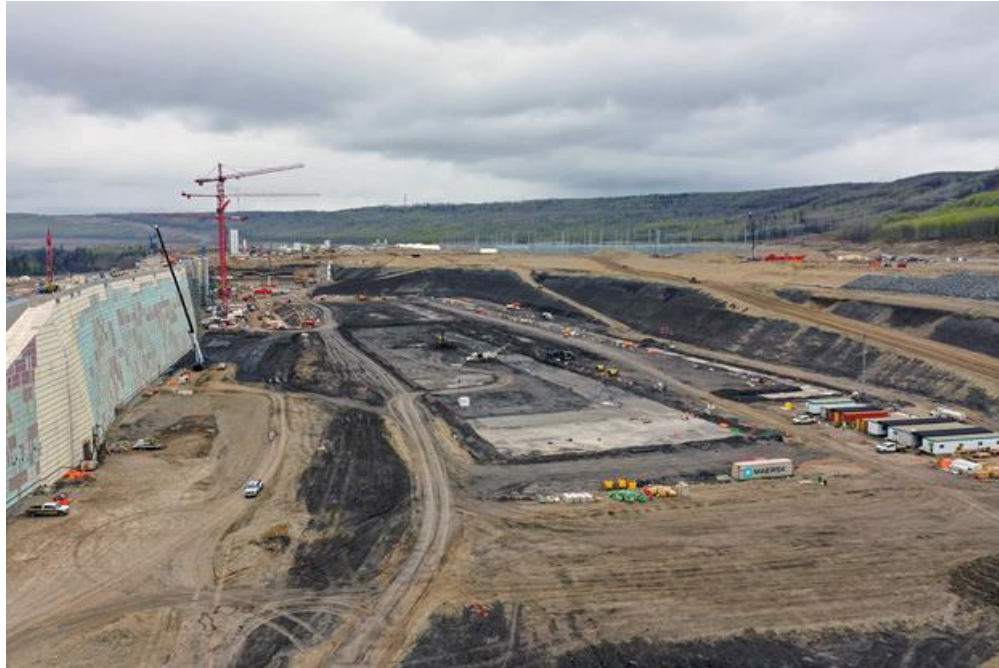
Figure A-9 Ongoing Construction of the Approach Channel (May 2022)

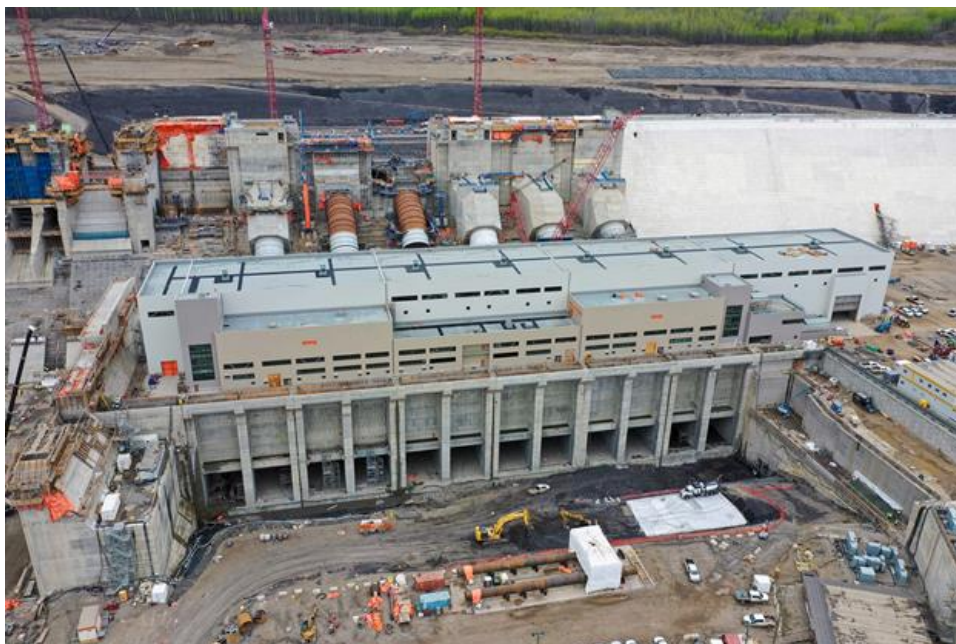
Figure A-10 The Powerhouse and Operation Building are Substantially Complete, with Foundation Enhancements Work Ongoing in Front of the Tailrace (May 2022)

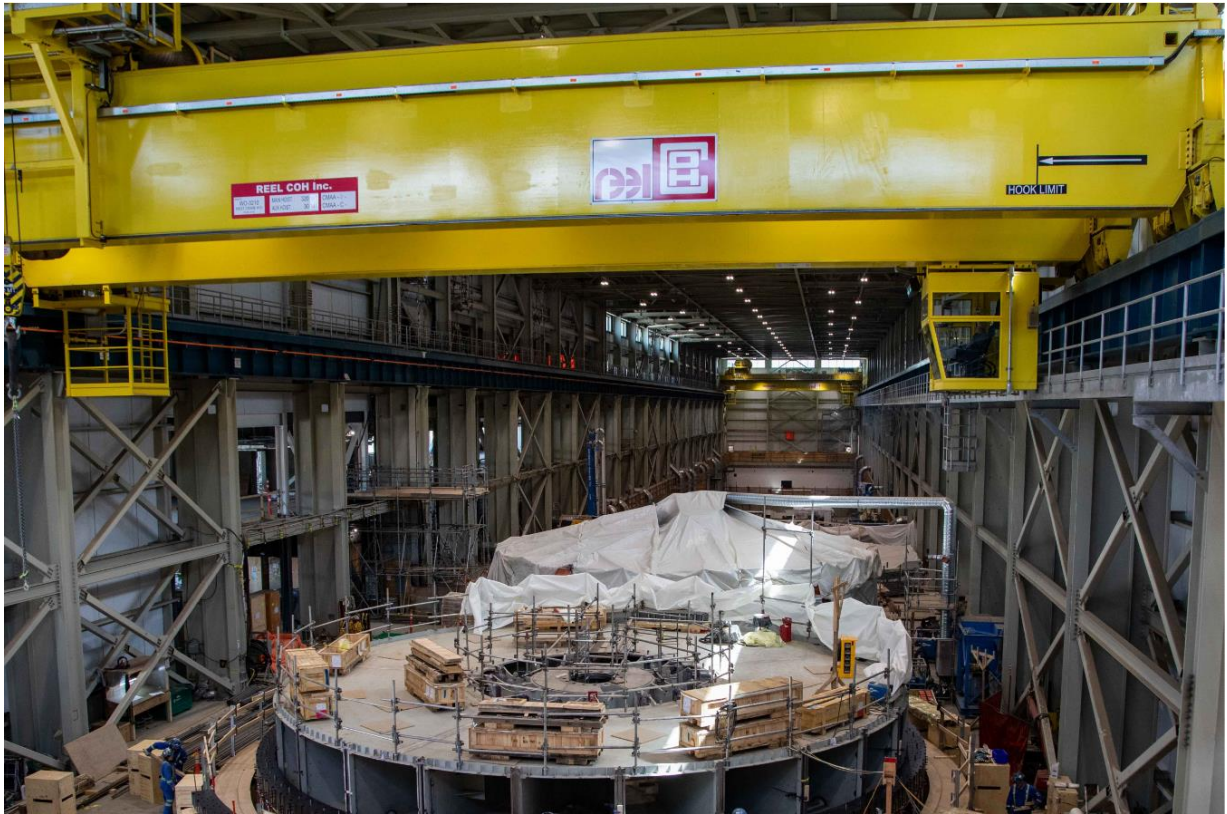
Figure A-13 Unit 1 and 2 Rotor Fabrication (June 2022)

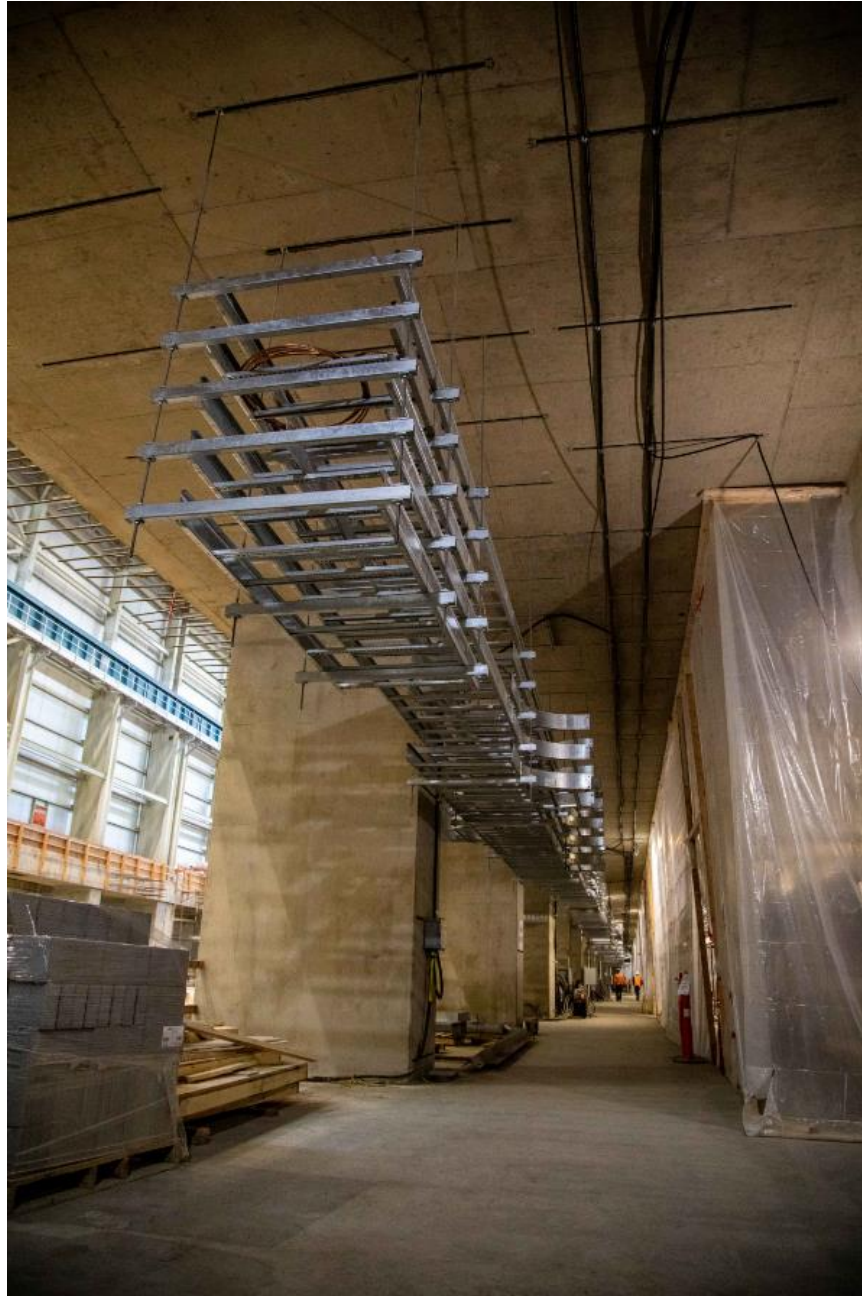
Figure A-12 Installation of Cable Trays is Underway in the Powerhouse (June 2022)

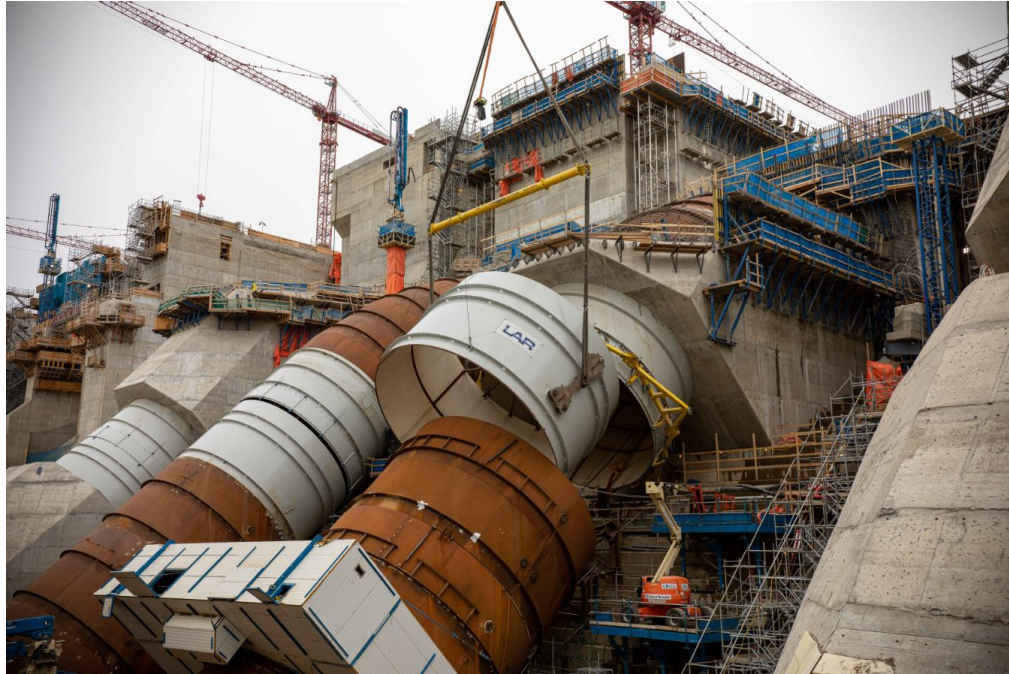
Figure A-14 The Last Penstock Segment is Lowered into Position (June 2022)

18 As the Project entered the summer months, construction activities ramped up. A
19 significant milestone was achieved with the arrival and placement of the final
20 penstock segment. Construction has continued to advance on all aspects of the
21 Project, including ongoing placement of materials at the earthfill dam, approach
22 channel excavations, right bank foundation enhancements and the Highway 29
23 realignment.

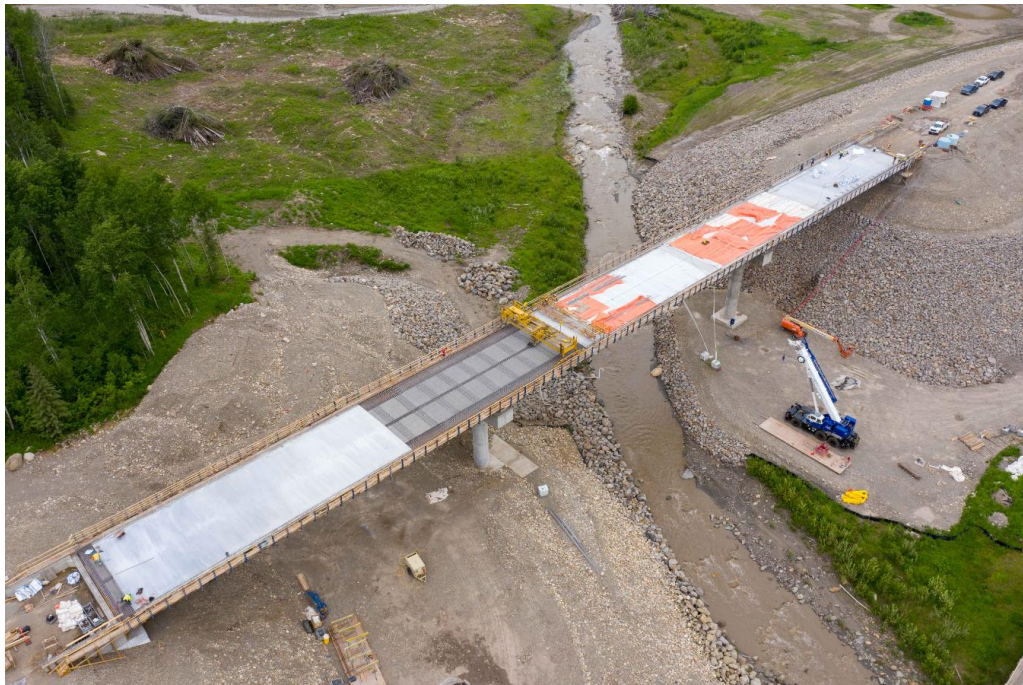
Figure A-15 Lynx Creek Bridge Before the Final Concrete Pour (June 2022)

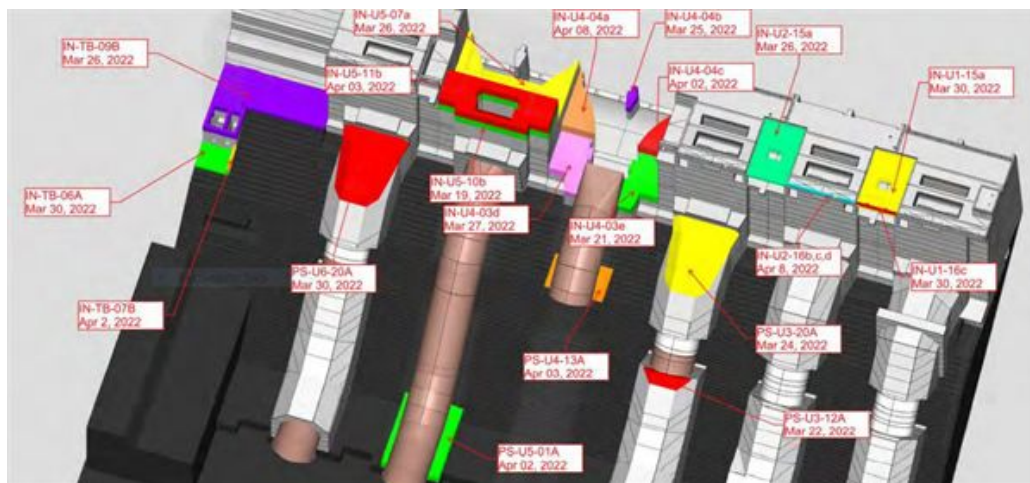
Most concreting now being carried out is repetitive, suggesting there should be no surprises. For example, while much remains to do on Intake and Penstock No 4, the equivalent works on Nos 1, 2, 3 and 6 are virtually complete. This is illustrated on the figure below, which is taken from the Building Information Model (BIM) being used by BC Hydro to manage overall construction sequences and which will itself form a valuable record of work done, and construction dates achieved.

Figure 2. Construction sequences planned for the Power Intakes during April 2022

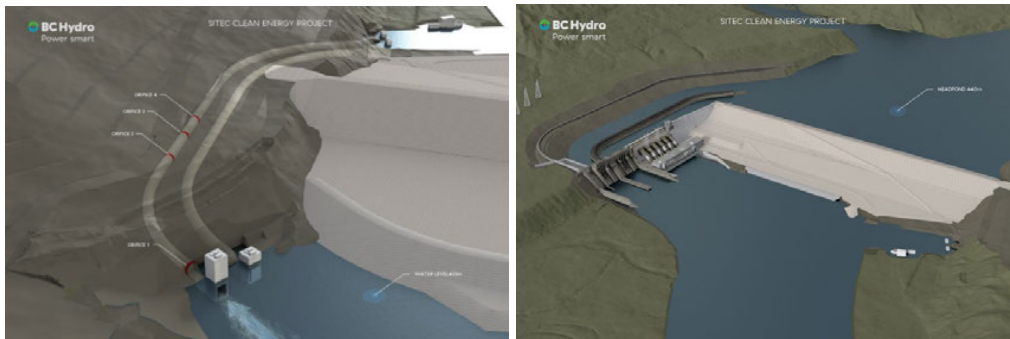
There are pros and cons to such a scenario. Considerations include the prolonged adoption of flow conditions, both in the tunnel and in the downstream outlet channel, that were previously seen as temporary. However previous and current model testing will enable informed decisions to be made on both aspects. Other potential advantages include greater timing flexibility for final filling earlier the following year. The TAB compliments the design team on their assessment of the filling options.

Figure 3. The image on the left shows the start of reservoir filling with water flowing through the converted Tunnel 2 after the closure of Tunnel 1 at El. 425 m. The image on the right shows flow of water into the Approach Channel.
