**RE: British Columbia Utilities Commission (BCUC or Commission)
British Columbia Hydro and Power Authority (BC Hydro)
Site C Clean Energy Project PUBLIC Quarterly Progress Report No. 30**

Site C Clean Energy Project

F2024 First Quarter

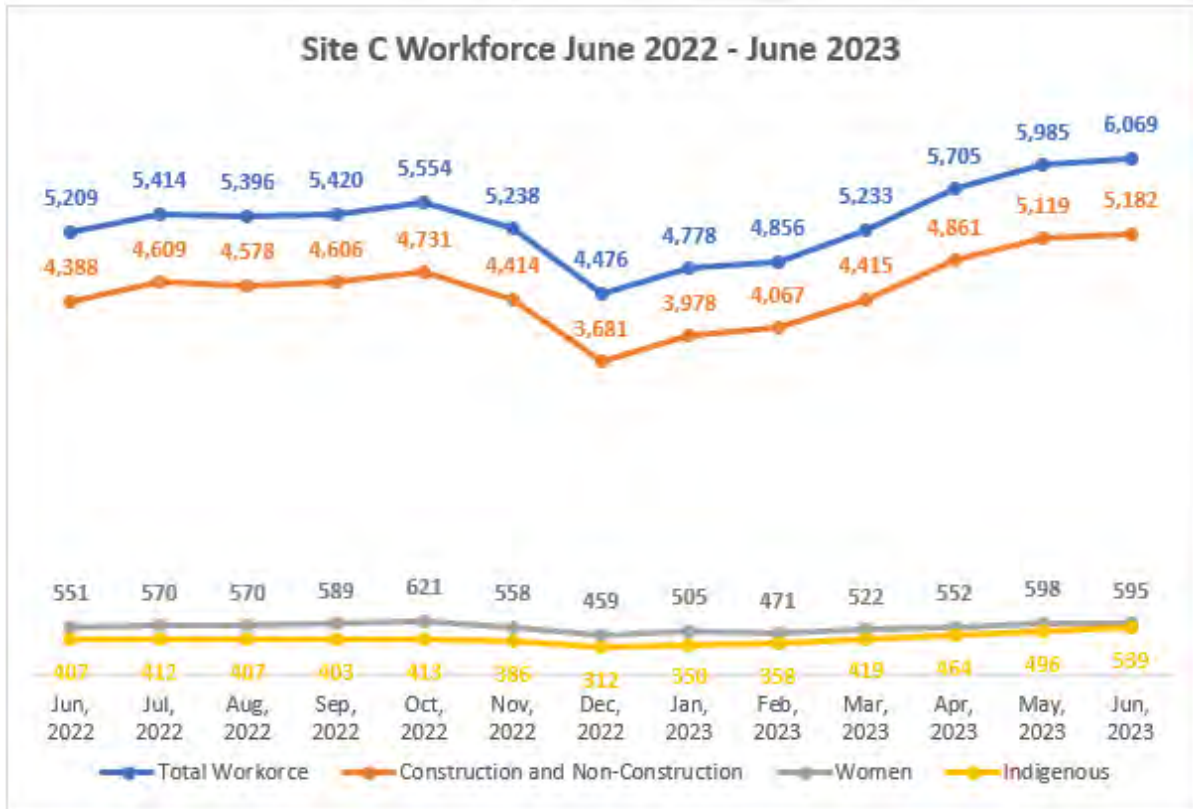
Figure 2 Site C Workforce June 2022 to June 2023²³

[Figure 2](#) shows the monthly Site C workforce over the period from June 1, 2022 to June 30, 2023.

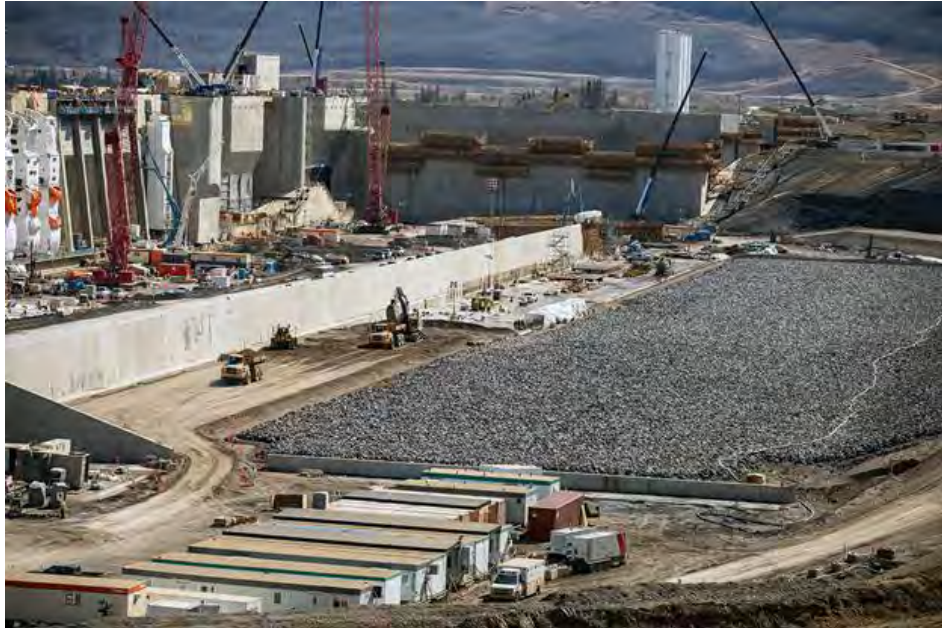
Figure A-1 A partially completed section of the approach channel lining, with riprap cover and granular fill | April 2023

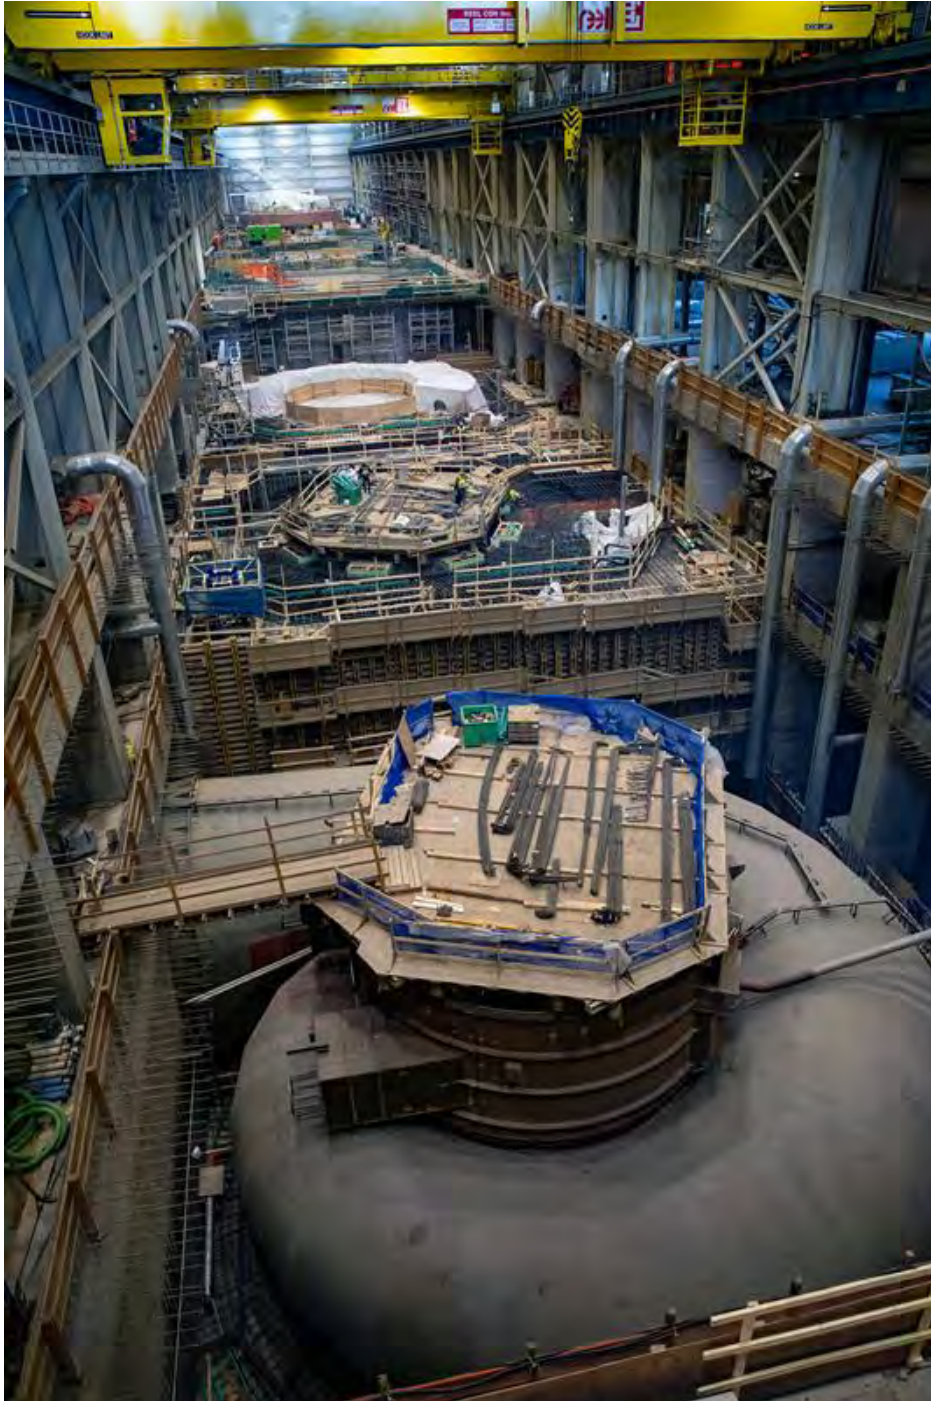
Figure A-3 Work continues in the powerhouse |
April 2023

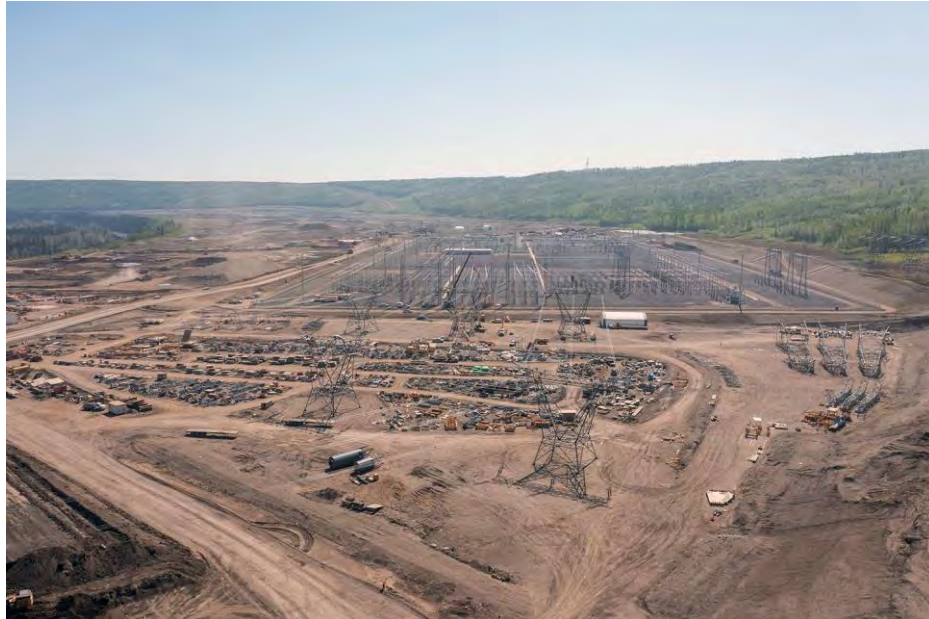
Figure A-4 The 500-kilovolt transmission towers are installed in the substation and ready to be connected to the generating station | May 2023

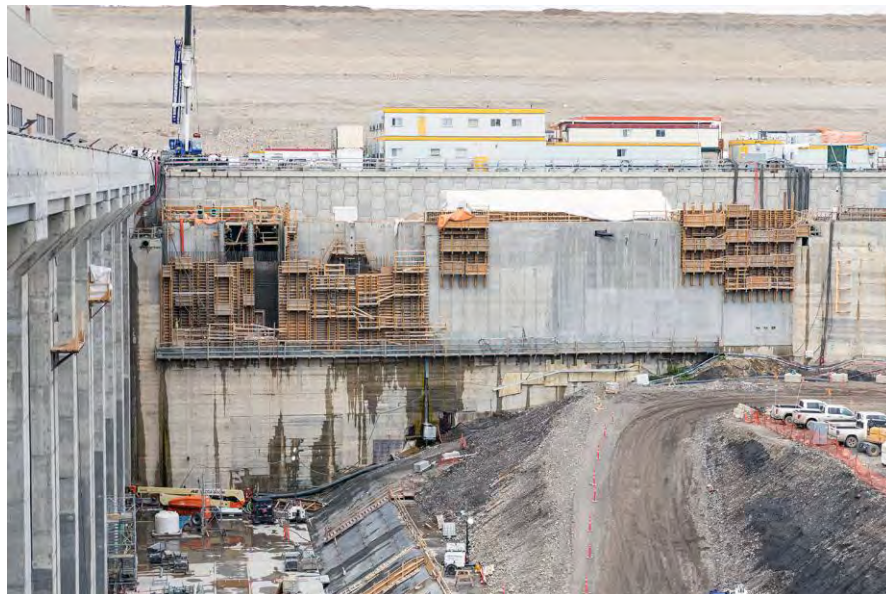
Figure A-5 Fish travelling up the Peace River will travel through the permanent upstream fish passage facility shown in this picture. Migrating fish will be sorted, tagged, and released past the dam site into the reservoir | May 2023

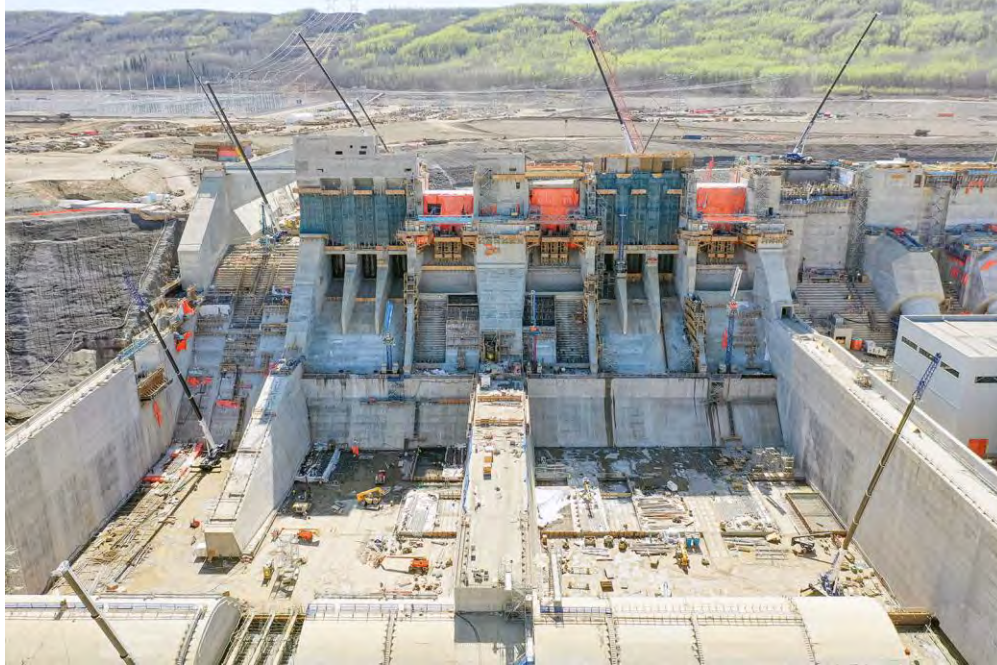
Figure A-6 Two mechanical spillways, operated with gates, will manage flows from the reservoir. The auxiliary spillway is on the left | May 2023

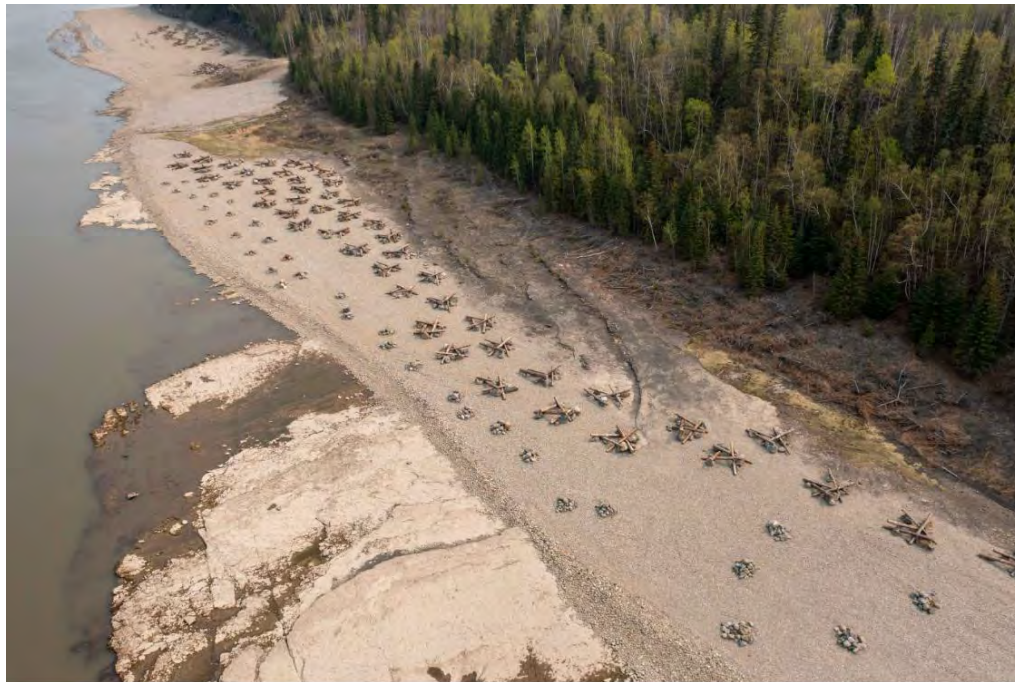
Figure A-7 Maurice Creek spawning shoal | May 2023

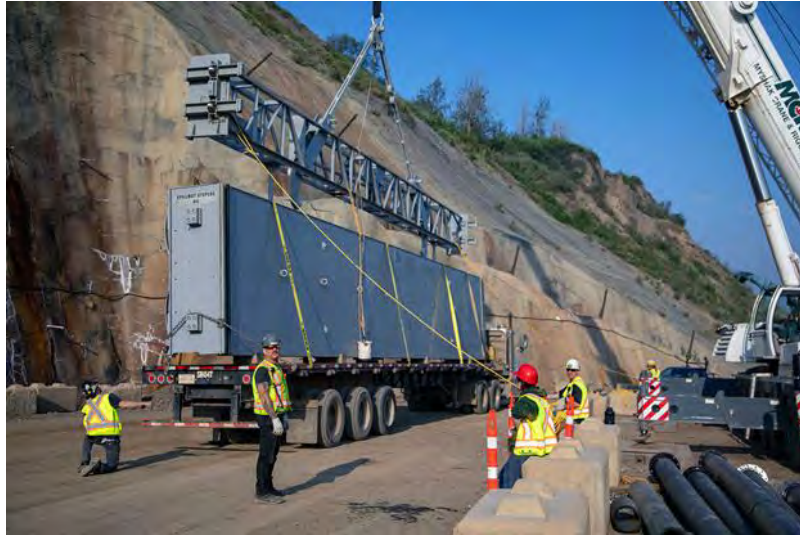
Figure A-8 Stoplogs are the hydraulic engineering control used to stop the flow of water at the outlet of Diversion Tunnel 2 | June 2023

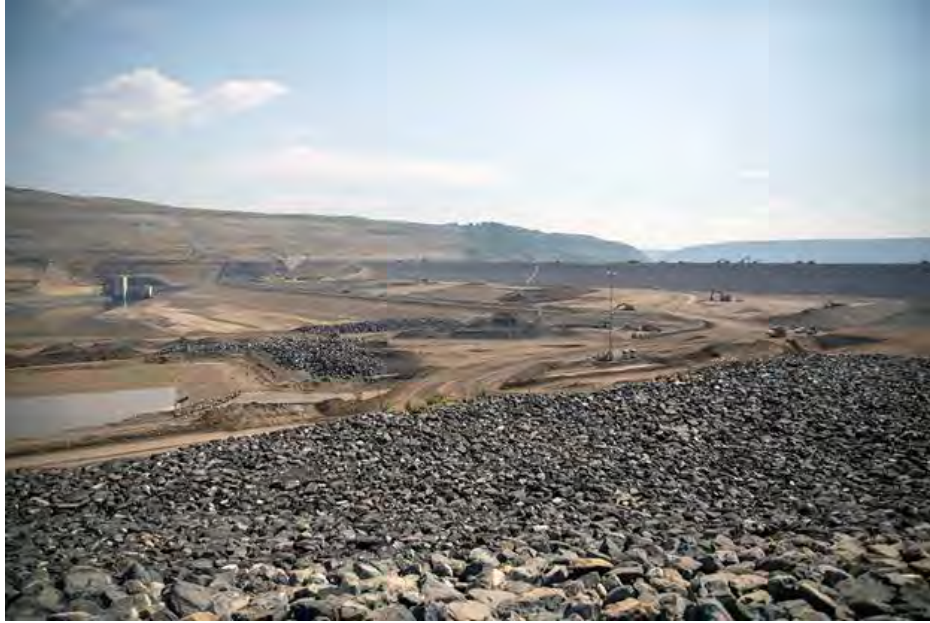
Figure A-10 Crews finish the upstream shell of the dam |
June 2023
