## SITE C PROJECT CONSTRUCTION

# NORTH BANK SLOPE STABILIZATION

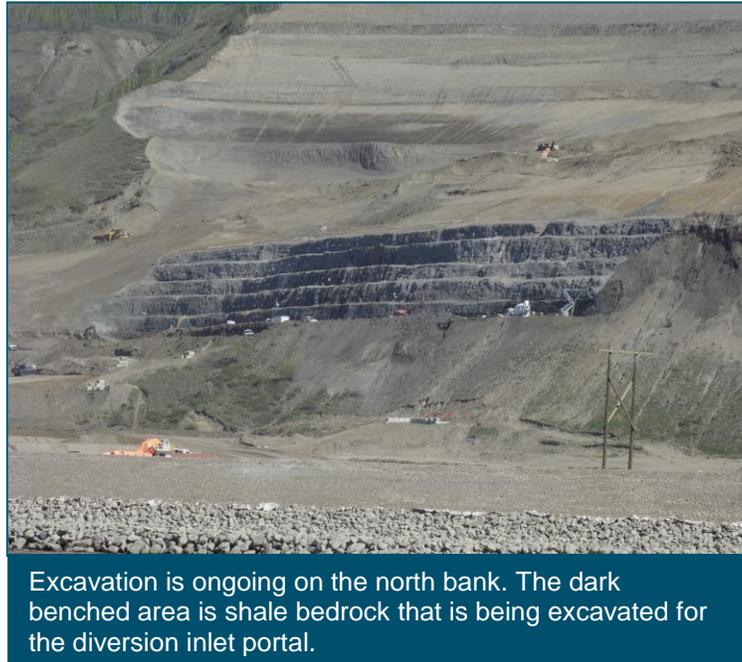
Excavation is ongoing on the north bank. The dark benched area is shale bedrock that is being excavated for the diversion inlet portal.

The main civil works contractor began excavation on the north bank shortly after their mobilization in mid-2016. After removing significant amounts of overburden, the project reached shale bedrock in several areas on the north bank in late 2017 and early 2018. In early 2018, the contractor began excavating benches in the shale bedrock along the north bank as part of the diversion inlet portal construction.
