Site C Clean Energy Project

Permanent Upstream Fish Passage Facility Operations Report

Reporting Period: May 1 to 31, 2025

Prepared by BC Hydro

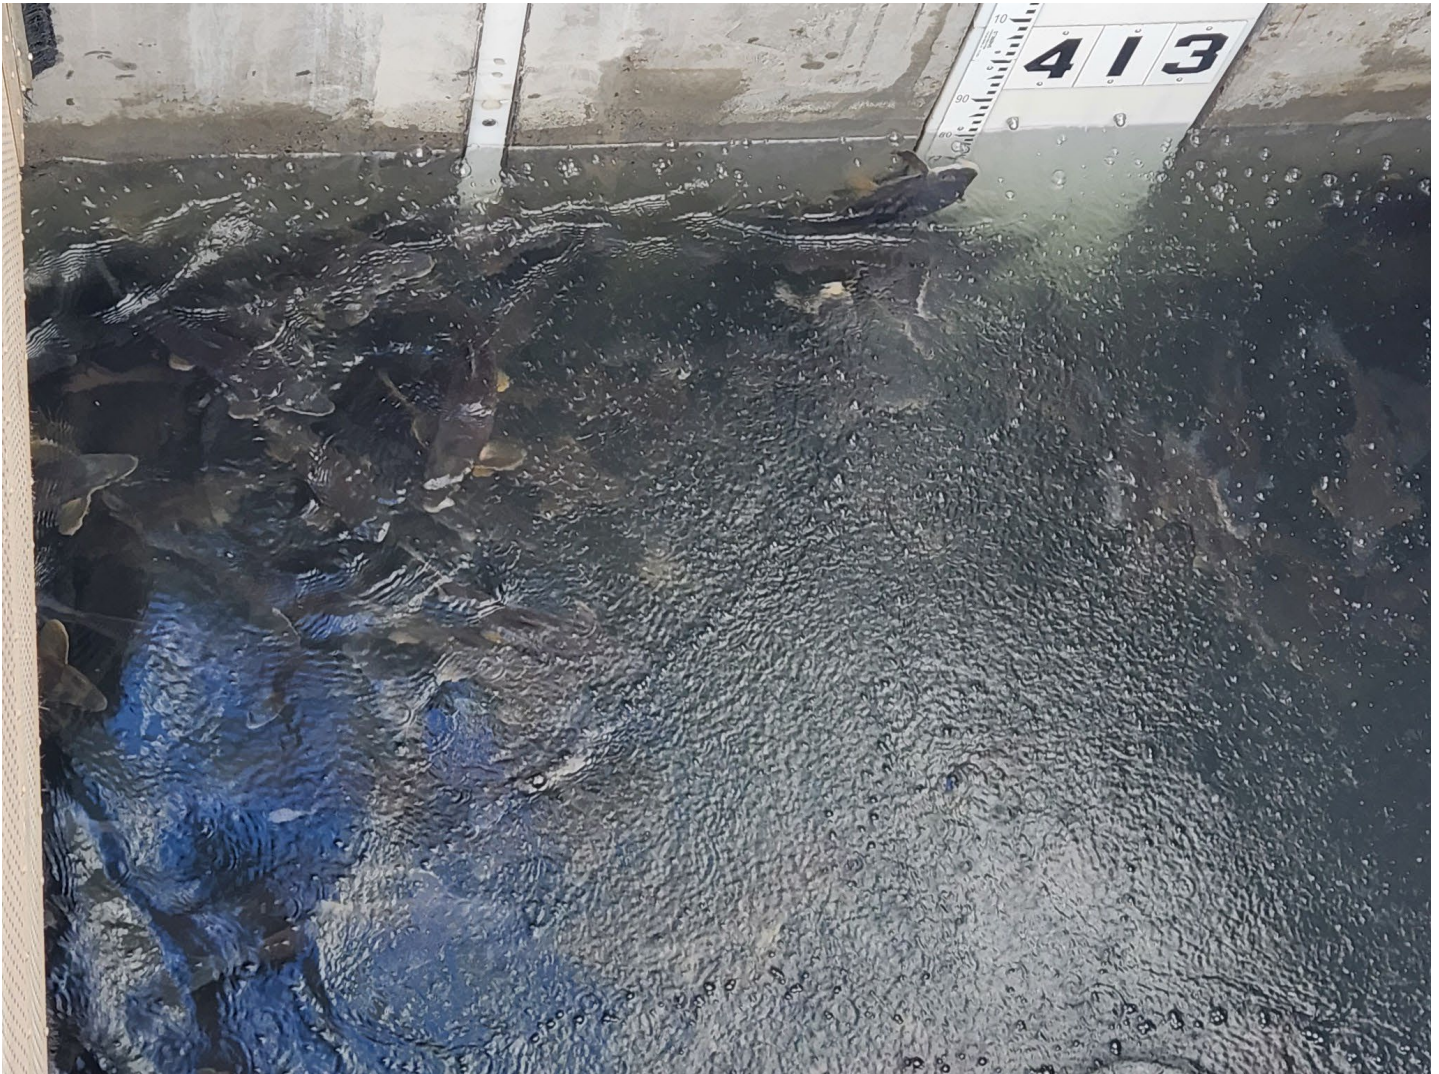
Photo 1. More than 2500 Suckers (1465 Largescale Sucker, 1193 Longnose Sucker, and 5 White Sucker) passed the permanent facility during the reporting period (May 22, 2025).

Large numbers of suckers (primarily Largescale Sucker and Longnose Sucker) passed the permanent facility during the reporting period; the operator observed two large pulses on May 22 (771 fish) and May 28 (721 fish) (Table 1, Figure 1, Photo 1). Suckers are known to spawn in the late spring or early summer, so these high numbers were expected and are consistent with what was observed at the temporary upstream fish passage facility from 2020 to 2024. High numbers of Arctic Grayling (49 fish) and Rainbow Trout (82 fish) also passed the permanent facility; these species are also known to spawn in the spring in tributaries upstream of the Project (Photo 2). Finally, the permanent facility also passed 36 Bull Trout (Table 1, Photo 2).

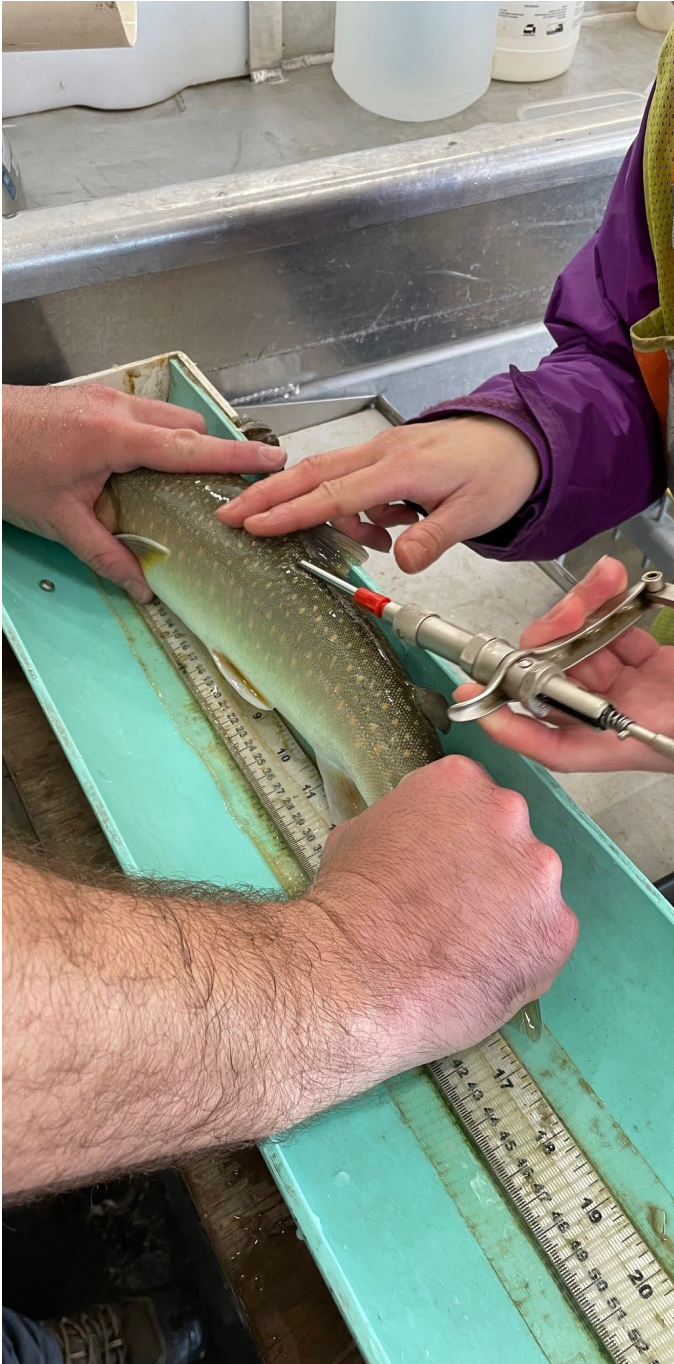
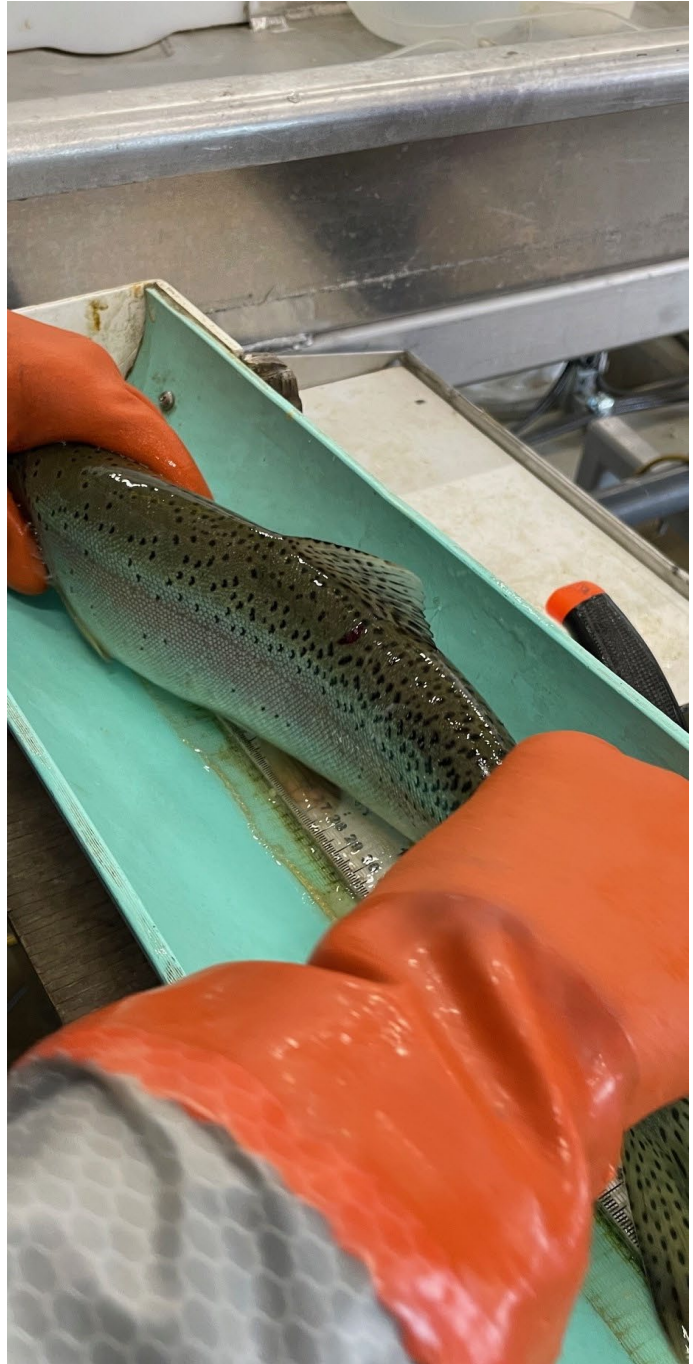
Photo 2. Operator processed 36 Bull Trout (left; May 28, 2025) and 82 Rainbow Trout (right; May 29, 2025) during the reporting period.
