## **Site C Clean Energy Project**

### **Temporary Upstream Fish Passage Facility Operations Report**

**Reporting Period: May 1 to 31, 2024**

Prepared by BC Hydro

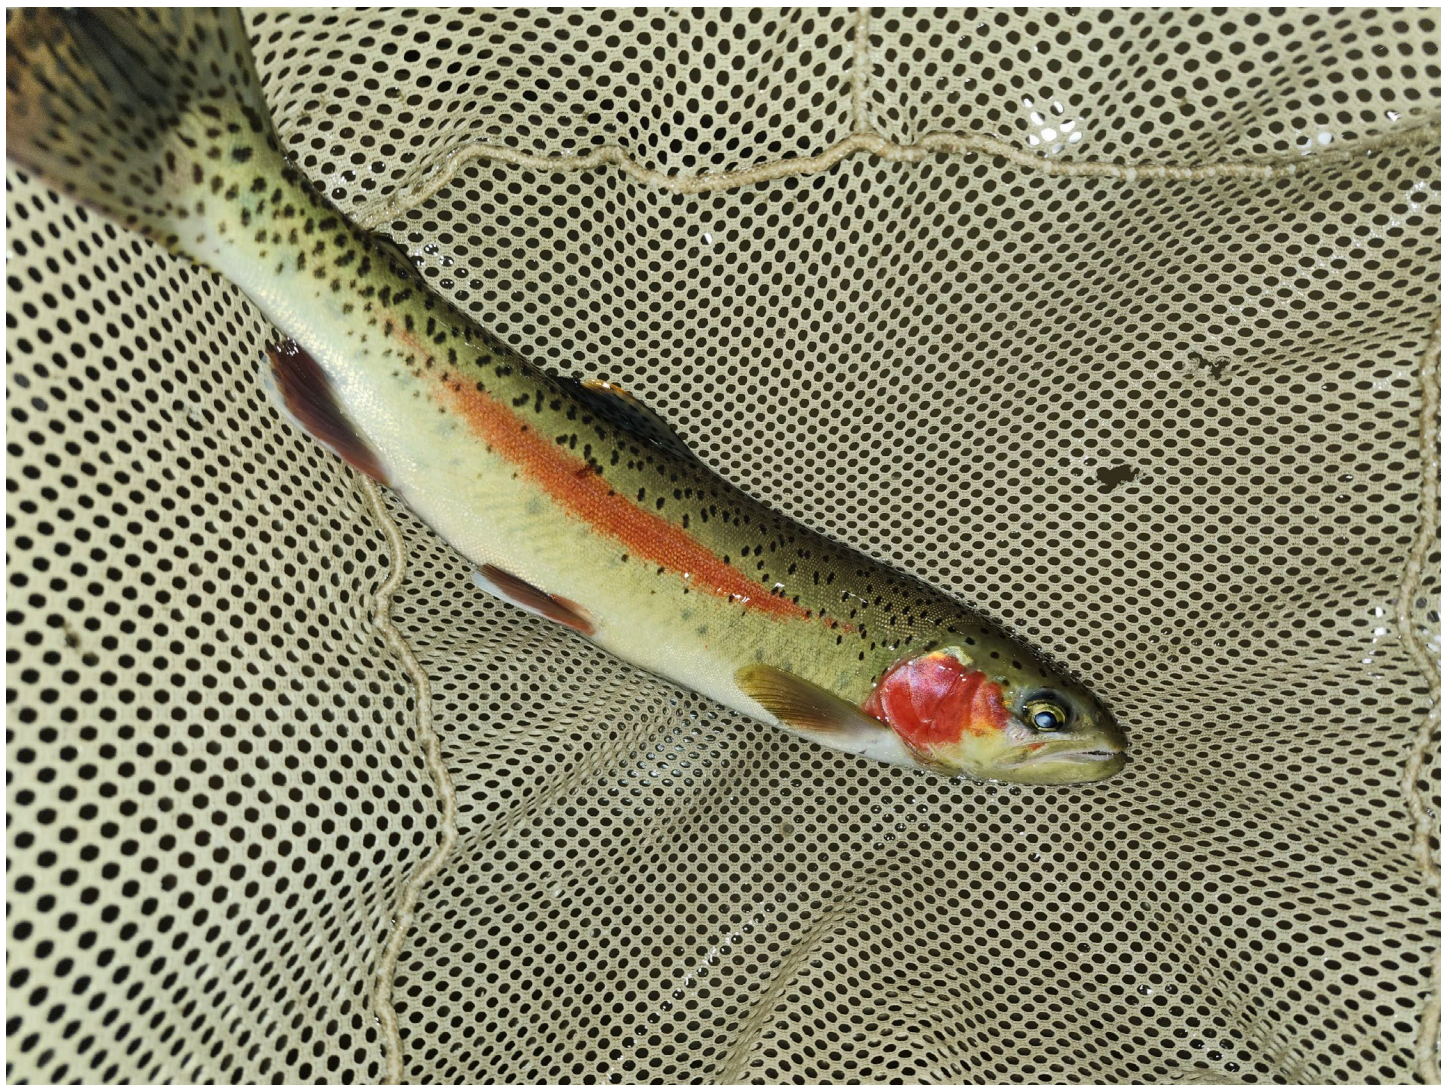
**Photo 1.** Biologists sample a Rainbow Trout in the sorting facility during the reporting period (May 26, 2024).

Forty three fish – 19 Mountain Whitefish, 15 Rainbow Trout, 6 Arctic Grayling, 2 Longnose Sucker, and 1 Slimy Sculpin – were sorted and sampled at the temporary facility, and transported and released into the Peace River upstream of the Project (Table 1, Photo 1).

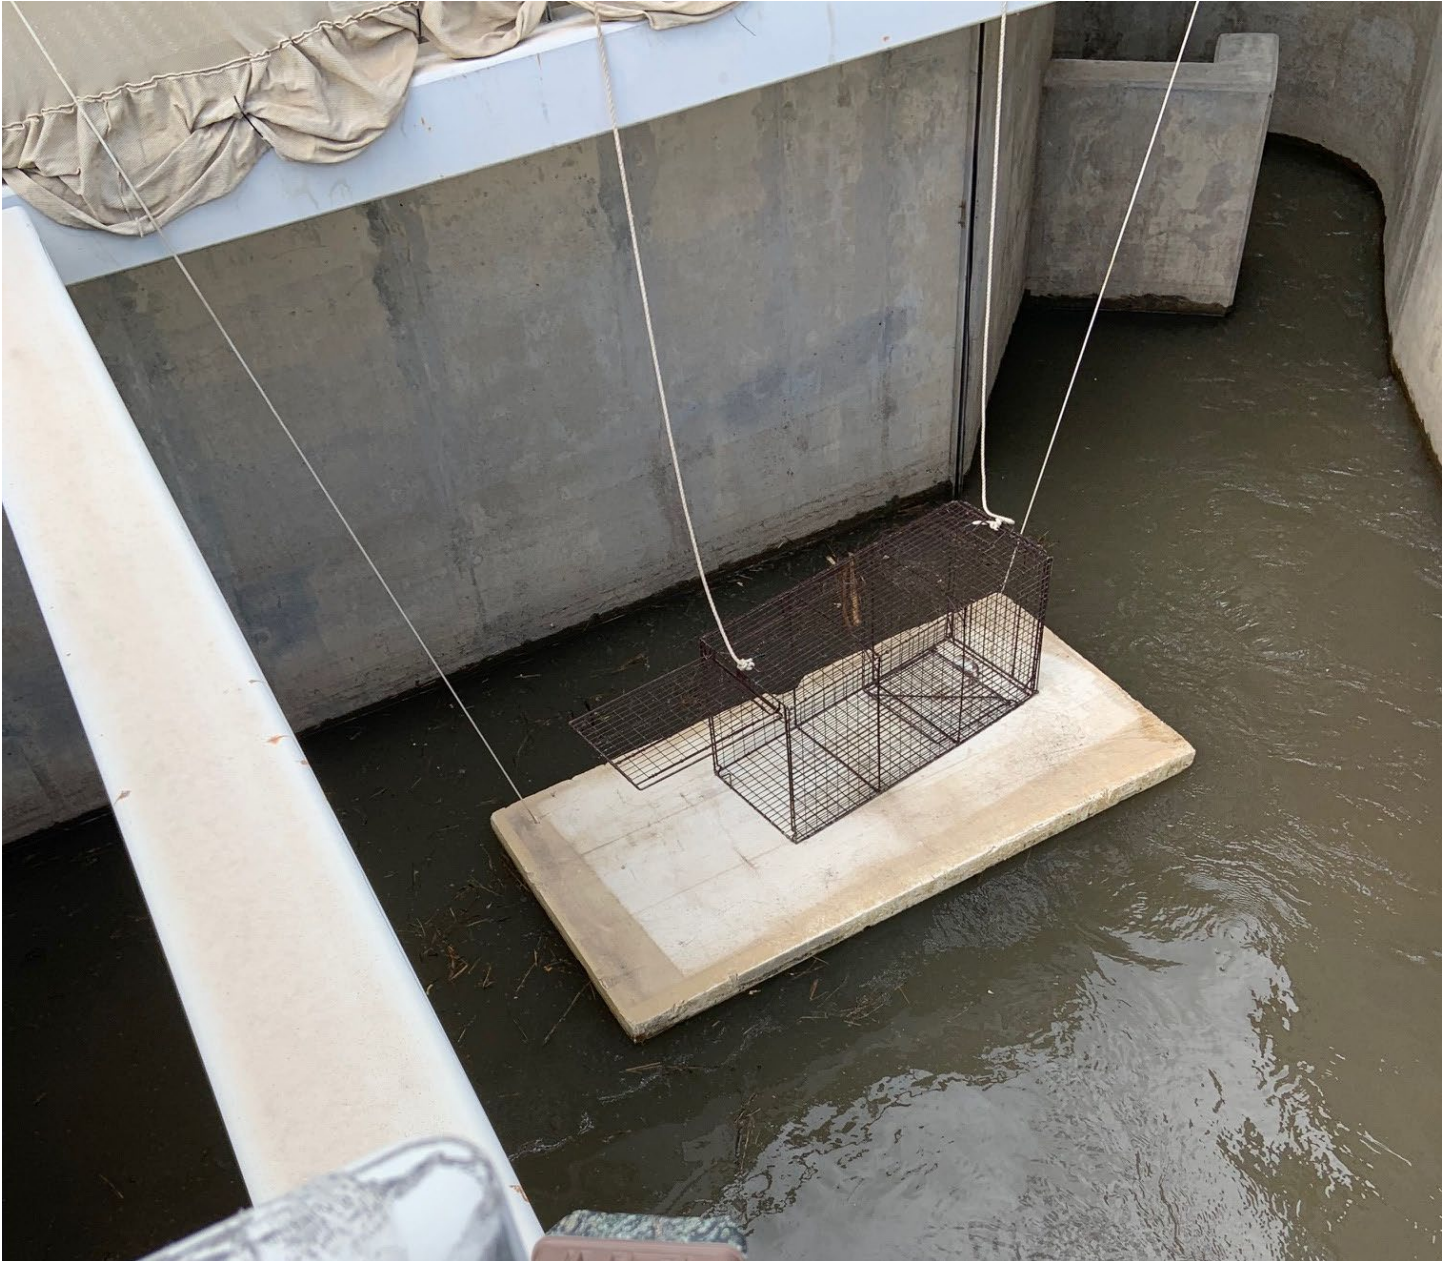
**Photo 3.** Baited trap deployed on a floating platform in the entrance pool in an attempt to trap and relocate river otters away from the facility (May 30, 2024).

River otters were observed on April 28 for the first time in 2024. As such, BC Hydro continued live trapping efforts by deploying a baited trap in the entrance pool (Photo 3). No river otters were trapped during the reporting period.
