Site C Clean Energy Project

Temporary Upstream Fish Passage Facility Operations Report

Reporting Period: October 1 to 31, 2020

Prepared by BC Hydro

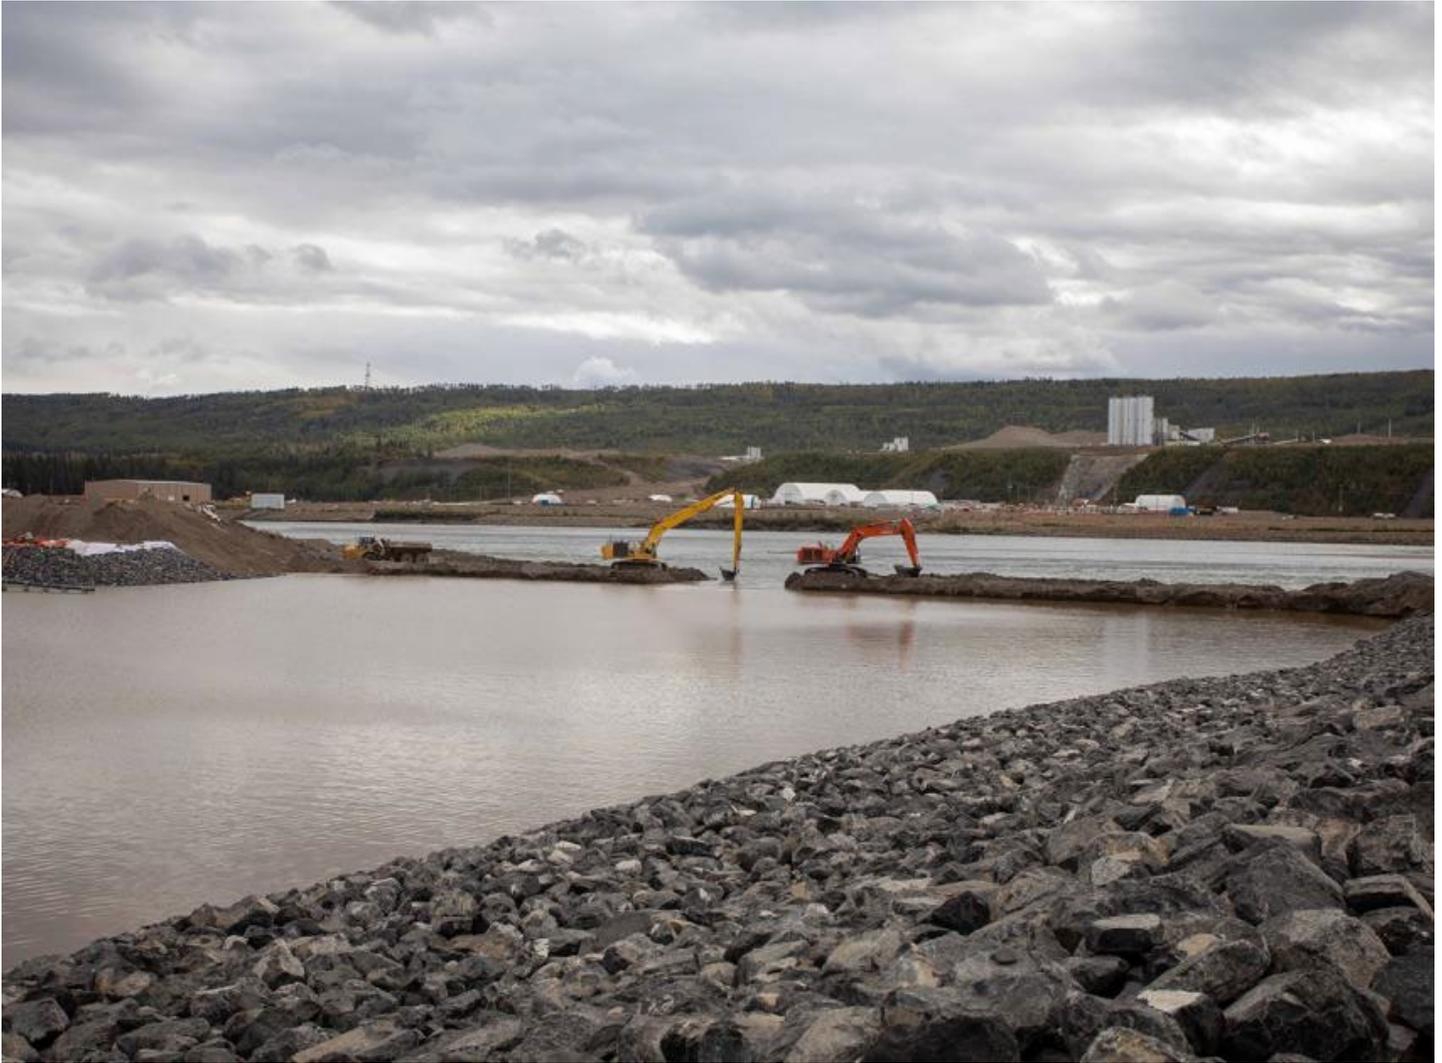
Photo 1. Excavators breach the Stage 1 Downstream Cofferdam to connect the diversion tunnel outlet with the Peace River (September 11, 2020).

- Diversion outlet cofferdam was breached on September 11 (Photo 1), providing a connection between the Peace River and the diversion tunnel outlet (Photo 2);
- Commissioning of the temporary facility from September 23 to 30 (Photo 3). Facility operator opened the trap at the top of the fishway (referred to as a 'vee-trap'), which allowed fish to swim into the pre-sort holding pool and be available for crowding into the sorting facility;
- Diversion tunnel gates were opened on September 30 (Photo 4), which started to divert the Peace River through the diversion tunnels;
- River closure occurred on October 3 (Photo 5) with the final rip rap placement of the rockfill berm across the Peace River; and
- Operation of the temporary facility from October 1 to 31.

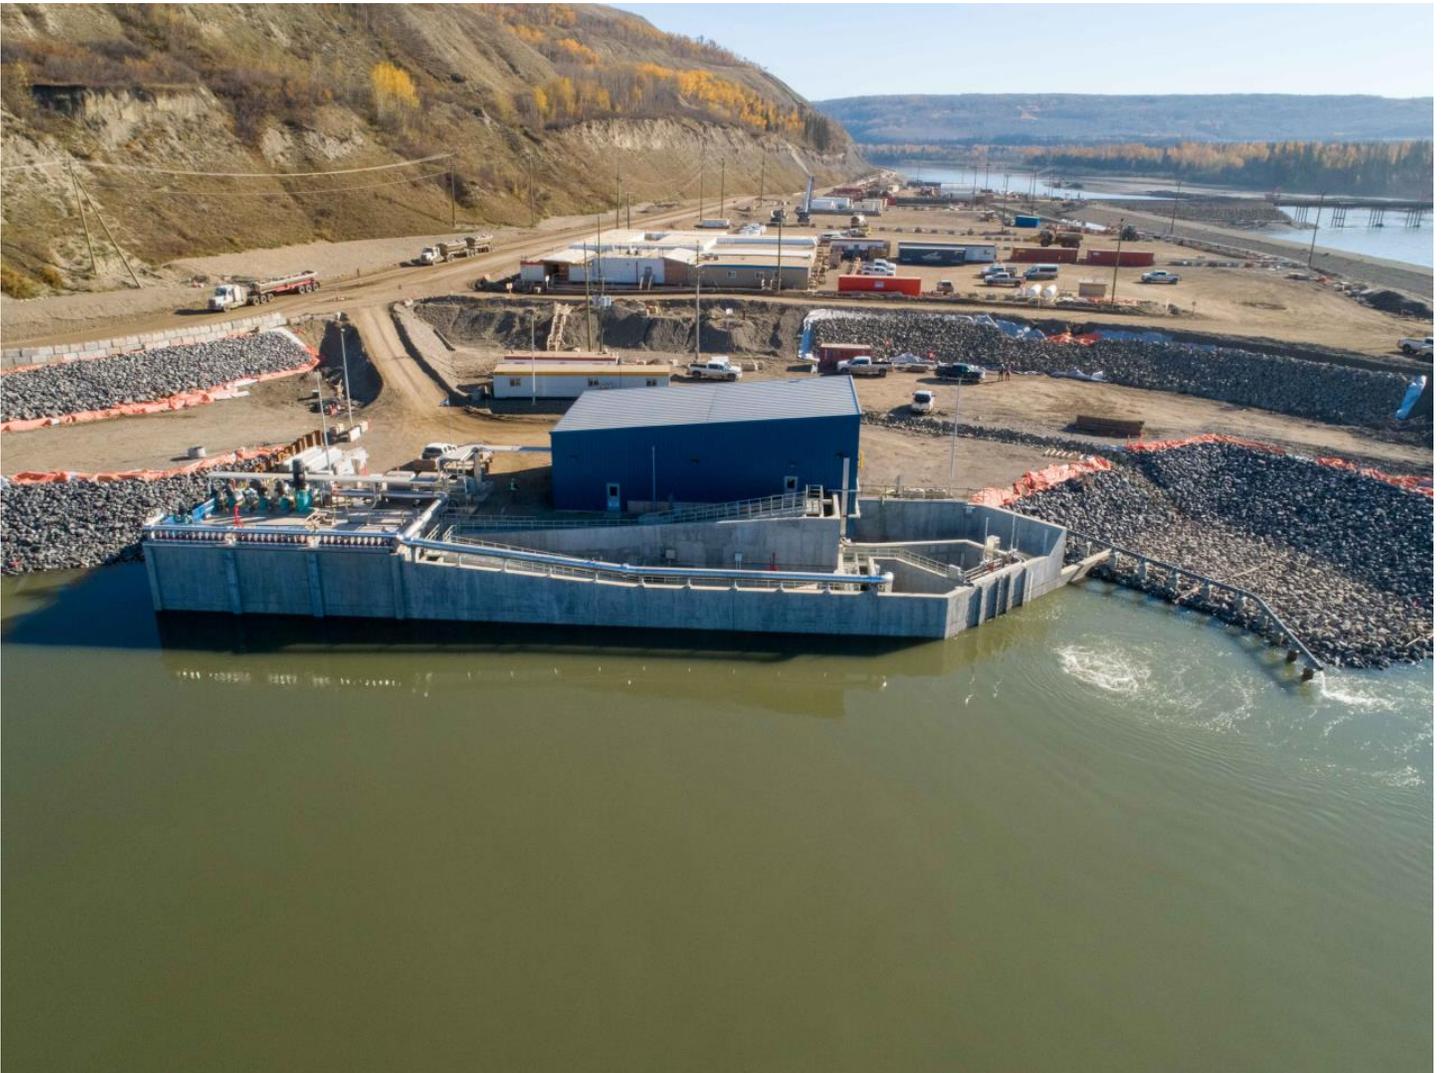
Photo 2. Overview of the temporary facility located at the outlet of the diversion tunnels (October 2, 2020).

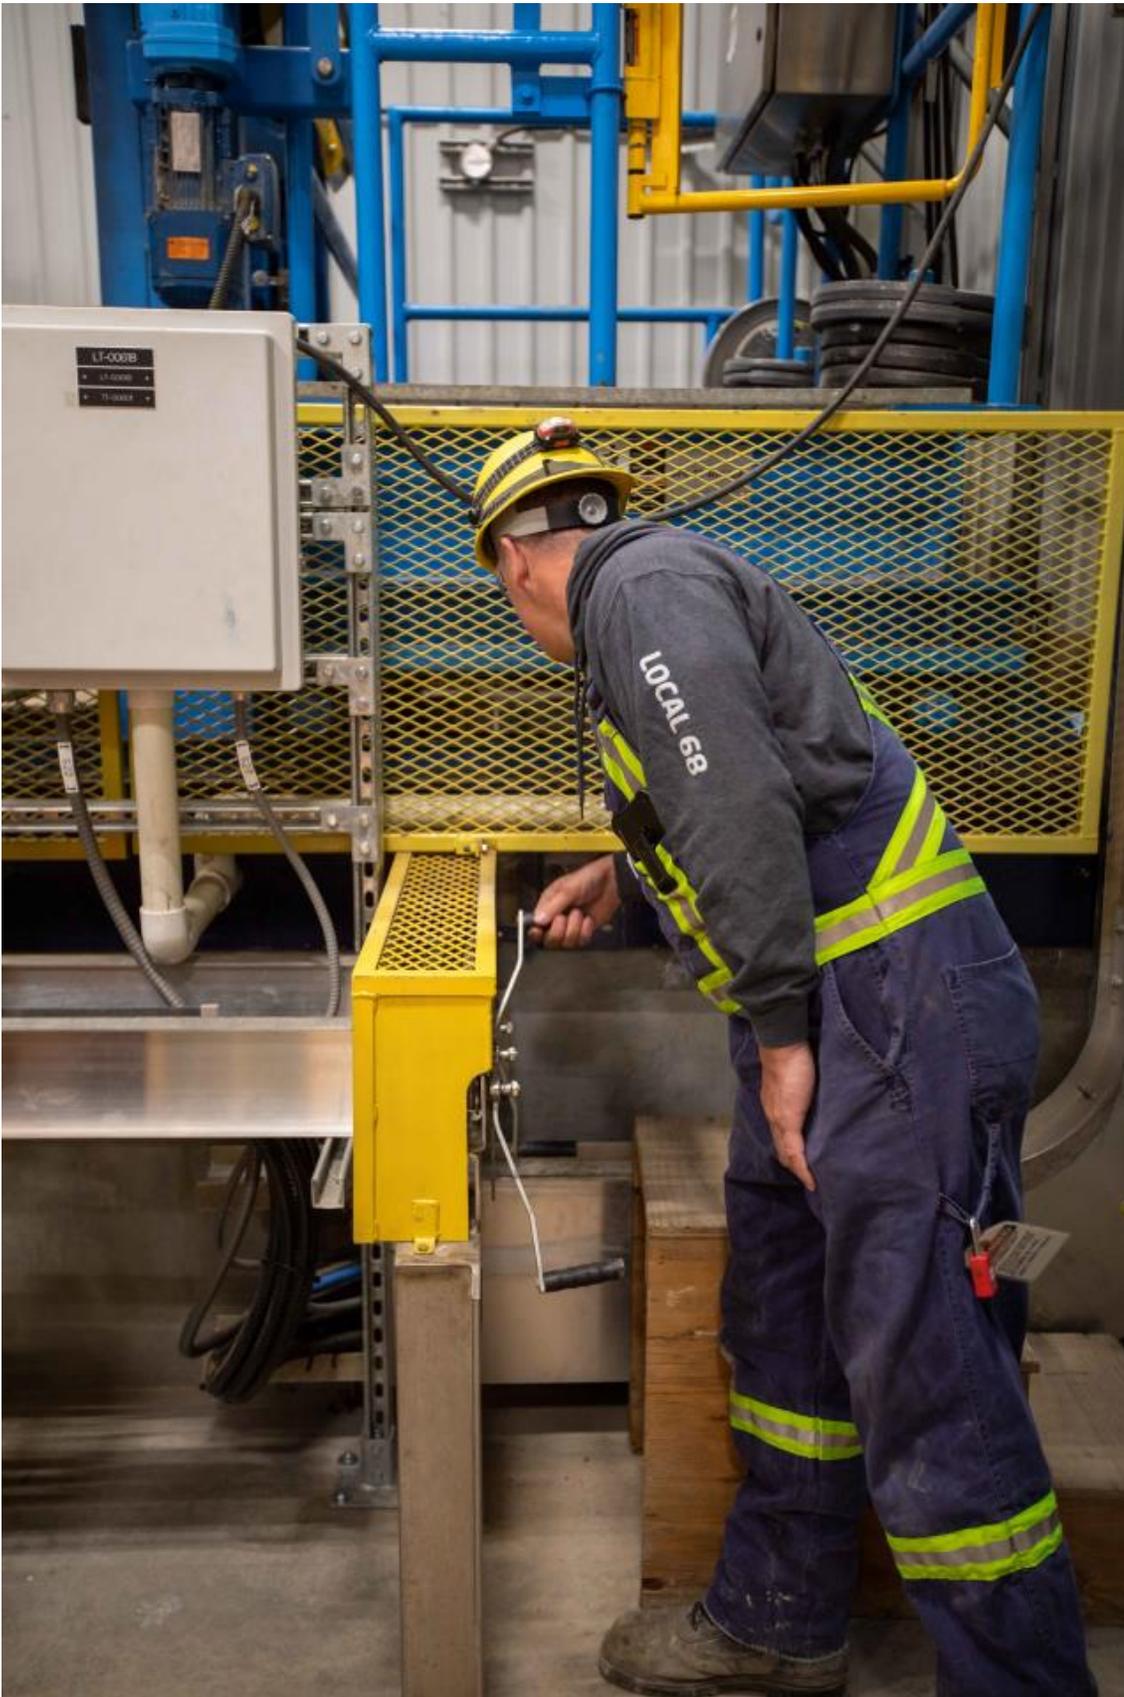
Photo 3. Worker opens the vee-trap on the first day of commissioning (September 23, 2020).

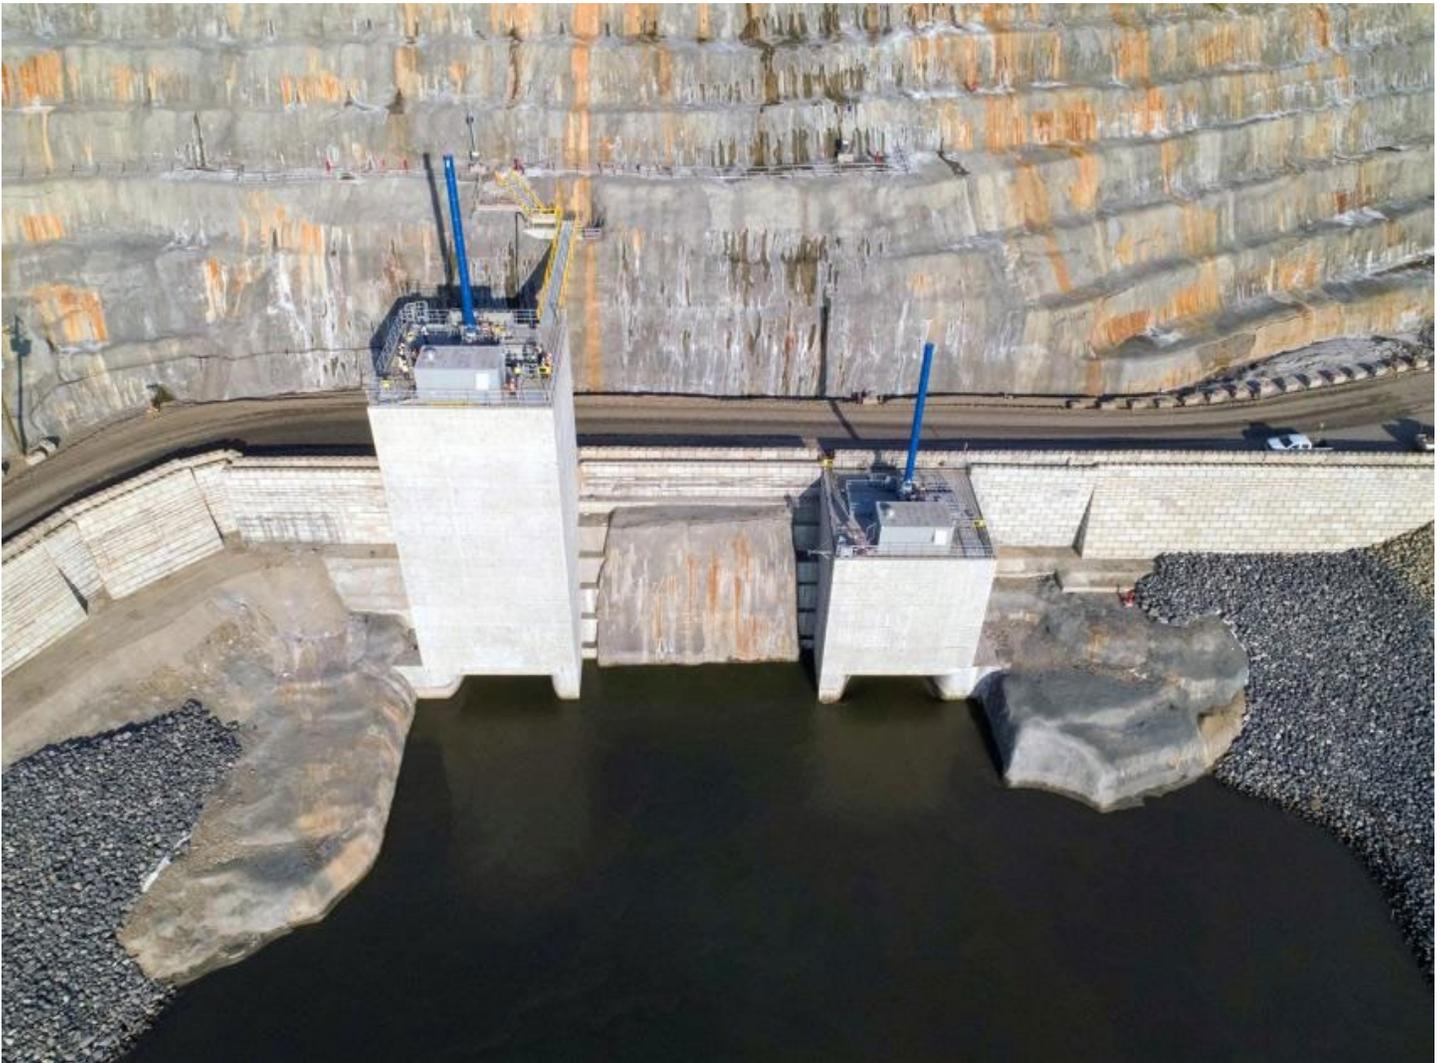
Photo 4. Diversion began on September 30, 2020, when the diversion tunnel gates were opened.

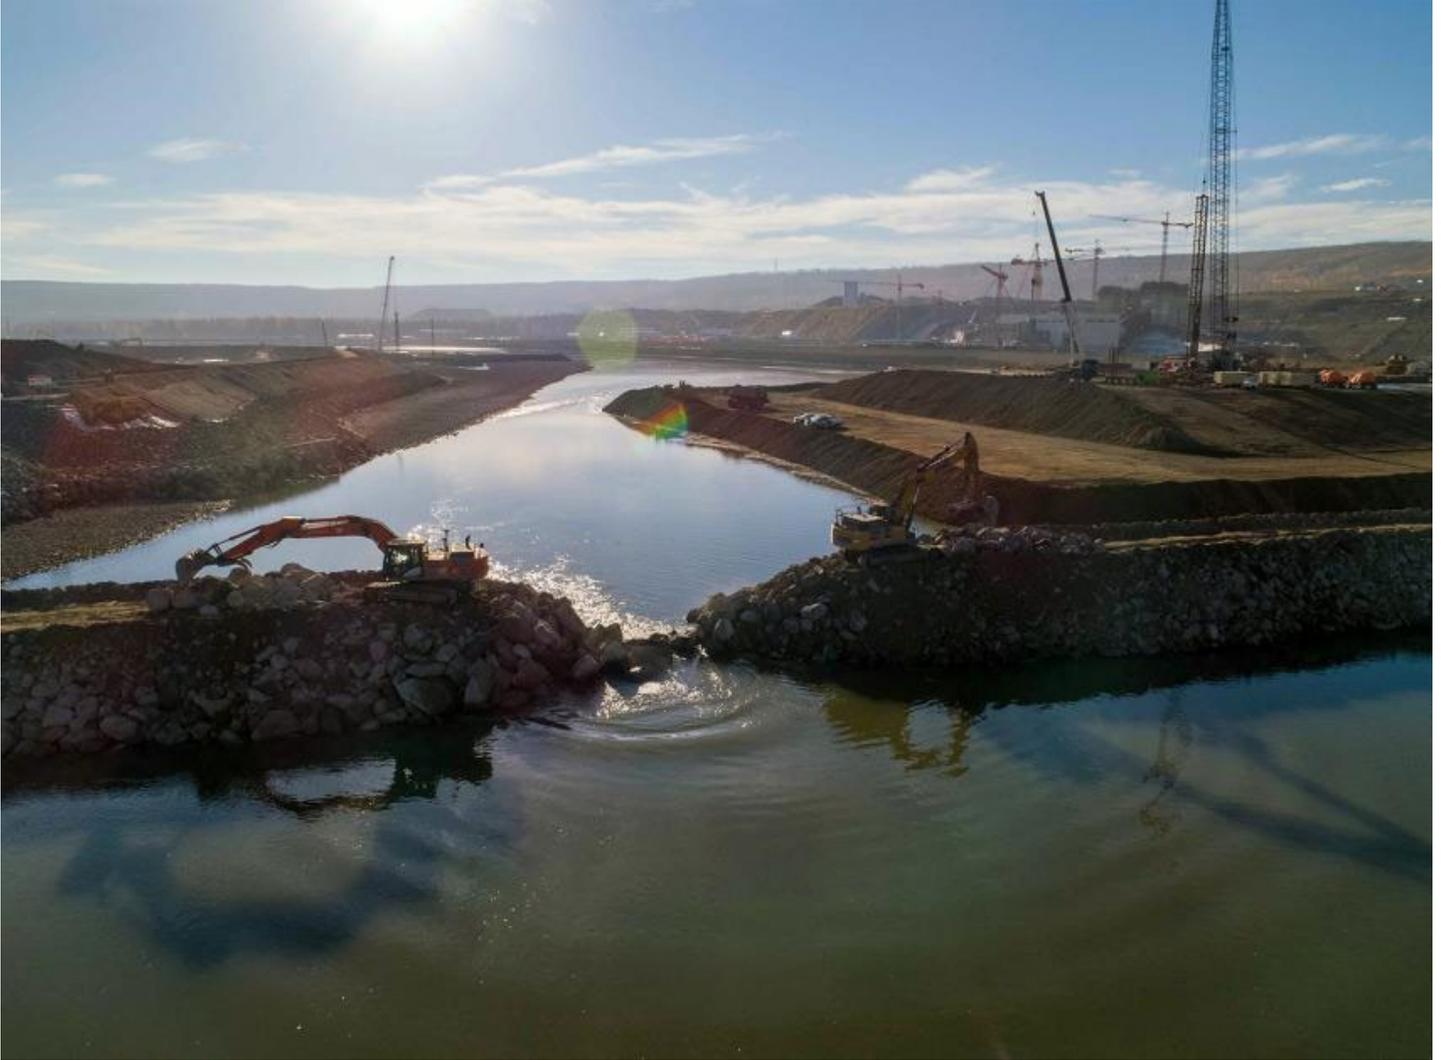
Photo 5. Final rip rap is placed on the rockfill berm (center) to close the Peace River on October 3, 2020 (looking downstream).

Discharge in the Peace River was held low (approximately 400 cms) from September 29 to October 3 to support placement of the final rip rap at the rockfill berm (Photo 5). Following river closure on October 3, flows increased to approximately 800 cms and remained above this level until a planned ramp down event at Peace Canyon Dam on October 31 to support Highway 29 construction activities at the Halfway River (Figure 2).

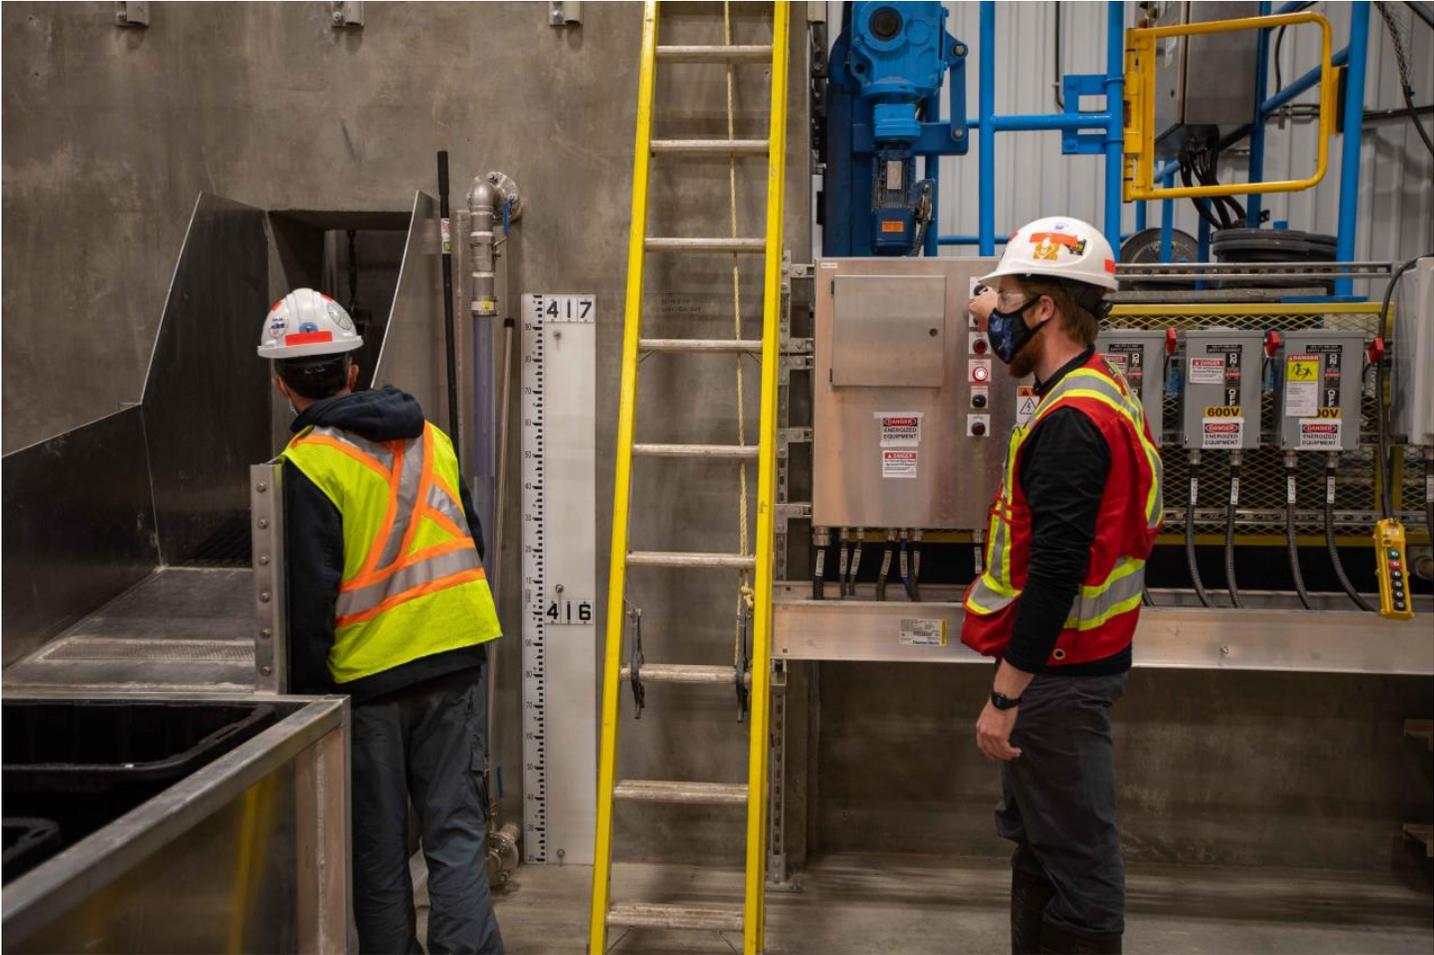
Photo 6. Workers conduct a crowding cycle during the first day of commissioning the temporary facility (September 23, 2020).

Fish were crowded daily from the pre-sort holding pool into the fish lock. Operators then proceeded to raise crowded fish to the elevation of the sorting facility. Note that this process is referred to as a “sorting cycle”.

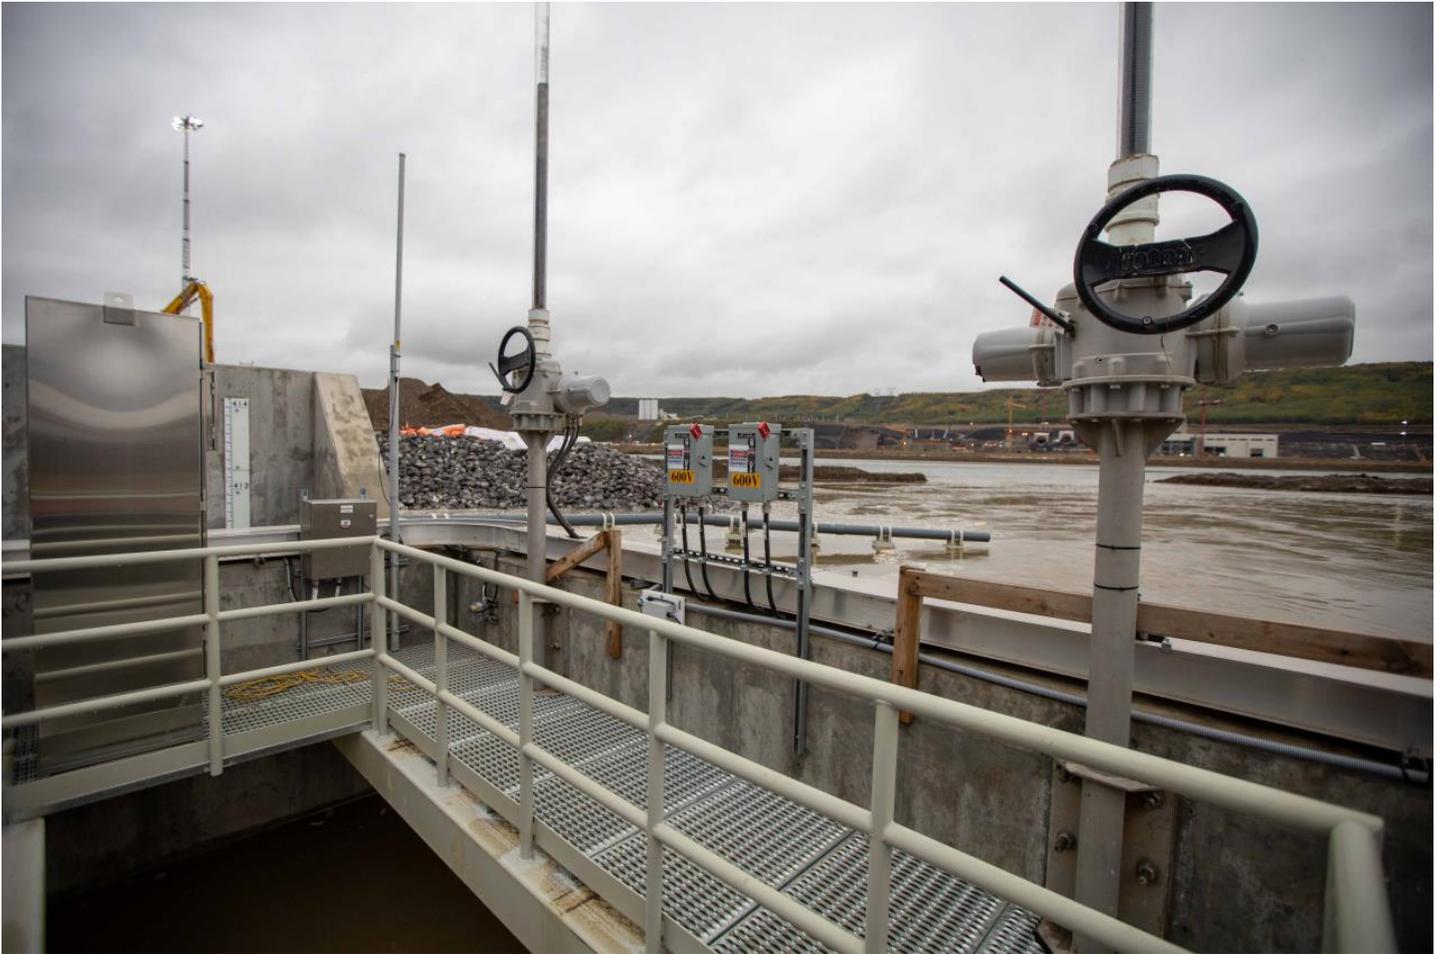
Photo 12. Two entrance gates provide the attraction flows at the fishway entrance. Gates are programmed to automatically adjust their position to maintain the same head differential between the entrance pool and the diversion tunnel outlet (September 14, 2020).

Operation of the attraction flows and high velocity jet intends to attract fish towards the fishway entrance. Once fish have entered the temporary facility, flows within the fishway intend to provide a flow signal for fish to detect and swim up each pool to the sorting facility.

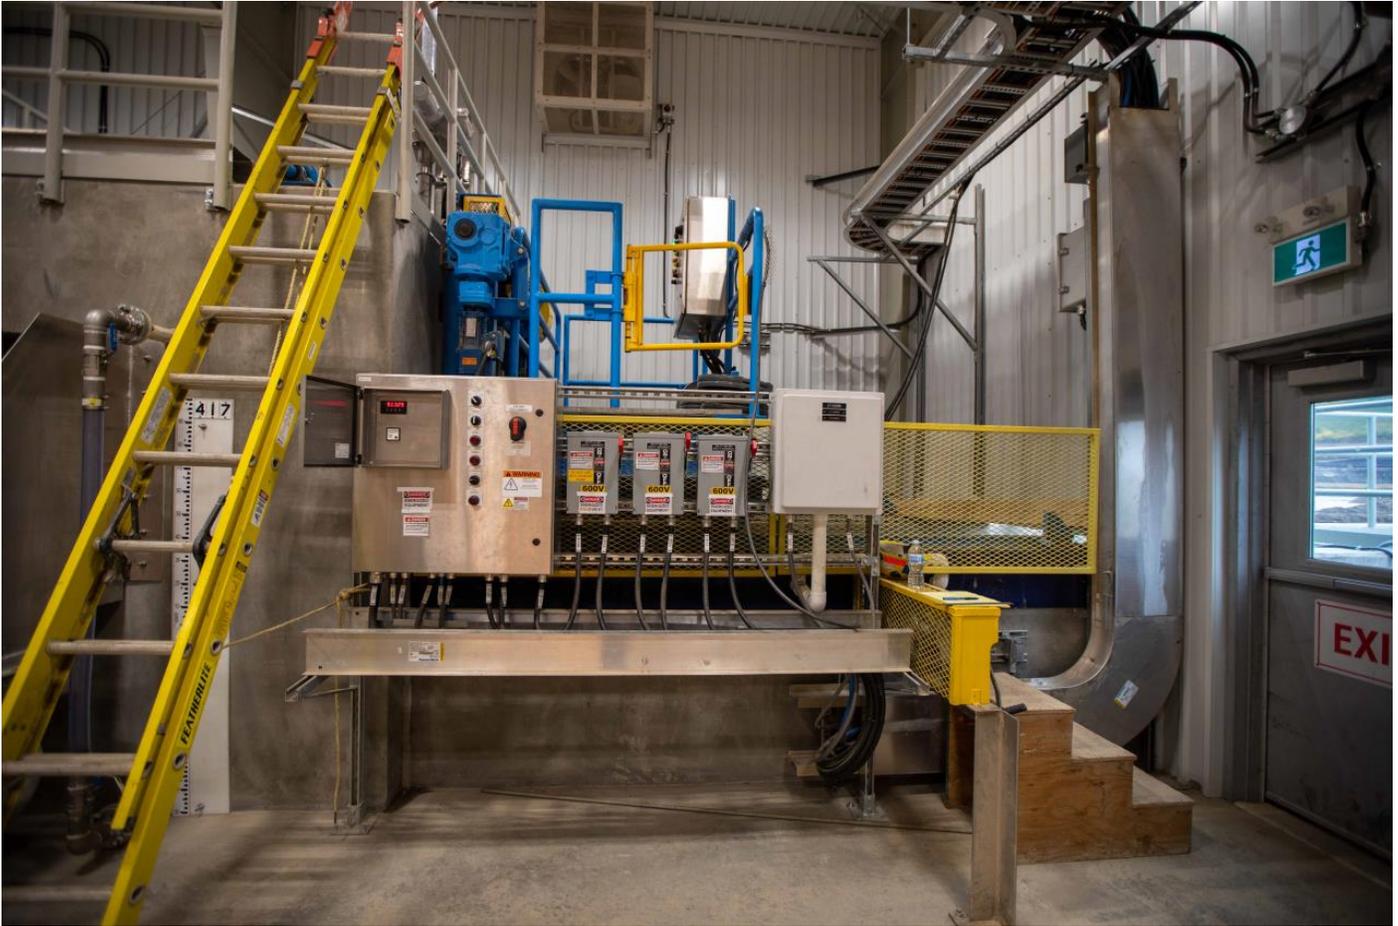
Photo 13. Fish enter the pre-sort holding pool (center) where they are crowded and raised to the elevation of the sorting facility through the use of the lock (left) (September 14, 2020).
