Appendix 12. Wetland Mitigation Program Closure Memo

To: Dana Eye and Jayme Brooks, Environment and Climate Change Canada;
Carl Johansson, Impact Assessment Agency of Canada;
Clayton Smith, BC Environmental Assessment Office

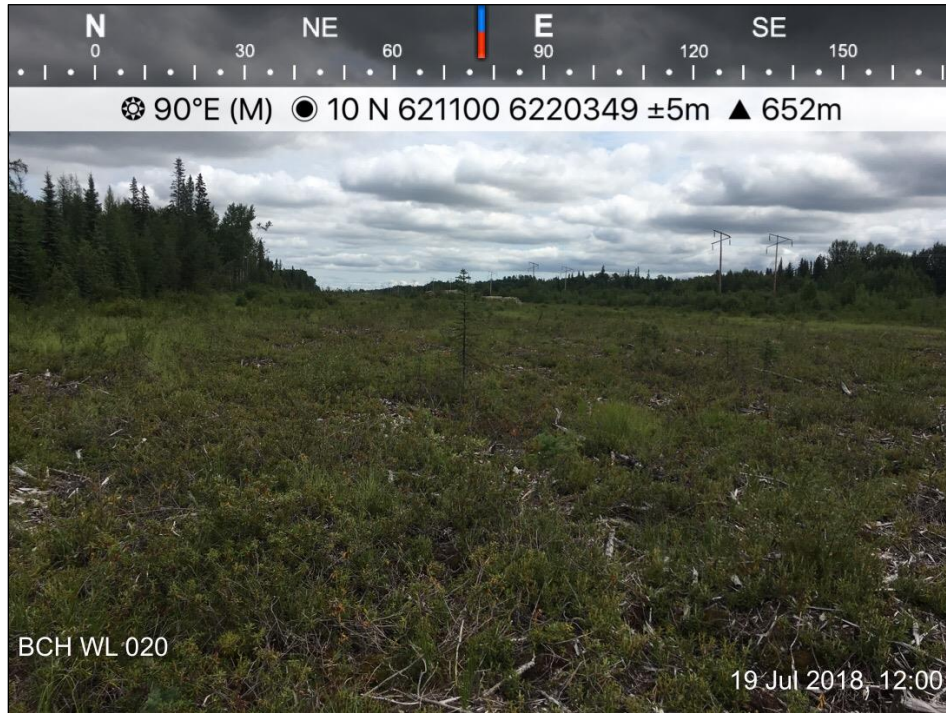
Plate 3.2-1 Wb06 Tamarack – Water sedge – Fen moss bog at wetland WL020 along the transmission line in 2018.

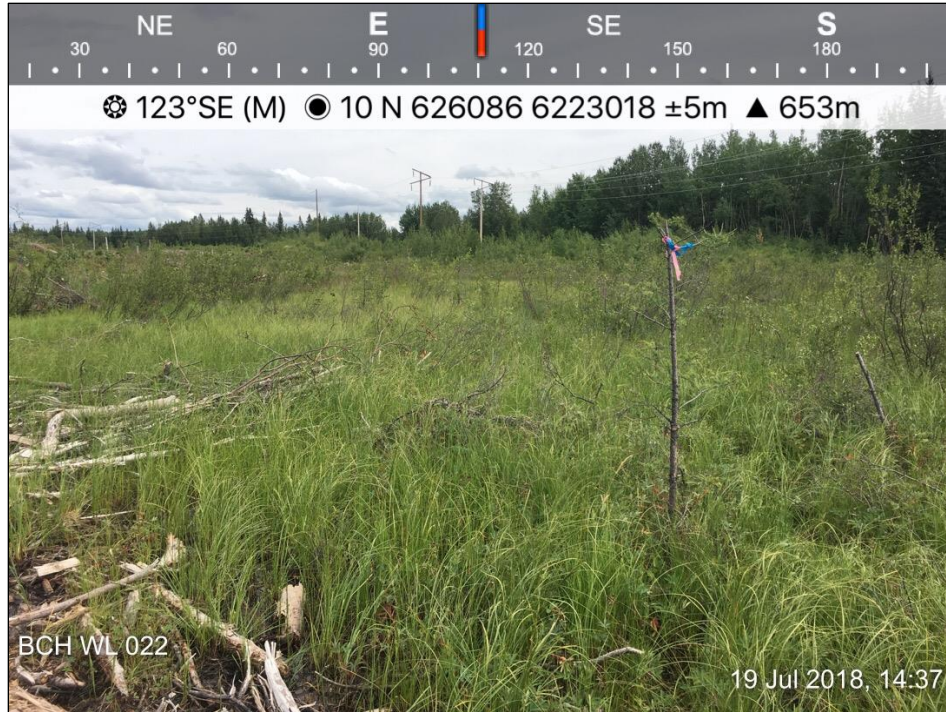
Plate 3.2-16. Wf02 Scrub birch – water sedge fen at WL021 along the transmission line in 2018 (plot number was incorrectly labelled in 2018)

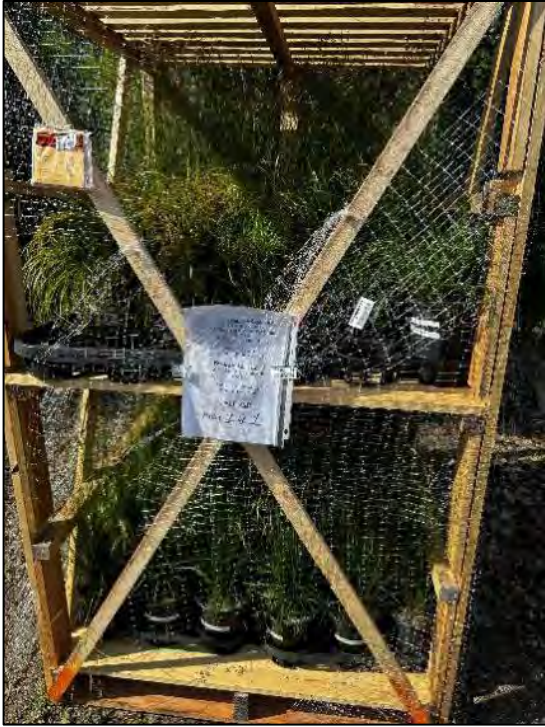
Plate 2.3-1. Plant shipment picked up from Dunvegan Gardens in Fort St. John (June 6, 2025)

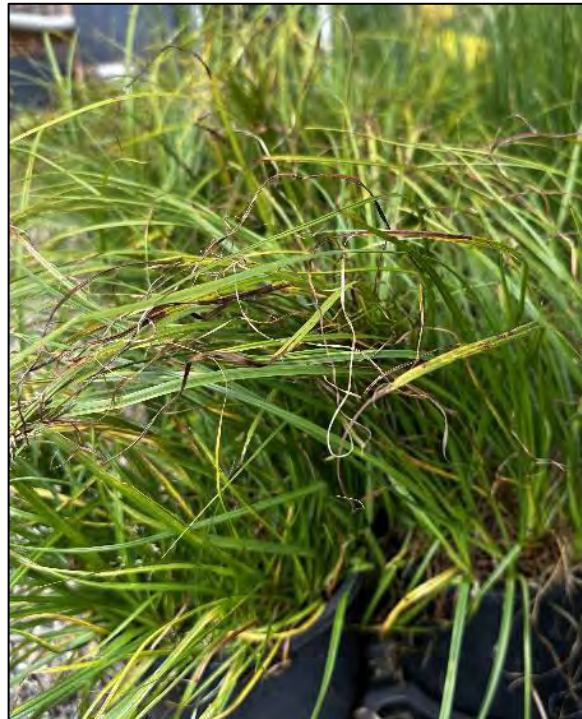
Plate 2.3-4. Minor desiccation observed on sedges (June 6, 2025)

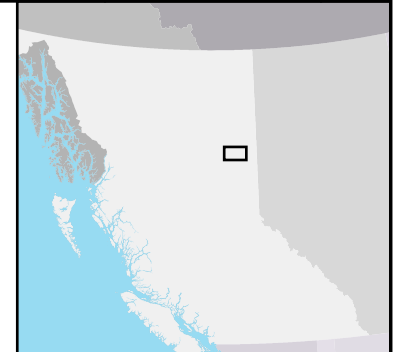
3.2 PHASE 2. EX-SITU PROPAGATION

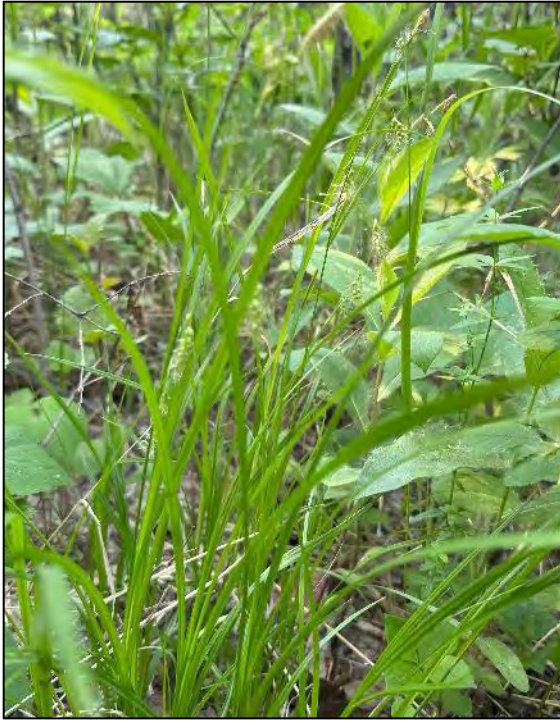
Plate 3.4-1. Example of adult Sprengel's sedge (tag 003) at site ID: CARESPR-2020-B-1B on June 10, 2025

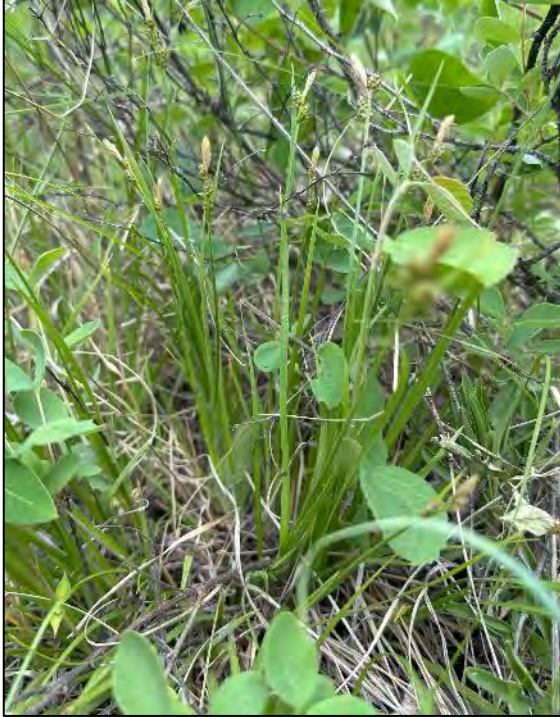
Plate 3.4-3. Example of adult Torrey's sedge (tag 441) at site CARETOR-2023-C subplot 1A on June 9, 2025

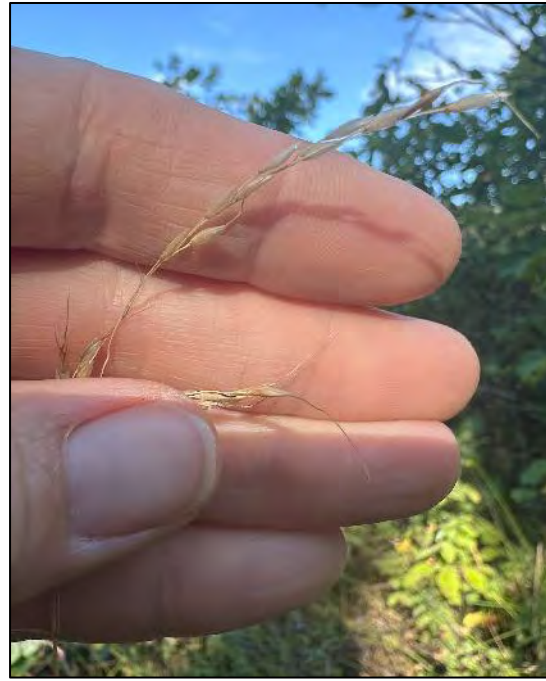
Plate 3.4-7. Close up of Canada mountain-ricegrass (tag 073) seedhead monitored at site ID: PIPTCAN-2023-C-Cohort 2 (August 17, 2025)

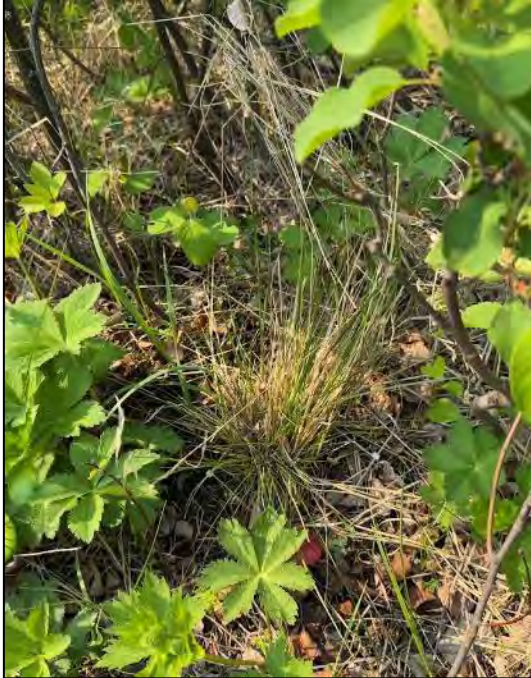
Plate 3.4-8. Example of vegetative greening of Canada mountain-ricegrass (tag 061) monitored at site ID: PIPTCAN-2024-D subplot 6 (June 7, 2025; Eagle Cap photo)

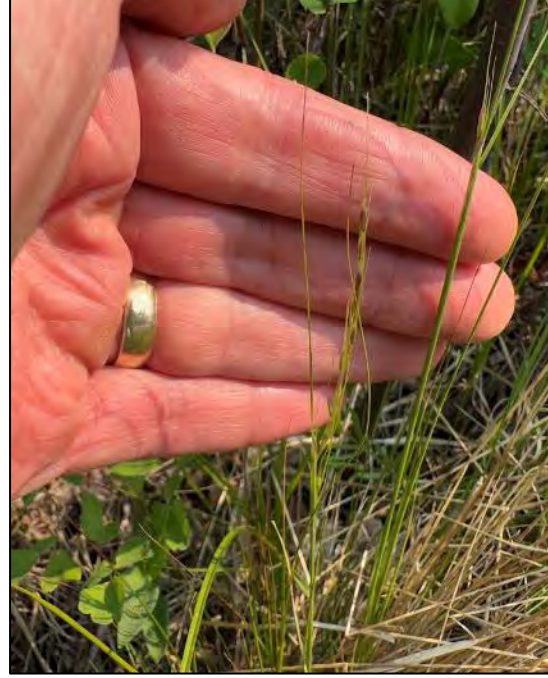
Plate 3.4-9. Example of Canada mountain-ricegrass budding inflorescence monitored at site ID: PIPTCAN-2024-D (June 7, 2025; Eagle Cap photo)

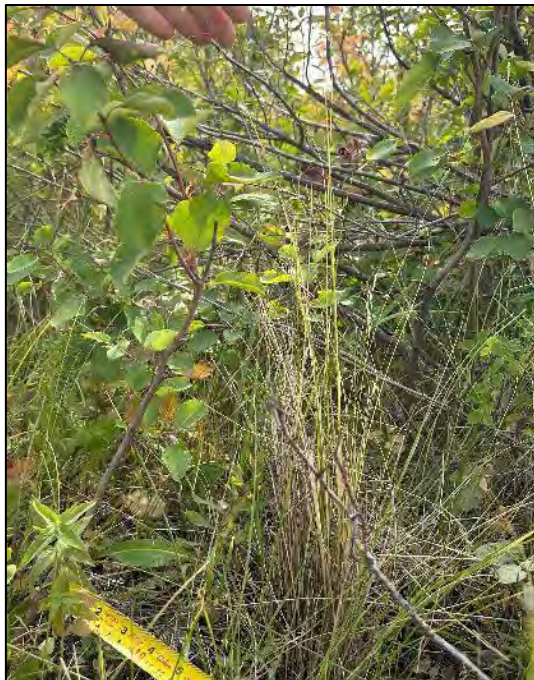
Plate 3.4-10. Sample of Canada mountain-ricegrass (tag 048) monitored at site ID: PIPTCAN-2024-D subplot 8 (August 18, 2025)

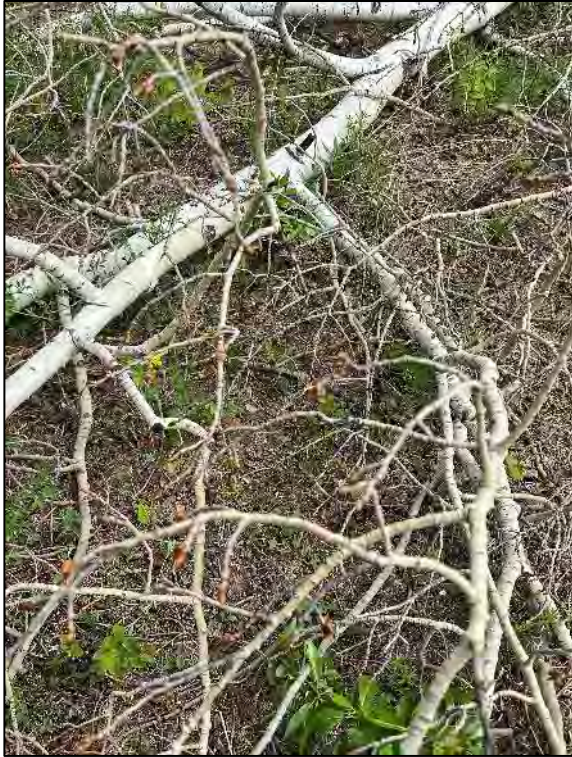
Plate 3.4-12. Beaver activity at site ID: RANURHO-2022-C (June 5, 2025; Eagle Cap photo)

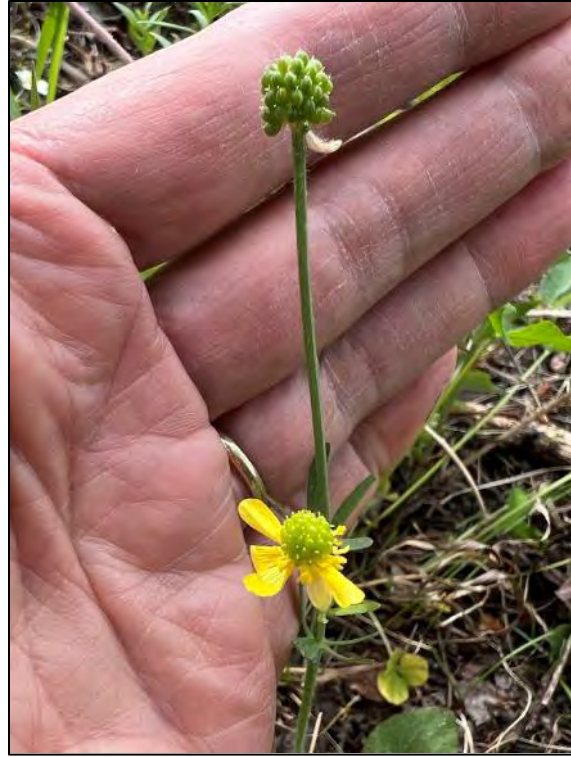
Plate 3.4-13. Example of inflorescence and developing seedhead on a monitored adult prairie buttercup at site ID: RANURHO-2022-C (June 5, 2025; Eagle Cap photo)

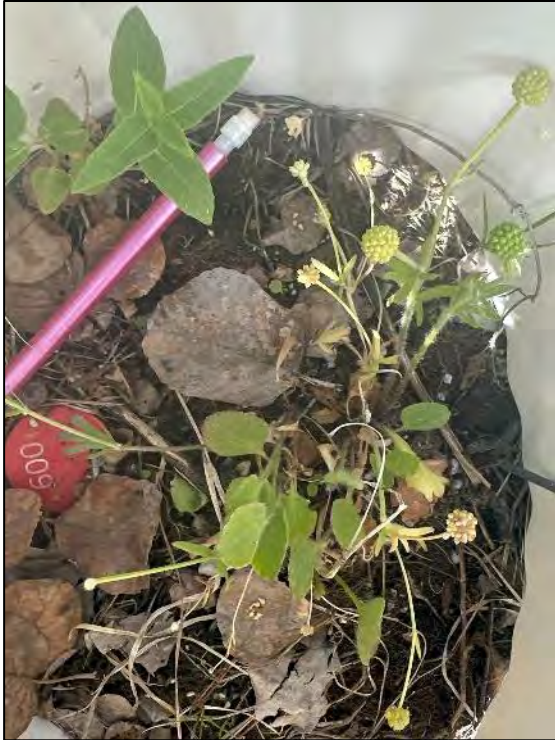
Plate 3.4-14. Example of individual prairie buttercup (tag 009) seedheads on June 9, 2025 (site ID: RANURHO-2023-E-1A-Cohort 2)

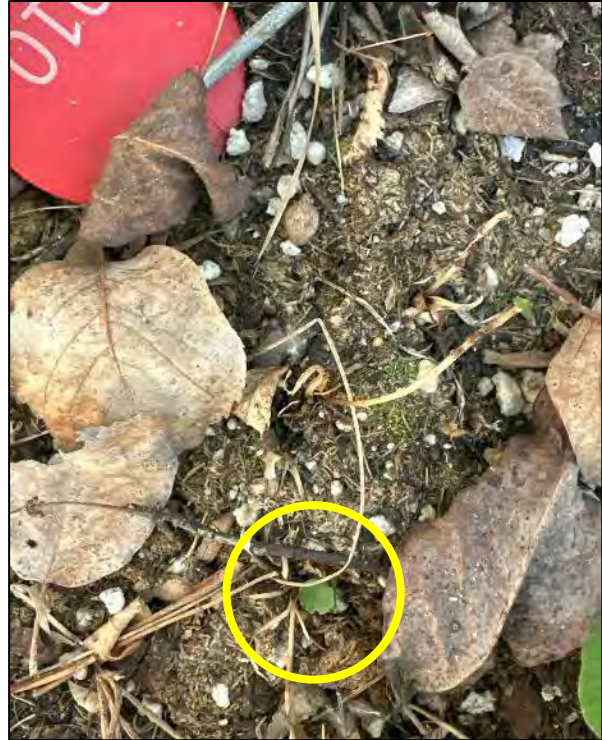
Plate 3.4-15. Example of prairie buttercup recruit (circled in yellow; parent tag 010) observed on June 9, 2025 (site ID: RANURHO-2023-E-1A-Cohort 2)

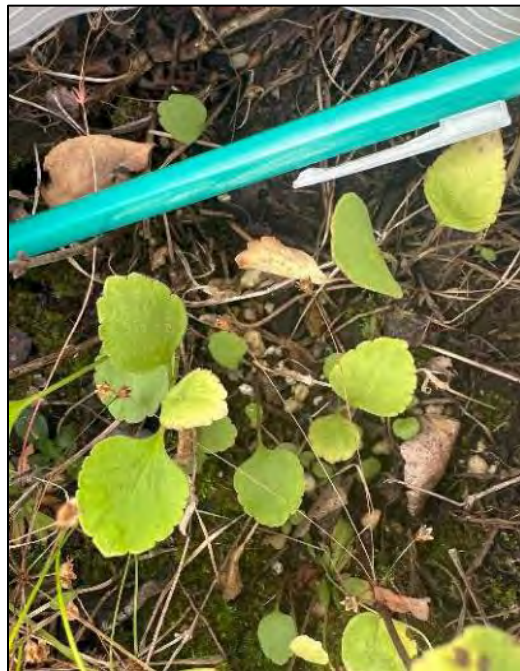
Plate 3.4-16. Prairie buttercup recruits observed during interim monitoring (site ID: RANURHO-2024-F; August 17, 2025)

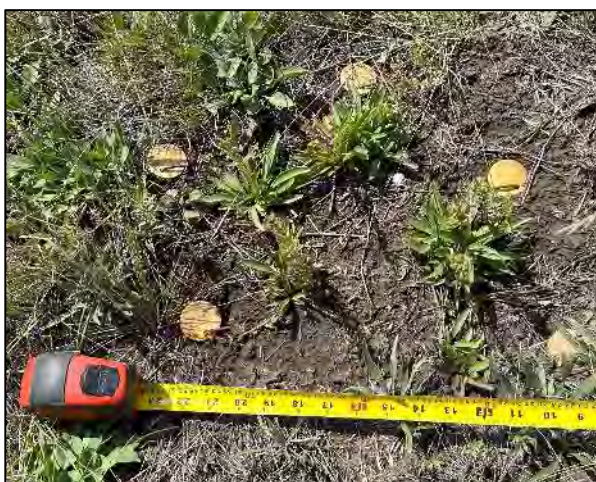
Plate 3.4-17. Sample of slender penstemon with inflorescences and developing seed pods at site ID: PENSGRA-2020-A (August 17, 2025)

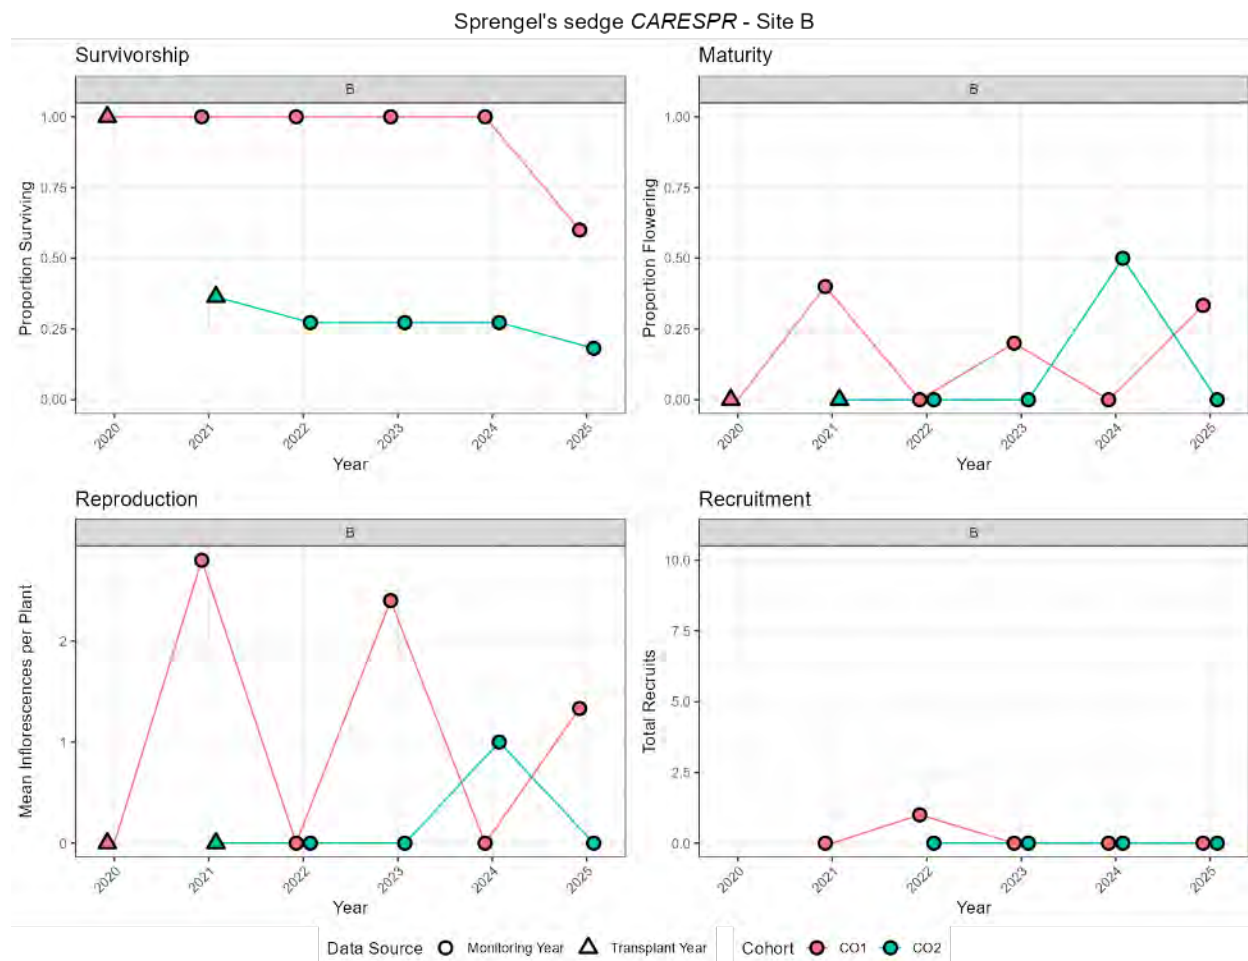
Figure 3.5-1. Patterns of survival, flowering, reproduction, and recruitment over time for Sprengel’s sedge at Site B (CARESPR-2020-B-1B). Site data are faceted into separate paired plots for each trait, with cohorts represented with different colored lines within sites.

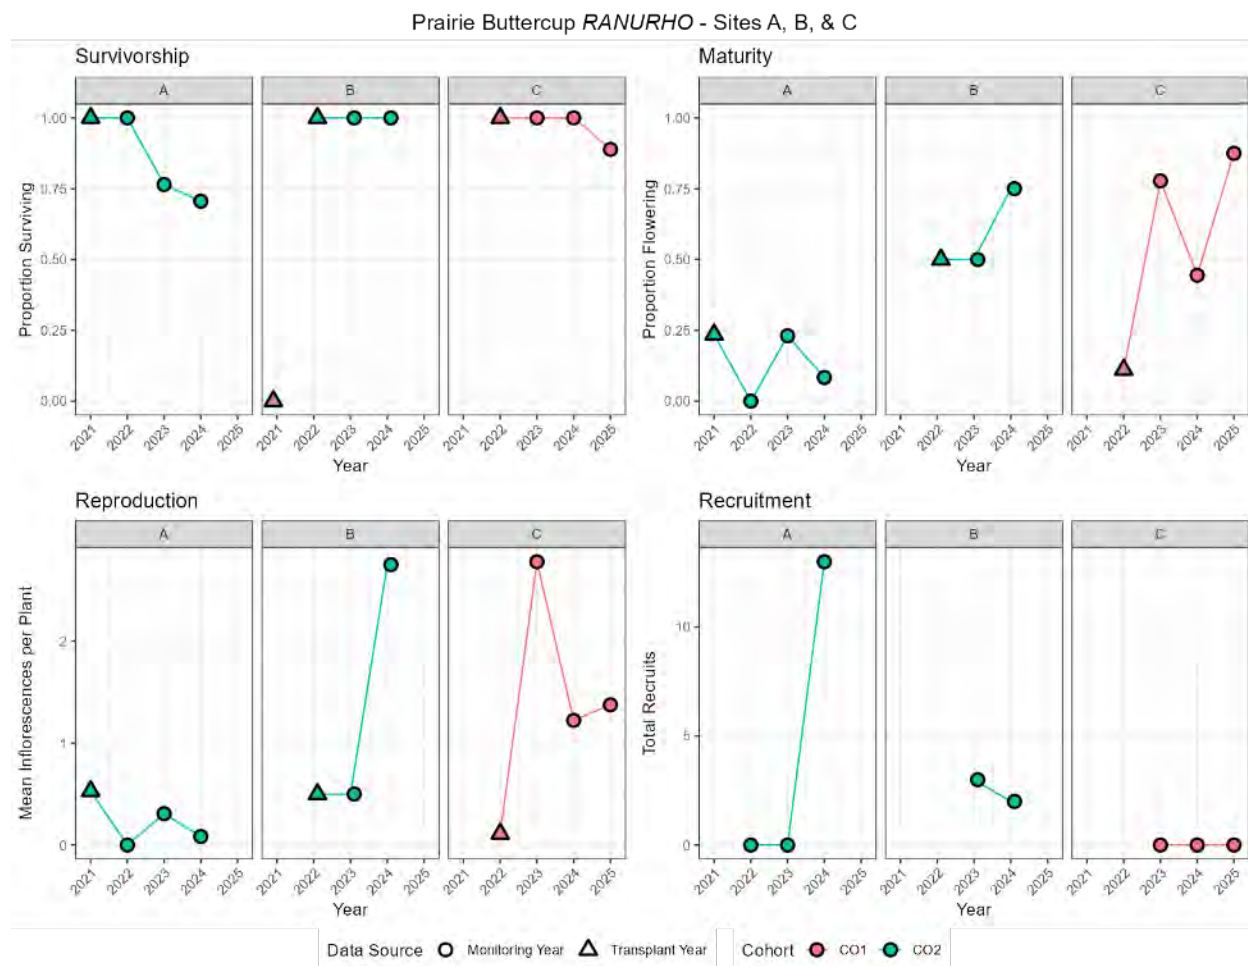
Figure 3.5-4. Patterns of survival, flowering, reproduction, and recruitment for prairie buttercup at Sites A, B, and C (RANURHO-2021-A, RANURHO-2021-B, RANURHO-2022-C). The data for sites are faceted into separate paired plots for each trait, with cohorts represented with different colored lines within sites.
