## **Appendix 15. 2025 Ground Nesting Raptors Report**

# Site C Clean Energy Project Ground-Nesting Raptor Monitoring 2025 Annual Report

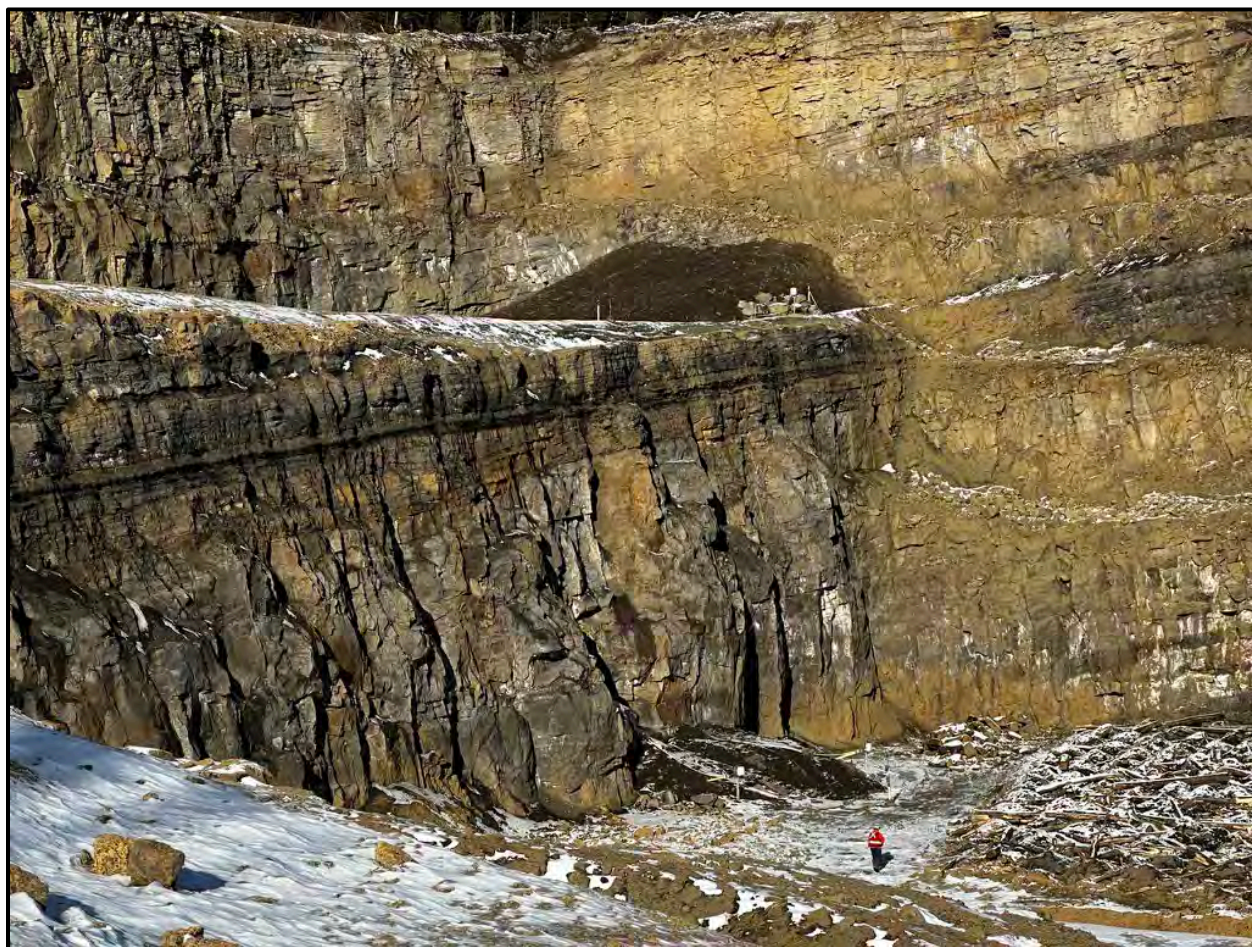
## Table of Contents

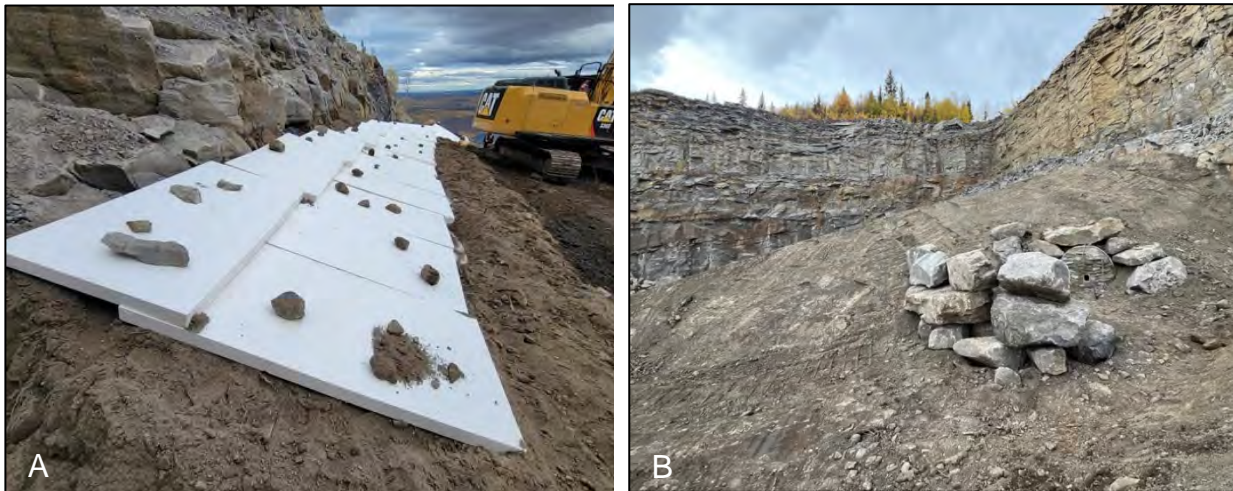
Figure 9. Insulation panels (A) and final soil cover and windbreak boulders (B) during construction of the culvert bat hibernaculum.

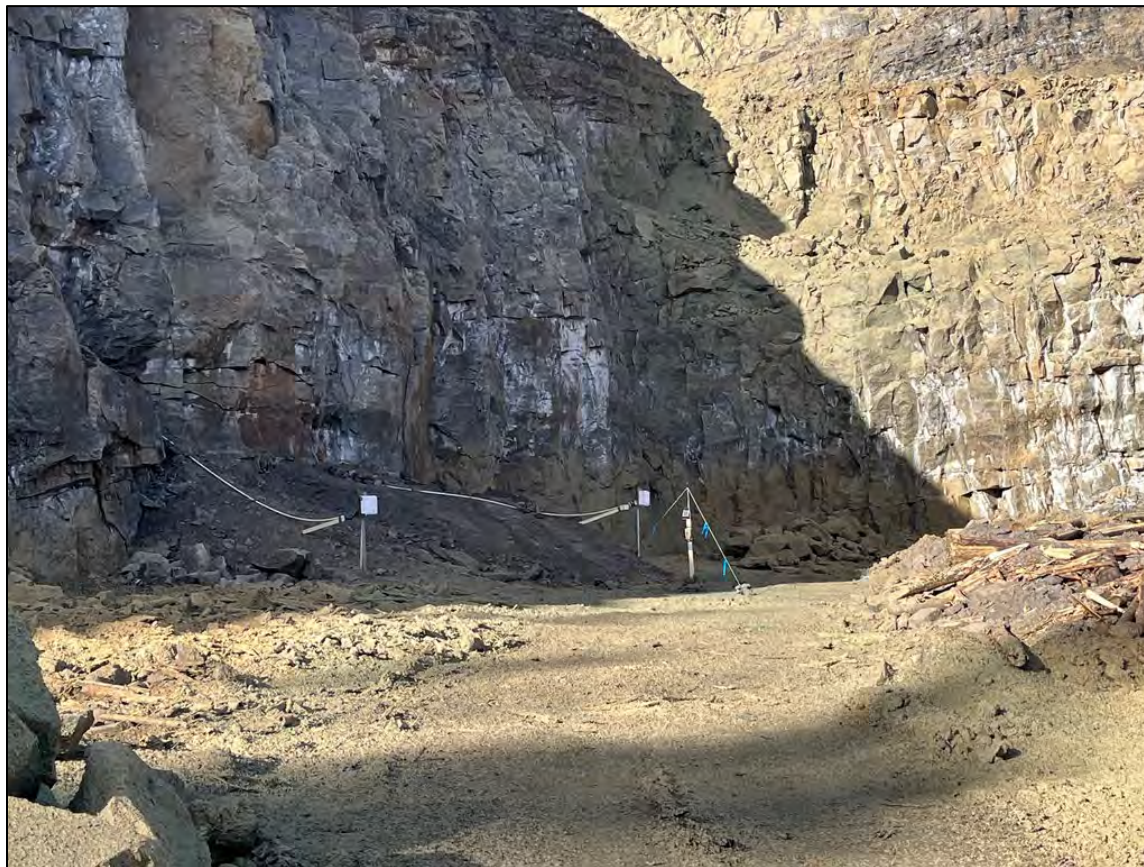
*Figure 11. ARUs installed at hibernacula Sites 1-30 and 1-31.*

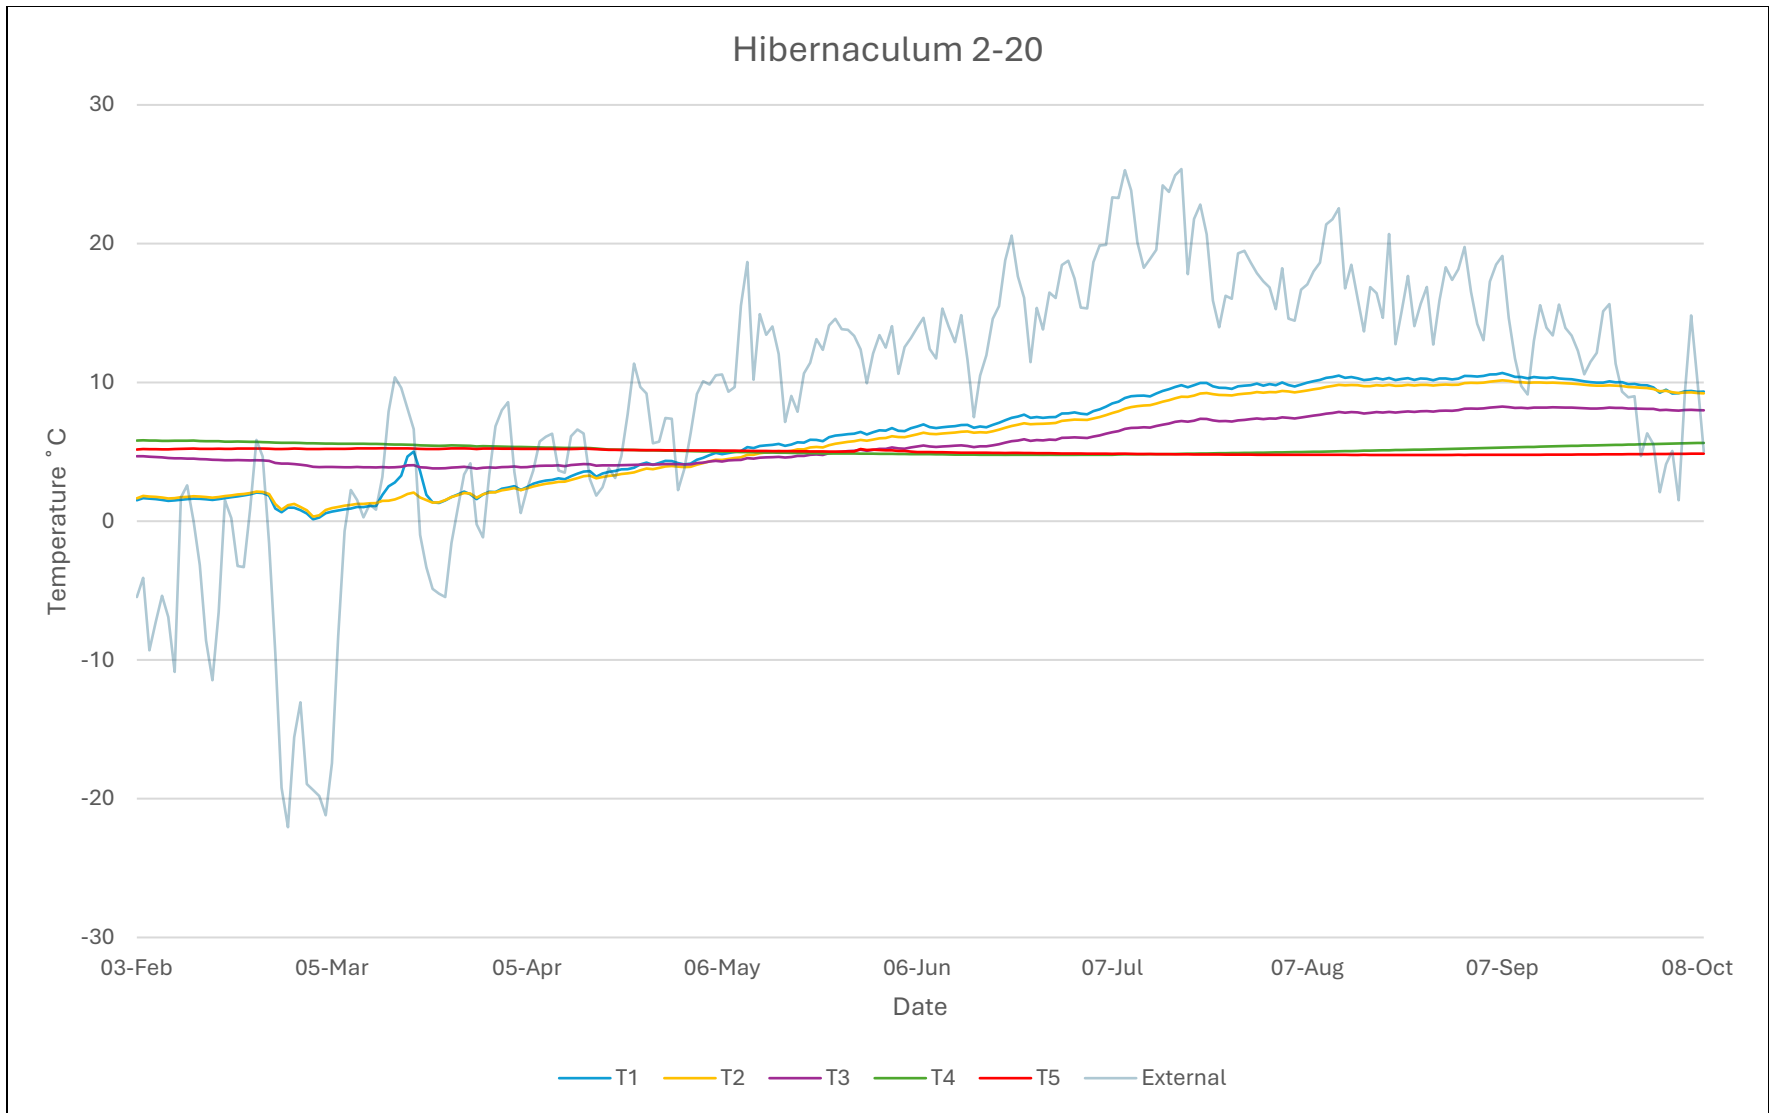
Figure 12. Results of temperature monitoring at Hibernaculum 2-20 from February 3 to October 9, 2024.

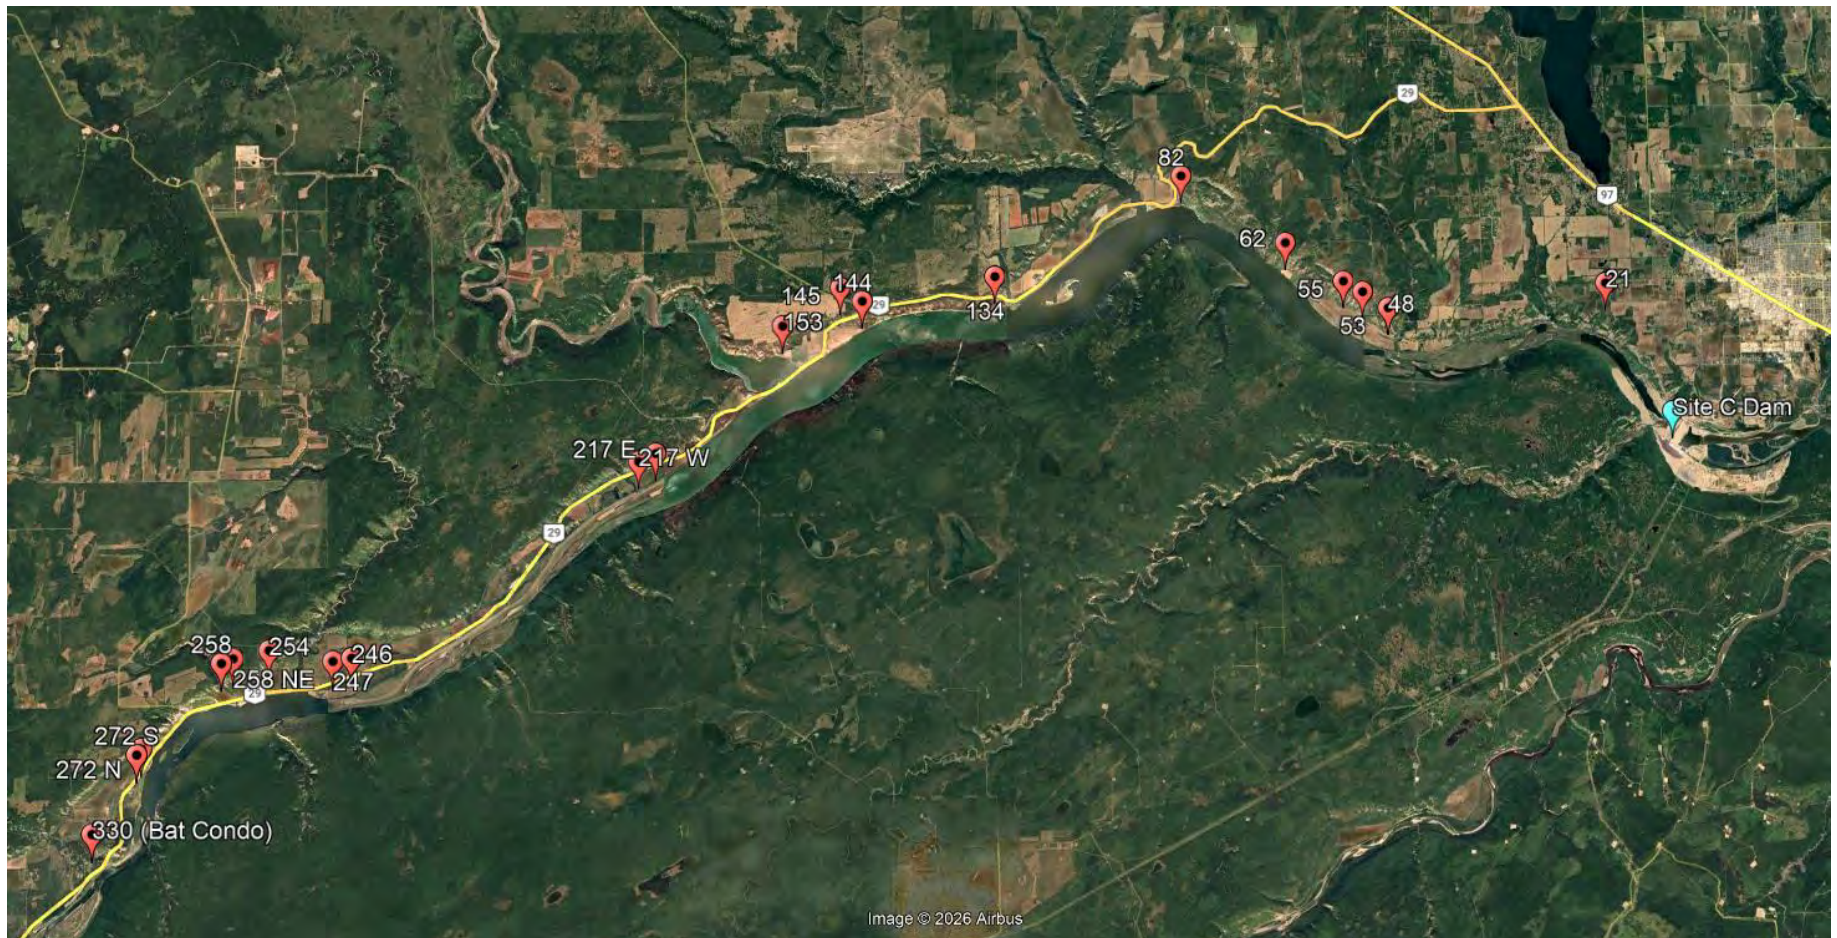
**Figure 1.** General overview map of the Program area and location. Red points mark the locations of the bat box clusters with the Site C Dam marked in light blue.

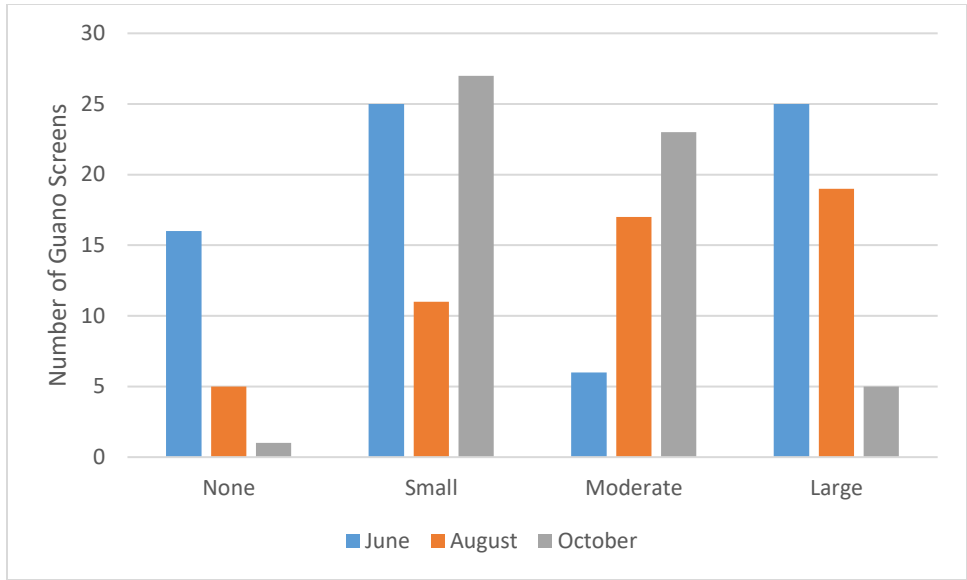
**Figure 4:** Number of guano screens surveyed with No guano, Small, Moderate, or Large quantities observed during the bat occupancy surveys in 2025.

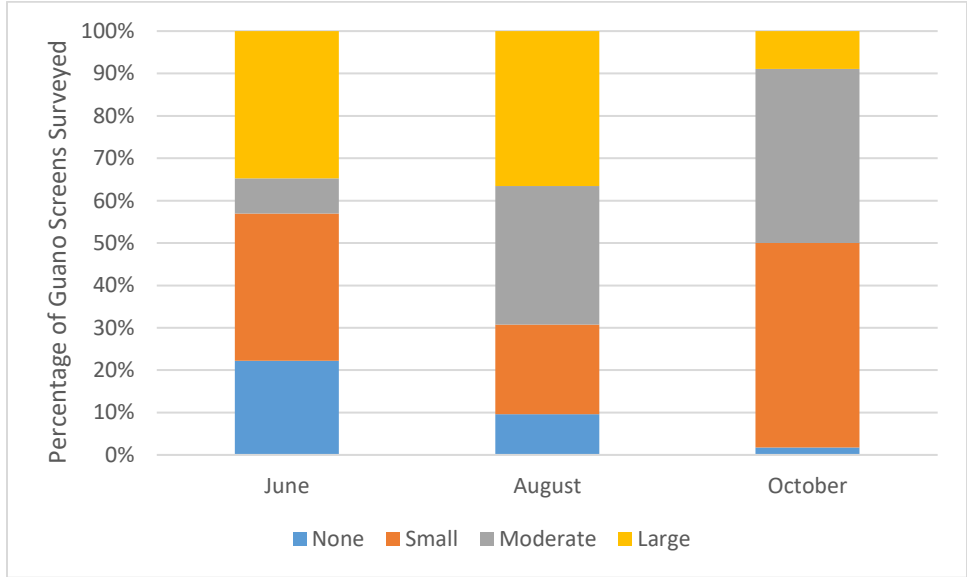
**Figure 5:** Proportion of guano screens surveyed with No guano, Small, Moderate, or Large quantities observed during the bat occupancy surveys in 2025.

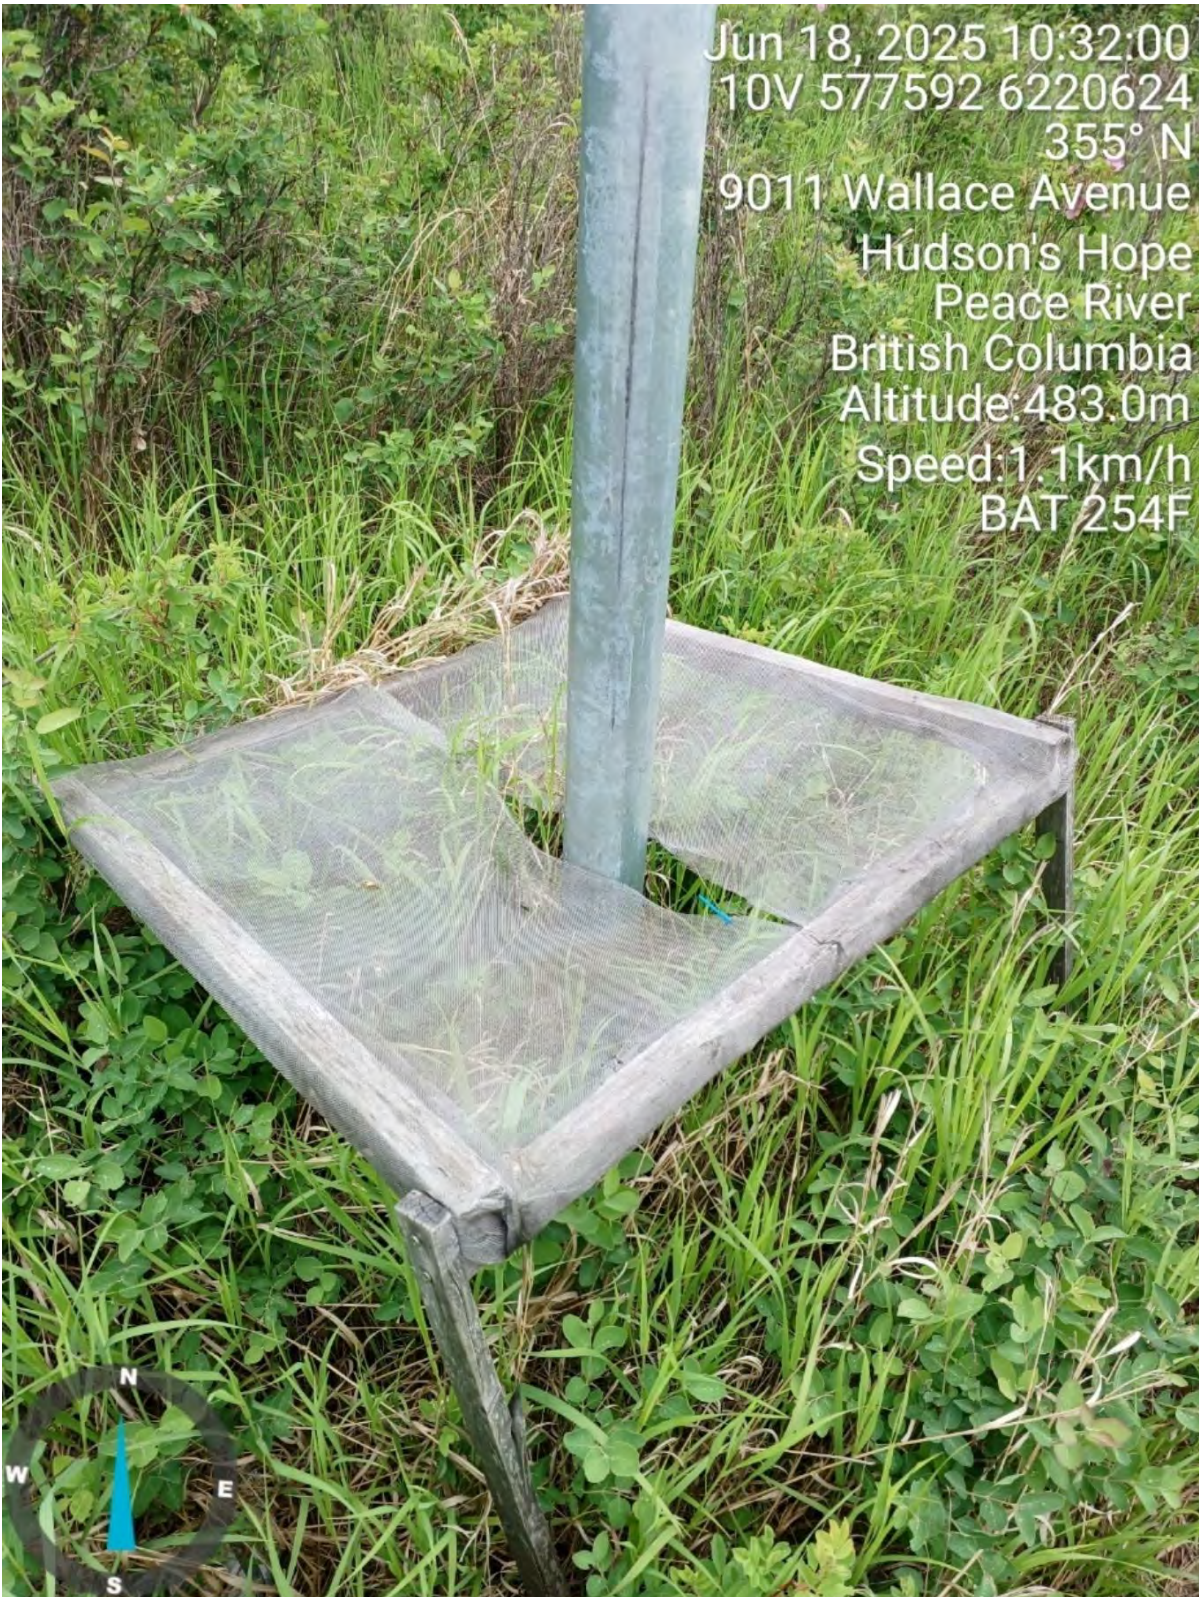
Jun 18, 2025 10:32:00  
10V 577592 6220624  
355° N  
9011 Wallace Avenue  
Hudson's Hope  
Peace River  
British Columbia  
Altitude: 483.0m  
Speed: 1.1km/h  
BAT 254F

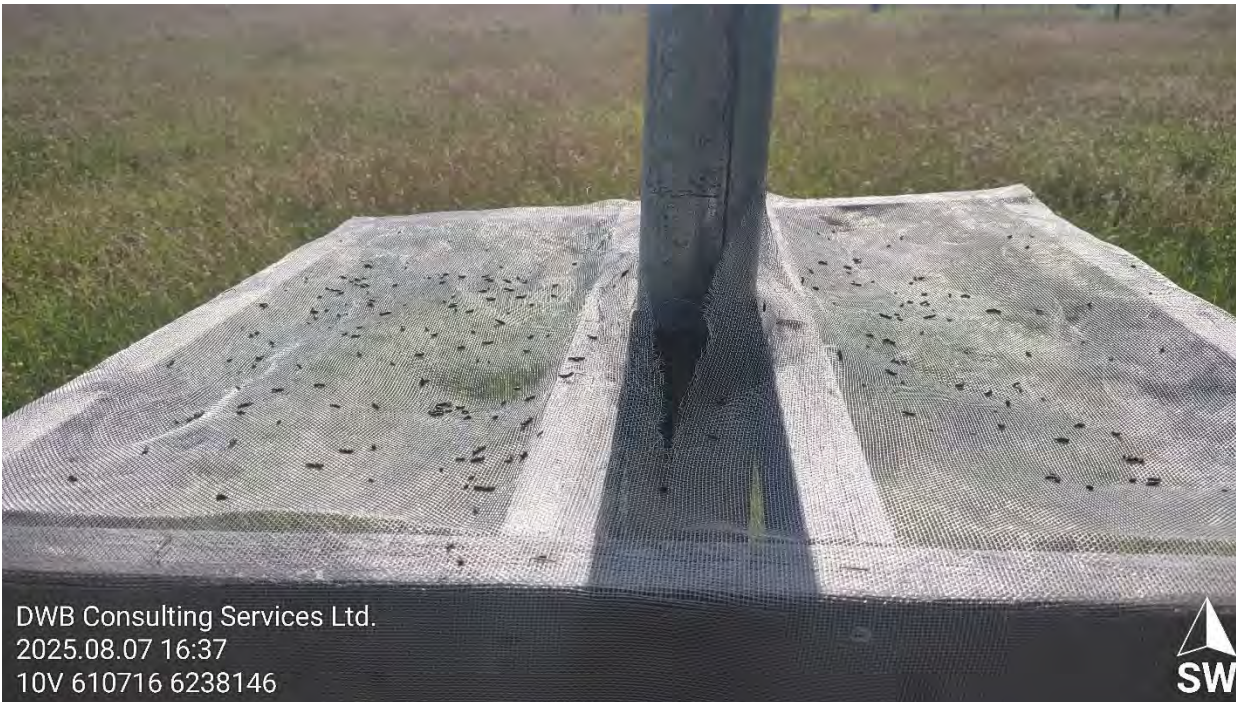
Photo 8: Example of a Small guano score (<100 pellets) at box Bat\_82.1 C/D on August 07 2025.

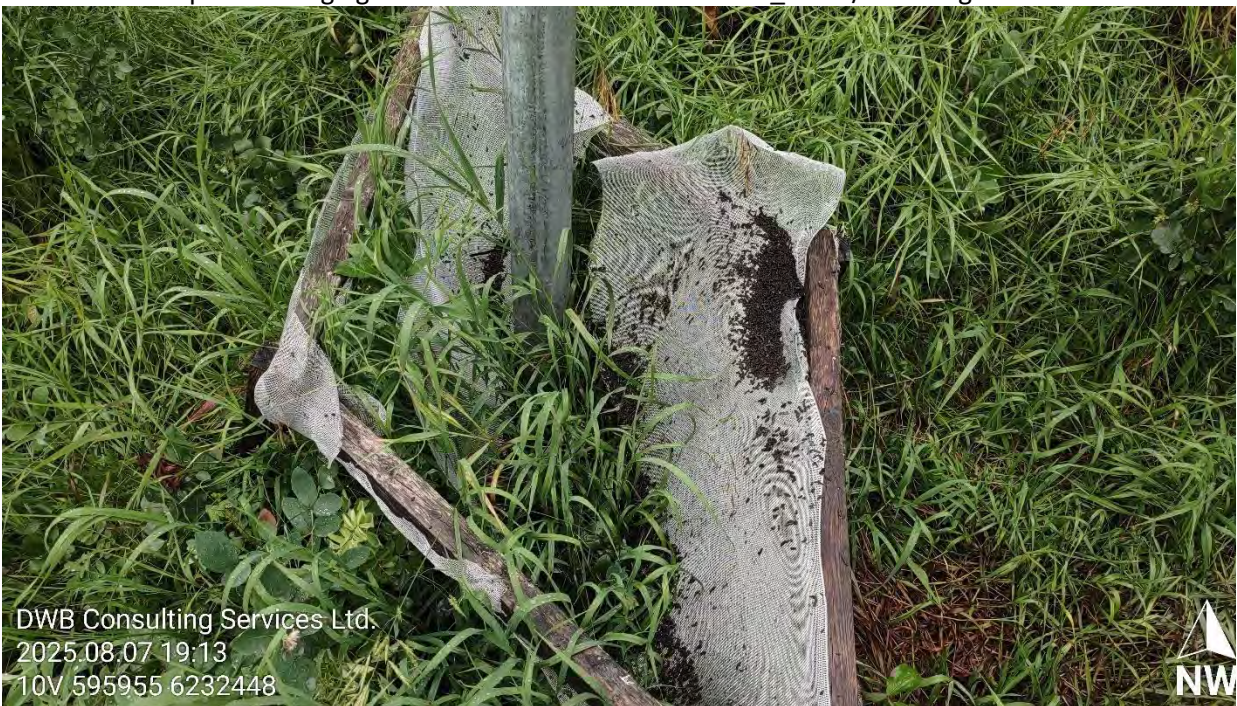
Photo 11: Ground-level guano screen underneath box Bat\_153 A/B damaged by wildlife on August 07 2025.

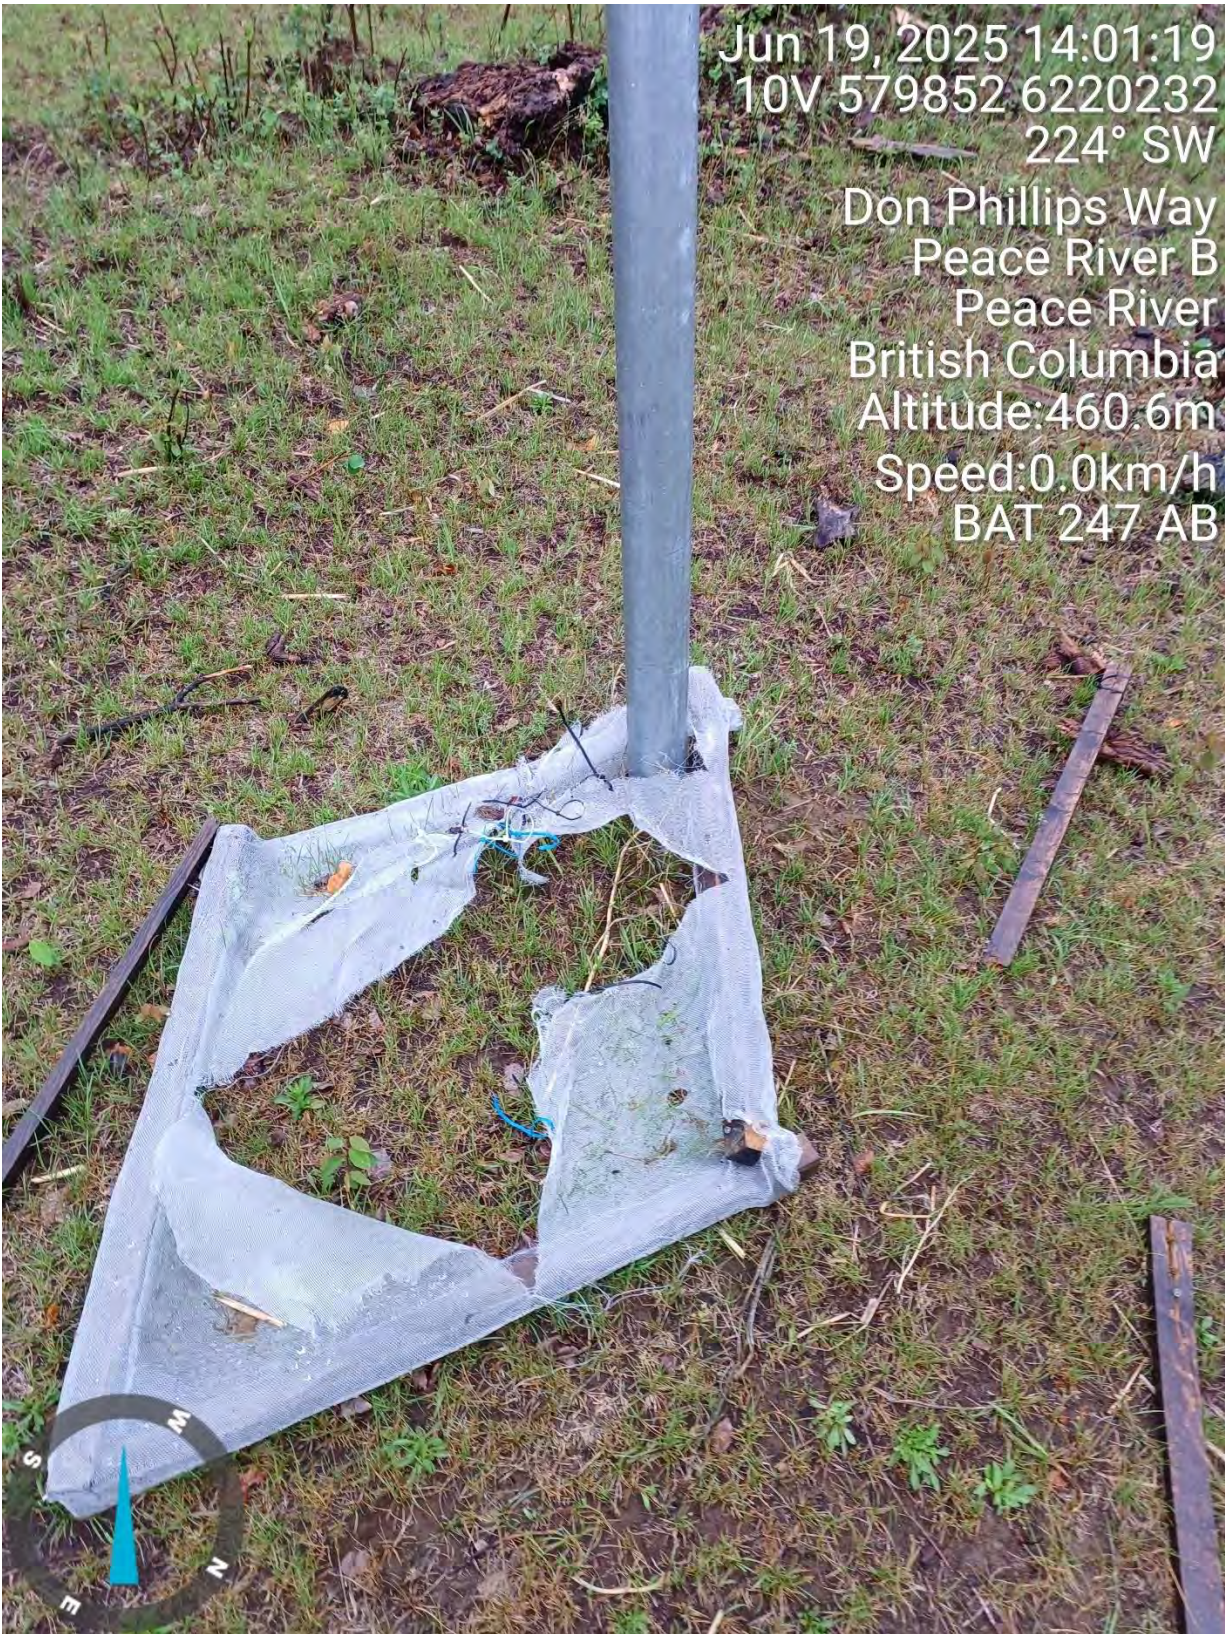
Photo 12: Ground-level guano screen underneath box Bat\_247 A/B destroyed by livestock on June 19 2025.

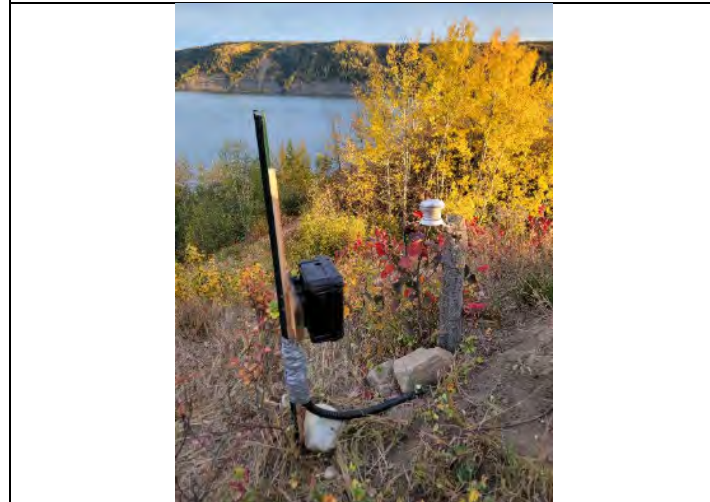
<p>Photo 5. Snake hibernaculum 134 temperature monitoring station repaired. Please note conduit further buried with rocks. Further upgrades to wire protection required, including burial of conduit and permanent wire strain protection.</p>

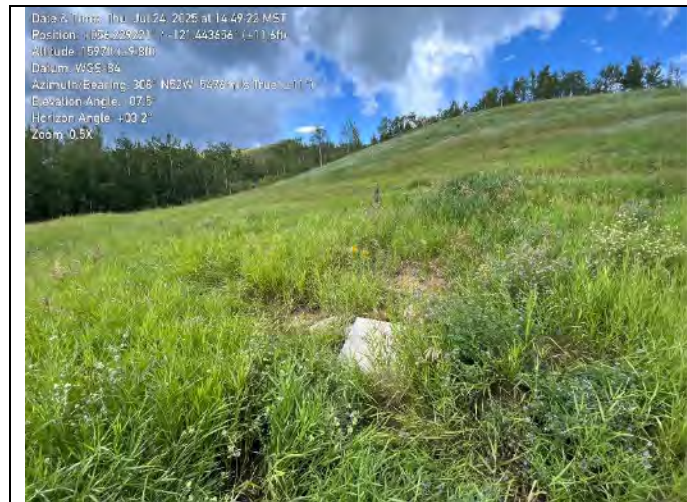
<p><small>Date &amp; Time: Thu, Jul 24, 2025 at 14:49:22 MST Position: 46°52'39.21" N, 121°44'36.56" W Altitude: 15970 m (52580 ft) Datum: WGS 84 Azimuth Bearing: 306° N (2° N) 827m (5150 ft) True Elevation Angle: 0.75° Horizon Angle: +30.2° Zoom: 0.5X</small></p>

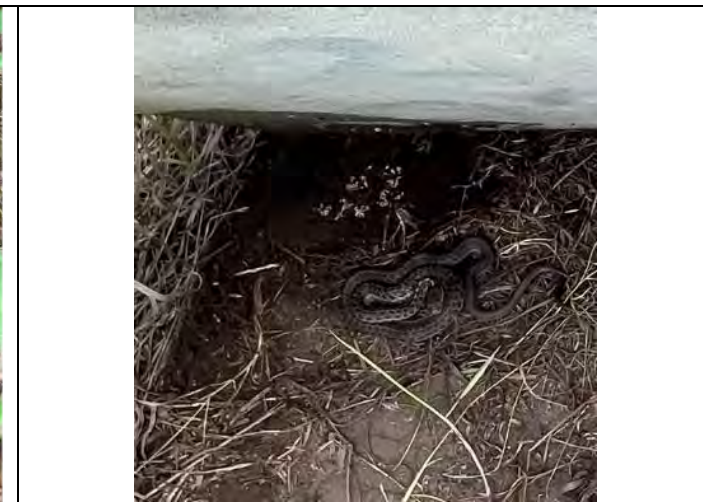
<p>Photo 1. Snake hibernaculum 153 entrance.</p>	<p>Photo 2. Snake hibernaculum 153 temperature monitoring cords chewed off.</p>	<p>Photo 3. Western Gartersnake observed near hibernaculum 153 entrance.</p>

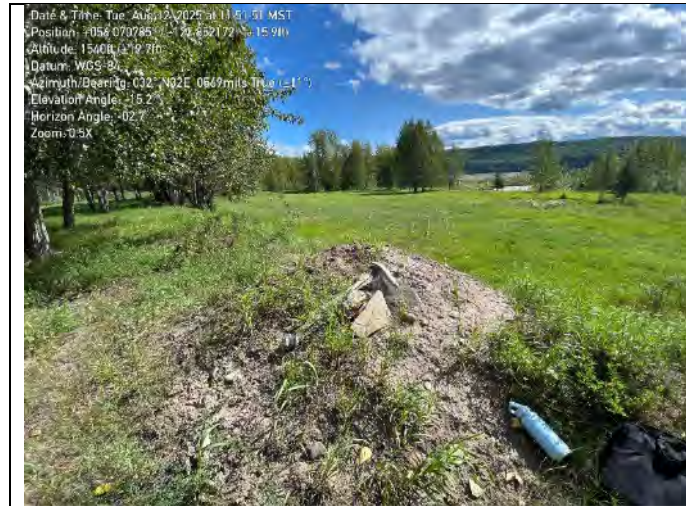
Photo 1. Snake hibernaculum 326 aspect.

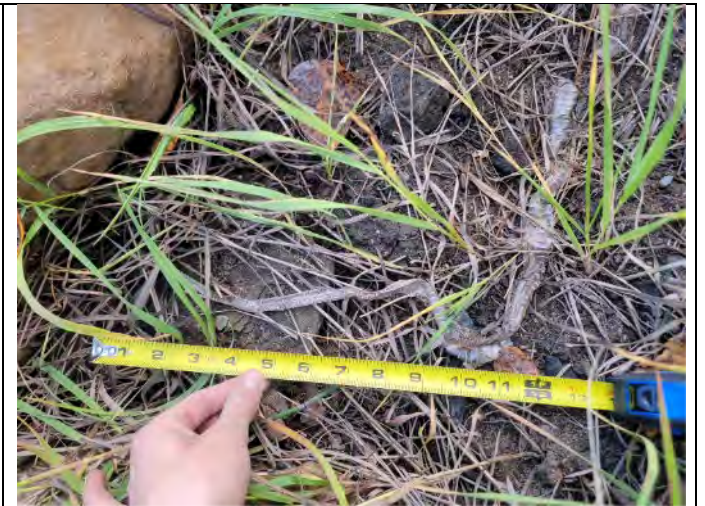
Photo 4. Snake shed observed near hibernaculum 326 entrance.

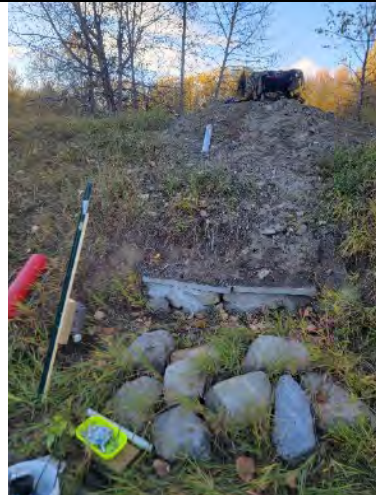
Photo 5. Snake hibernaculum 326 entrance with camera trap.

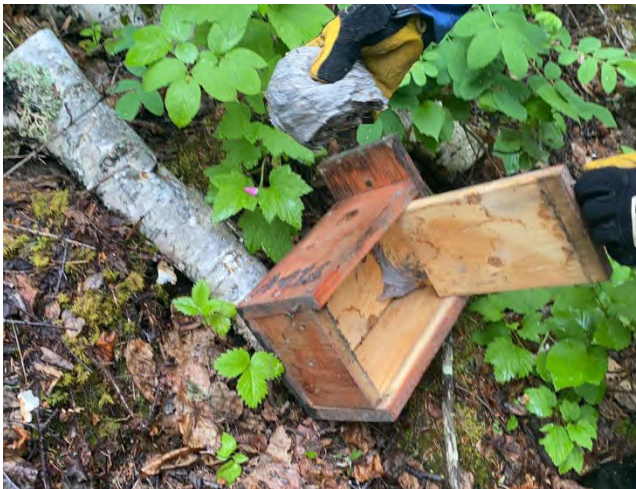
**Photo 1:** View of nest box A-016 found fallen on the ground and needing to be reattached to a new tree.

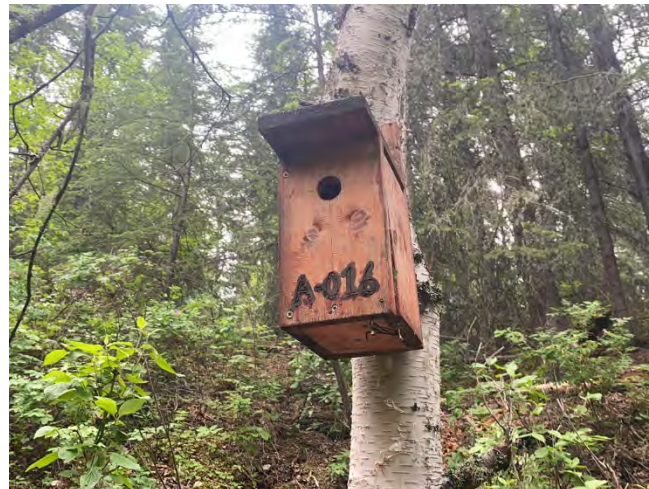
**Photo 2:** View of nest box A-016 after being reattached to a birch tree adjacent to where box was found on the ground.

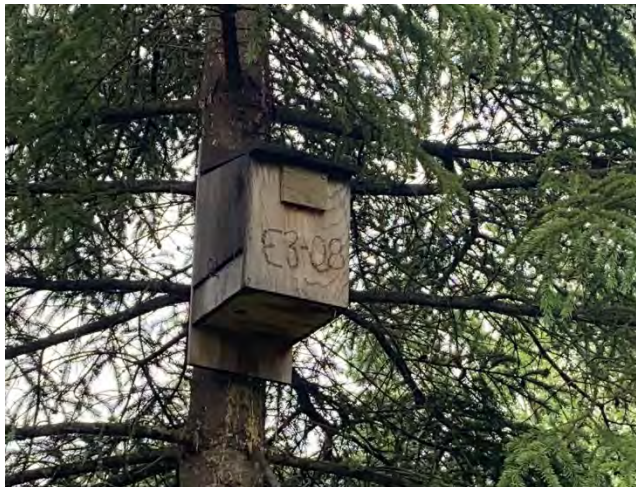
**Photo 3:** View of nest box E3-08 before it was reactivated.

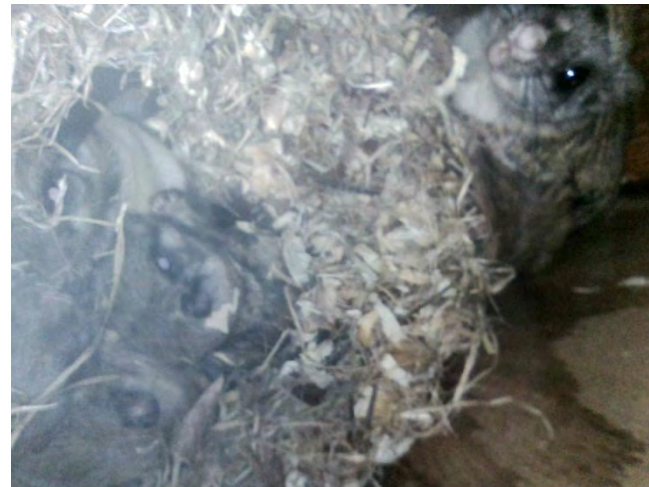
**Photo 4:** View of Northern Flying Squirrels found using nest box E2-15.

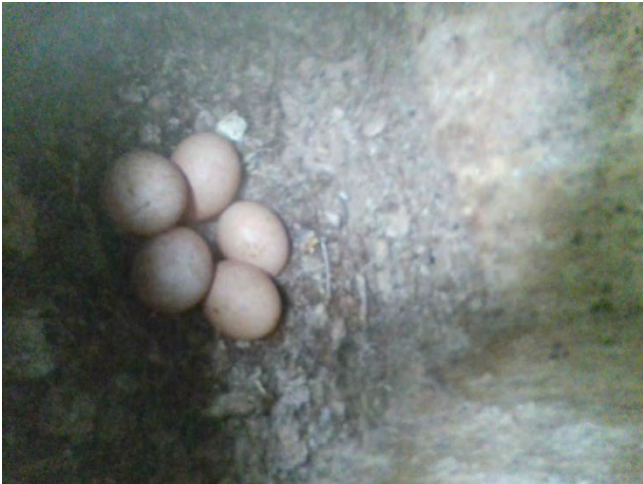
**Photo 5:** View of American Kestrel eggs observed within nest box E2-14.

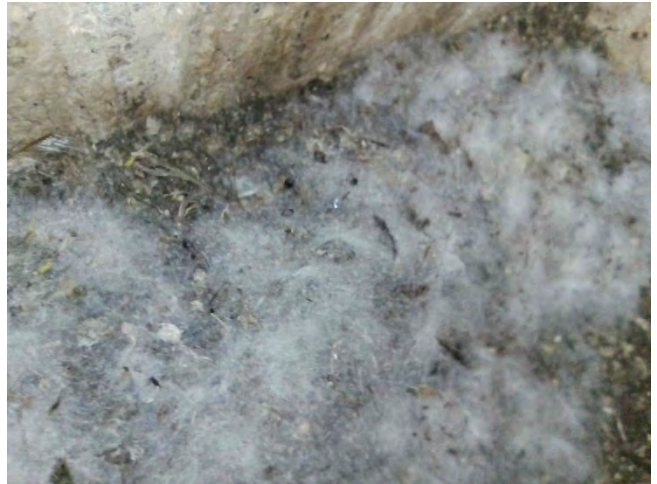
**Photo 6:** View of down lined nest box, suspected to be used by Common Goldeneye (nest box F-36).

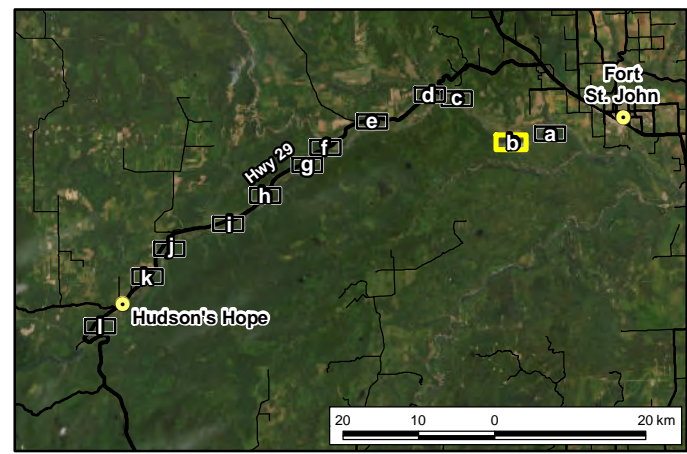
**NOTES**  
 Base data source:  
 CanVec 1:50,000 (2019)  
 Imagery from ESRI; Vantor (2023)

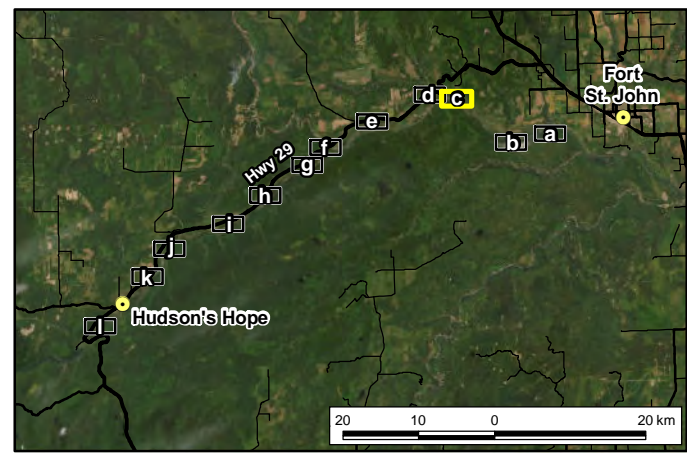
**NOTES**  
 Base data source:  
 CanVec 1:50,000 (2019)  
 Imagery from Goole Earth Pro; Airbus (2025)

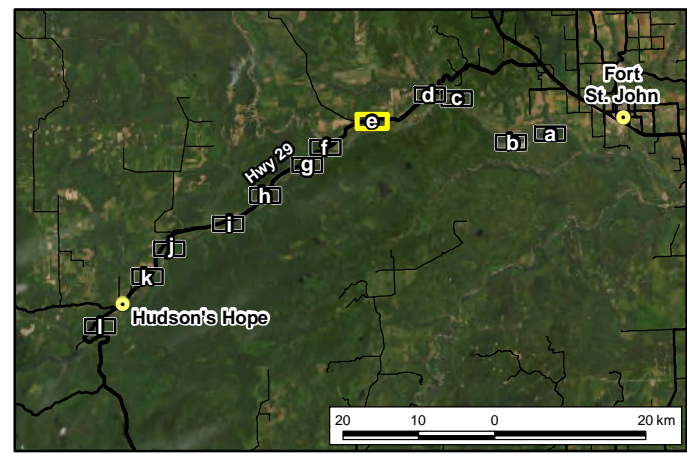
**NOTES**  
 Base data source:  
 CanVec 1:50,000 (2019)  
 Imagery from Goole Earth Pro; Airbus (2025)

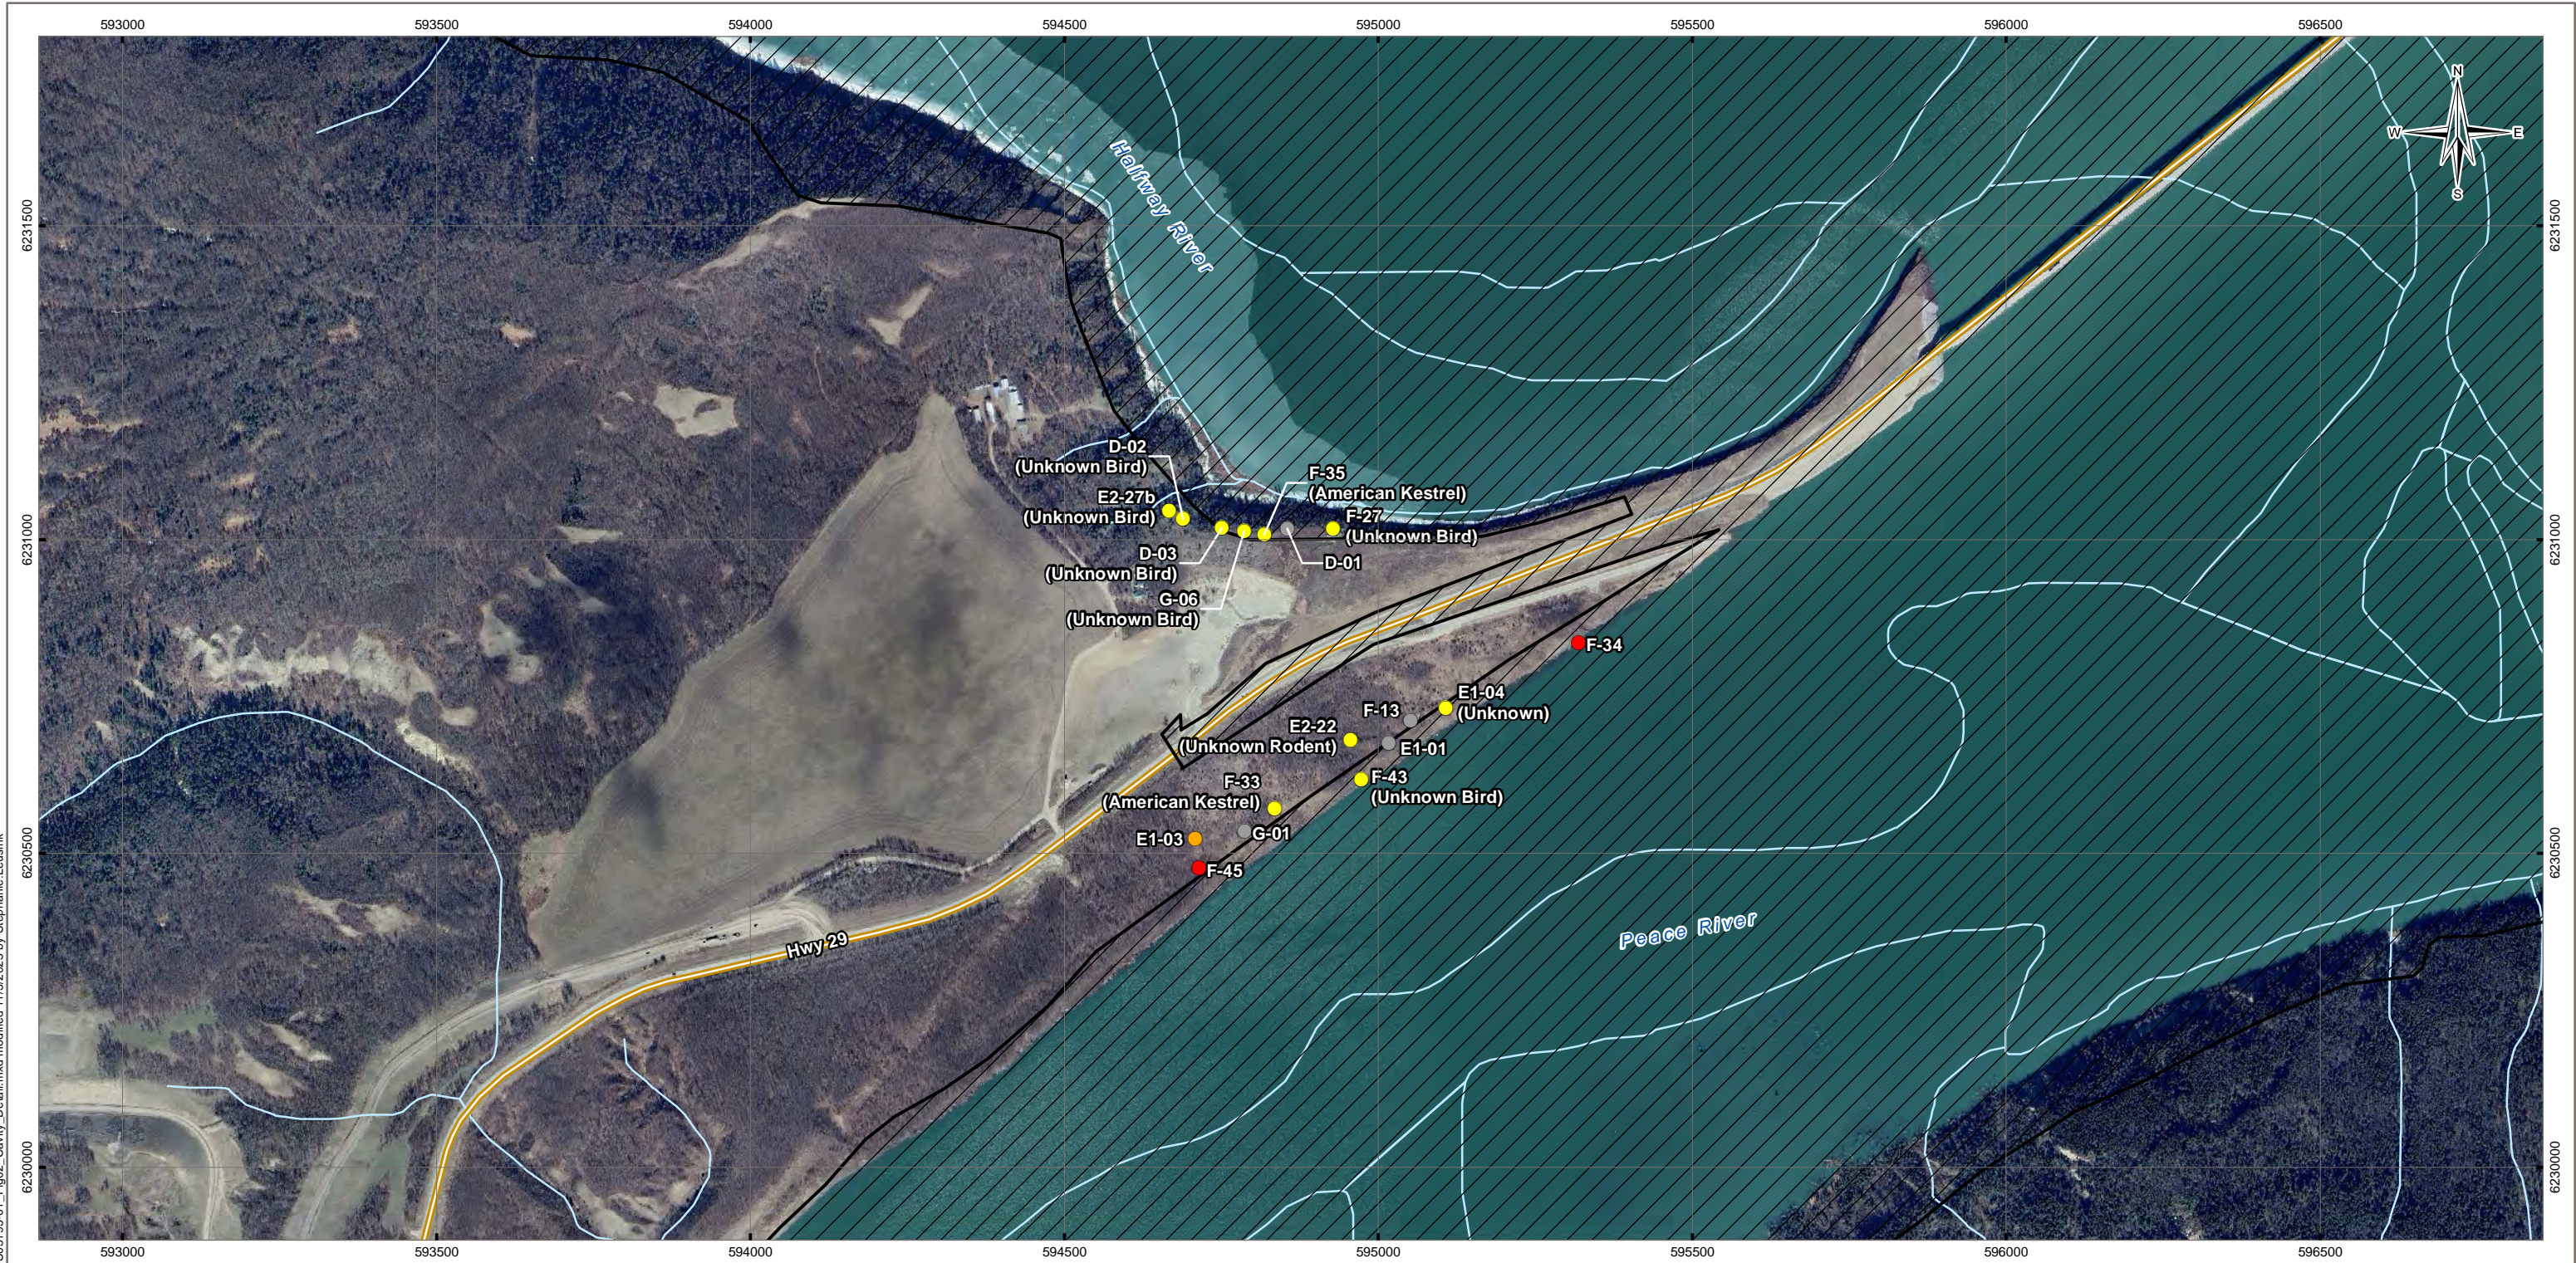
**STATUS**  
ISSUED FOR USE

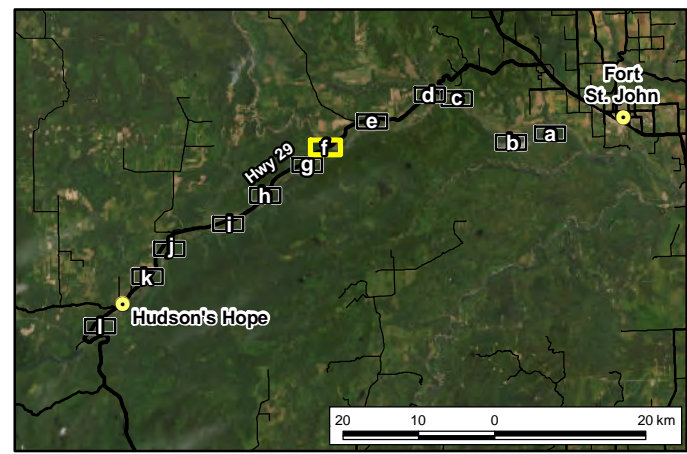
**NOTES**  
 Base data source:  
 CanVec 1:50,000 (2019)  
 Imagery from Goole Earth Pro; Airbus (2025)

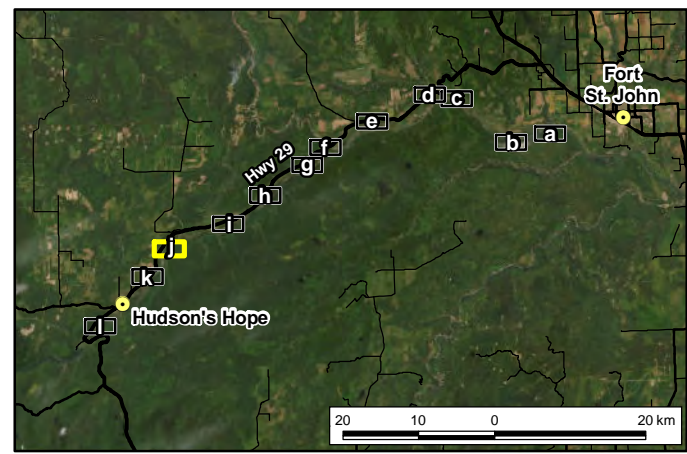
**NOTES**  
 Base data source:  
 CanVec 1:50,000 (2019)  
 Imagery from Goole Earth Pro; Airbus (2025)

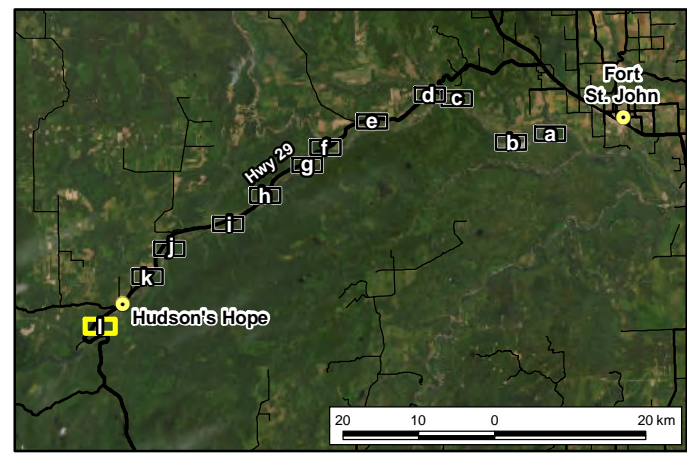
**NOTES**  
 Base data source:  
 CanVec 1:50,000 (2019)  
 Imagery from Google Earth Pro; Airbus (2023)
