## **Appendix 15. 2025 Ground Nesting Raptors Report**

# Site C Clean Energy Project Ground-Nesting Raptor Monitoring 2025 Annual Report

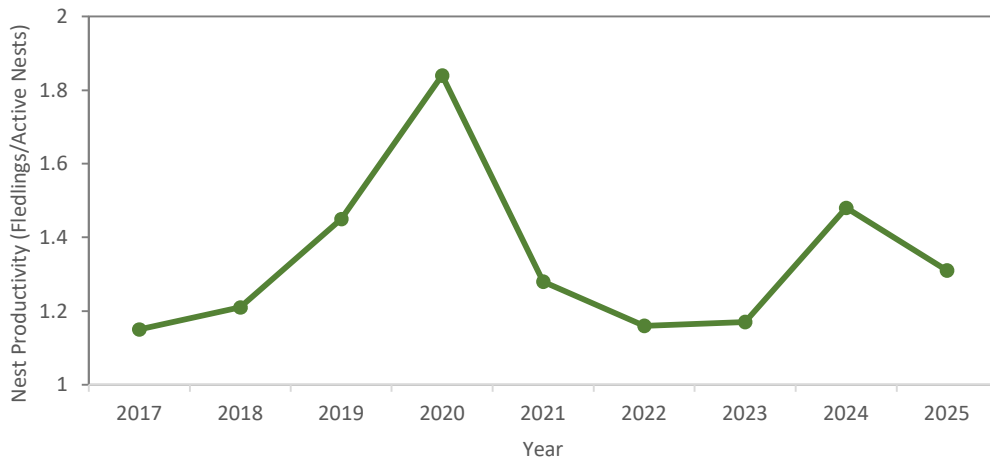
Figure 2. Annual bald eagle nest fledging success rate from 2017 to 2025.

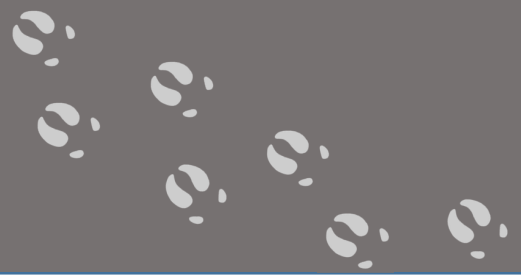
West Moberly – DWB Limited Partnership
