## DIVERSION UPDATE

### Site C Diversion Update: August 24, 2020

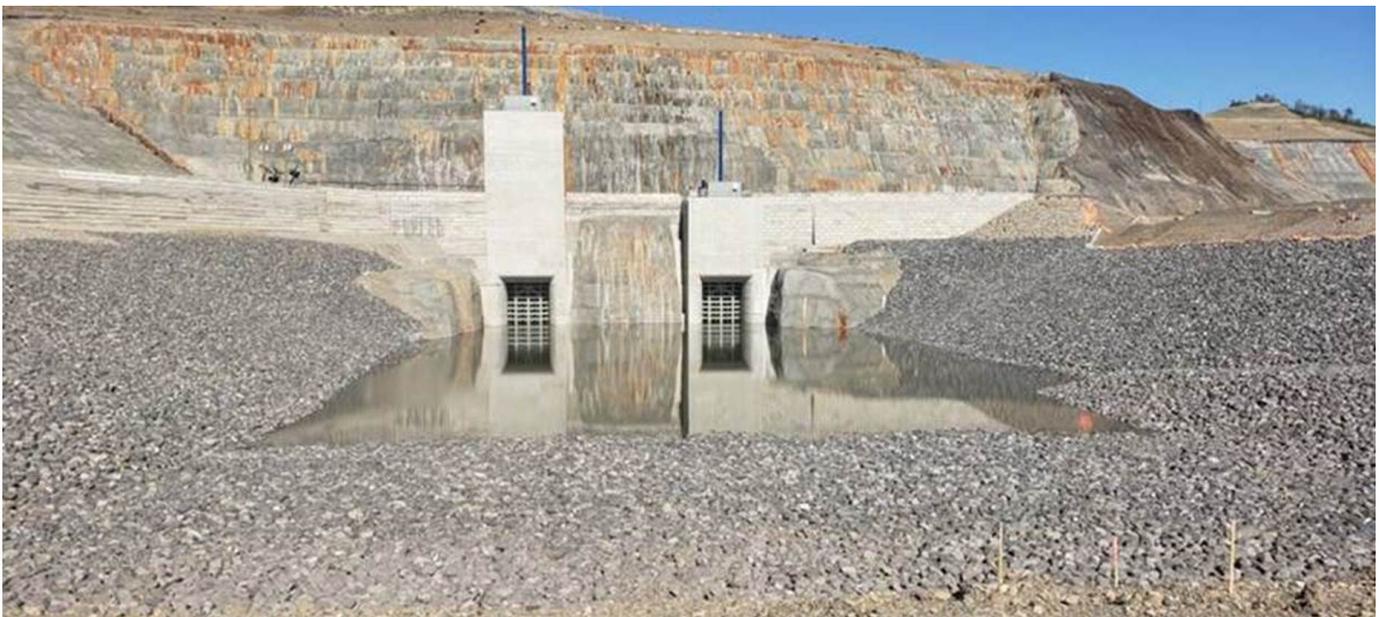
Water is being pumped into the inlet cofferdam. This water is approximately seven metres deep at the inlet gates and was pumped in about one day.

We started pumping water behind the inlet and outlet cofferdams which was then followed by the start of lowering the inlet and outlet cofferdams themselves as we work towards breaching the cofferdams and opening the tunnels. While we are still a few weeks away from full removal of the cofferdams, we completed the first phase of pumping water in and the lowering of the cofferdams. Over the next few weeks the construction teams will continue to remove portions of both cofferdams. Once the construction teams have removed as much of the cofferdams as possible more water will be pumped in and remaining portions of the cofferdams will be removed.

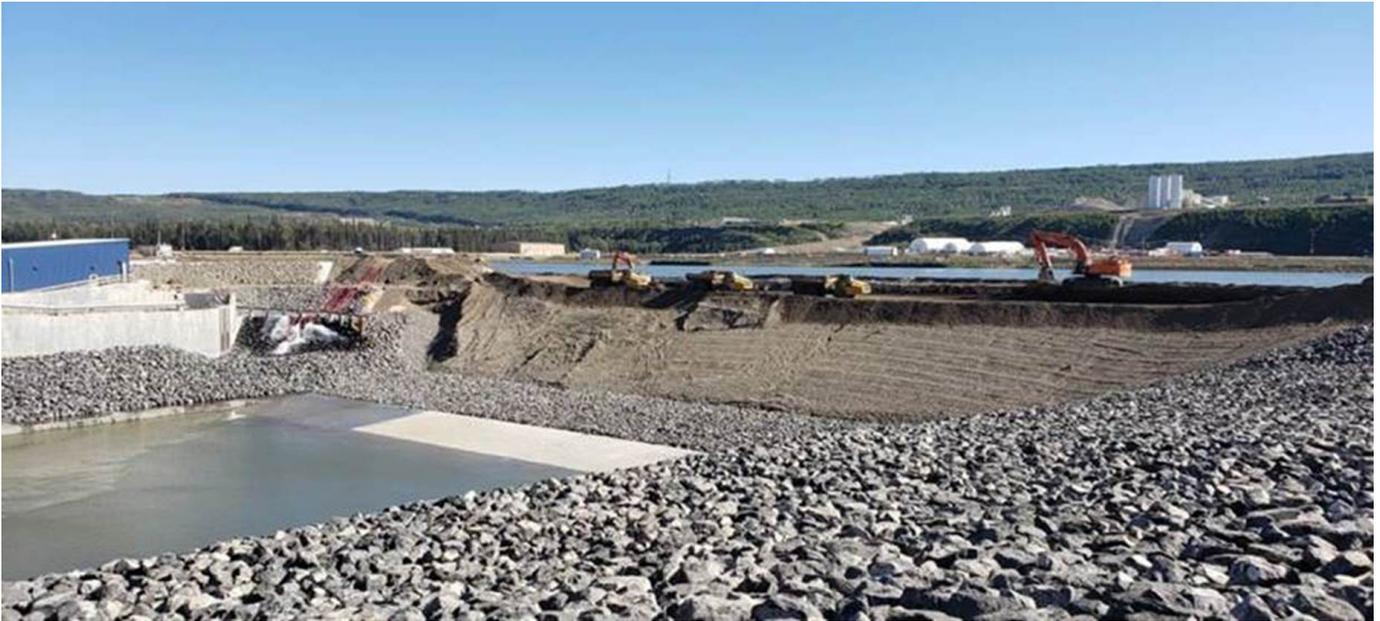
Water being pumped into the outlet cofferdam (left) while equipment removes material at the top of the outlet cofferdam.

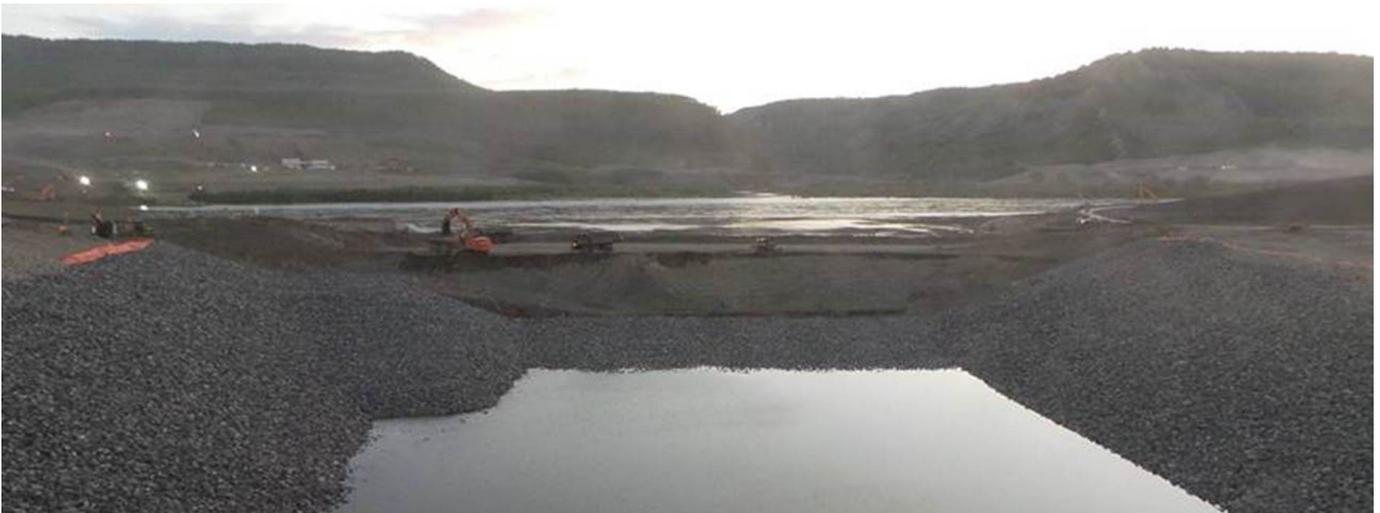
Top phase of the inlet cofferdam removed and an excavator beginning the next phase of cofferdam removal.

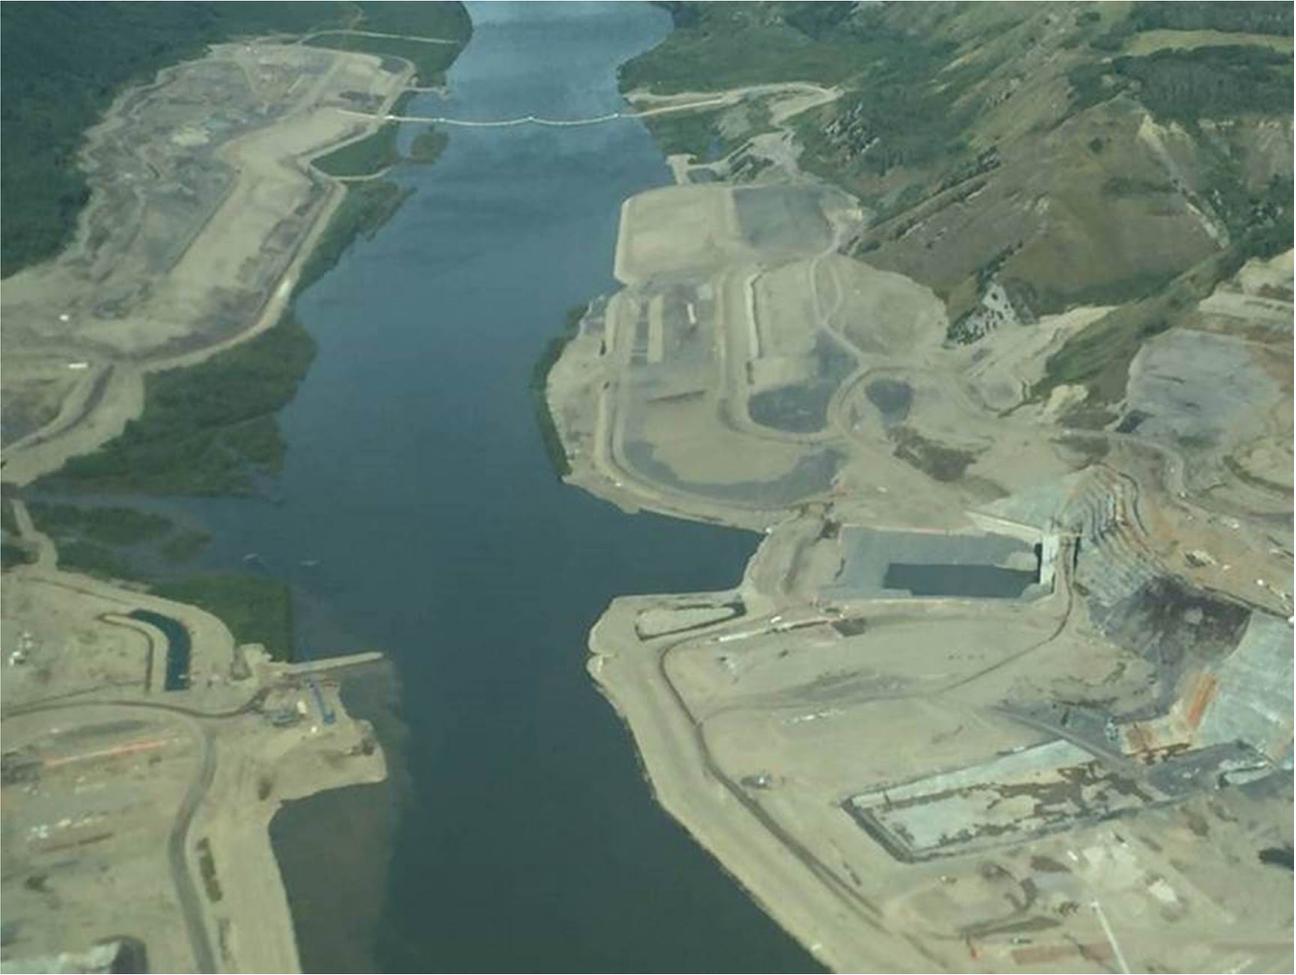
Aerial photo of the upstream cofferdam progress into the river (left), inlet cofferdam full of water (right), and upstream debris boom (top).

Our construction teams have extended the rock berm a further 10 metres into the Peace River upstream of the cofferdam. The upstream cofferdam rock berm is 77 metres into the Peace River. This is a relatively small distance, but is a good step in keeping the progress of the cofferdam and rock berm going. While we don't have any pictures of that work being completed we do have a great aerial shot of the site.

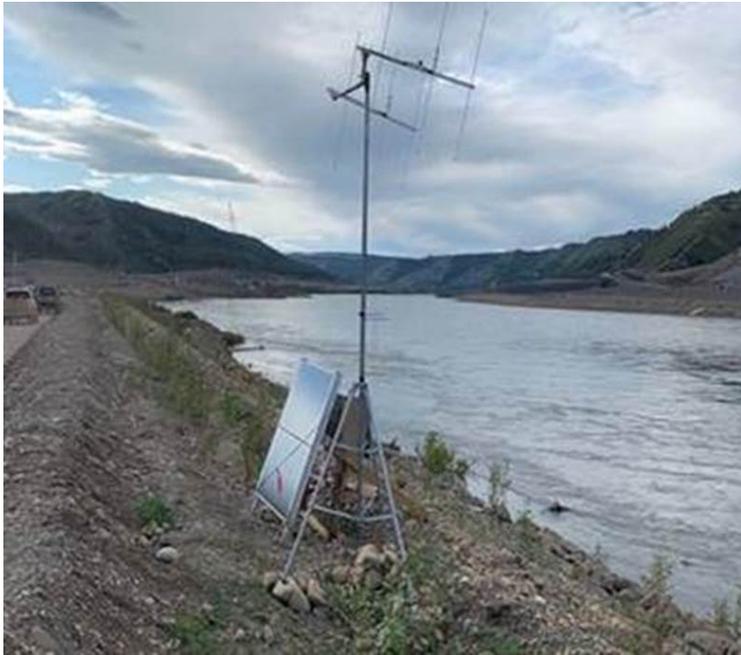
Monitoring equipment is positioned on the right bank to track the movements of tagged fish as they swim through the dam site. Note the rockfill berm and upstream cofferdam in the background.

In July 2019, we installed monitoring equipment throughout the Peace River and its tributaries to track the movements of tagged fish. We have since installed additional equipment at the dam site to collect more detailed information on fish movement. We've detected tagged fish moving upstream past the project during each increment of encroachment. We continue to closely monitor water flows through the site and impacts of changes in flows through a number of in-river instruments. Results from hydraulic modelling, velocity measurements and fish movement data have shown that fish have been able to safely swim through the dam site despite the in river construction and high flows.

Once we've diverted the river, this equipment will be used to monitor tagged fish as they approach, enter and pass the [temporary fish passage facility](#).
