## SITE C PROJECT CONSTRUCTION

# NORTH BANK SLOPE STABILIZATION

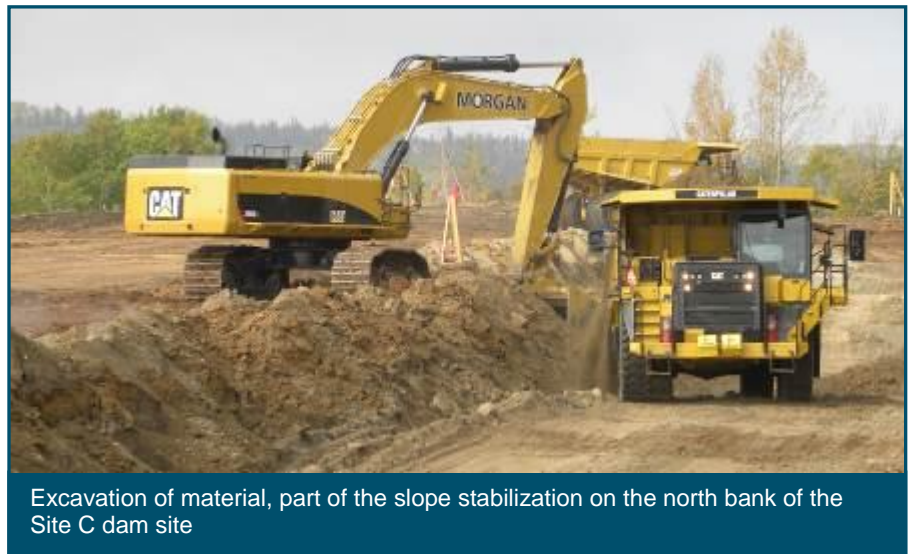
Excavation of material, part of the slope stabilization on the north bank of the Site C dam site

Slope stabilization activities include the construction of access roads and haul roads, excavation of unstable materials and relocation and storage of excavated materials for future use on other areas of the project.
