Site C Clean Energy Project

Quarterly Progress Report No. 25

F2022 Fourth Quarter

January 1, 2022 to March 31, 2022

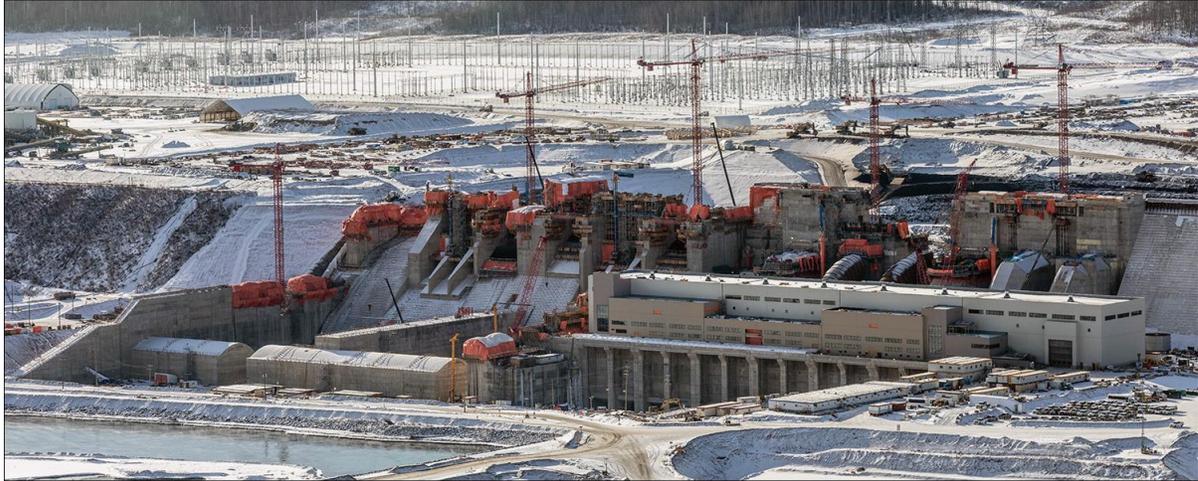
Figure A-1 View of the powerhouse and spillways
(January 2022)

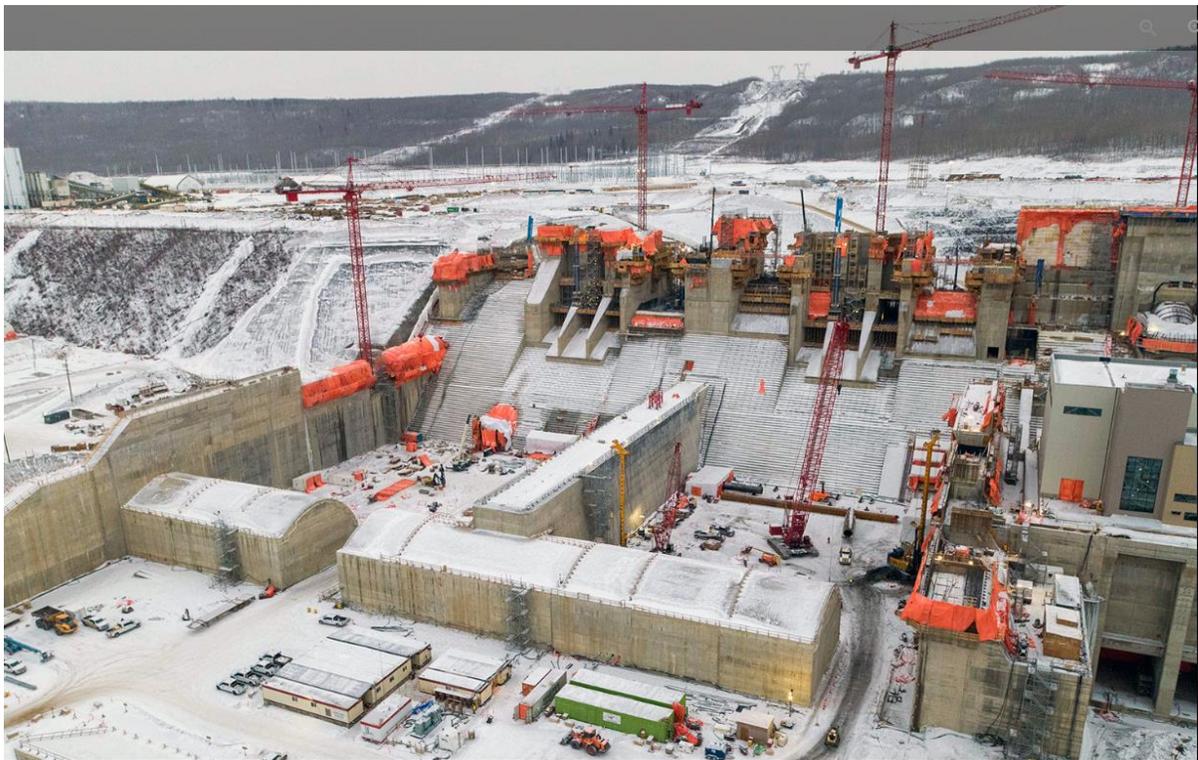
Figure A-2 Construction on the spillways including
foundation enhancement work in the west bay
(January 2022)

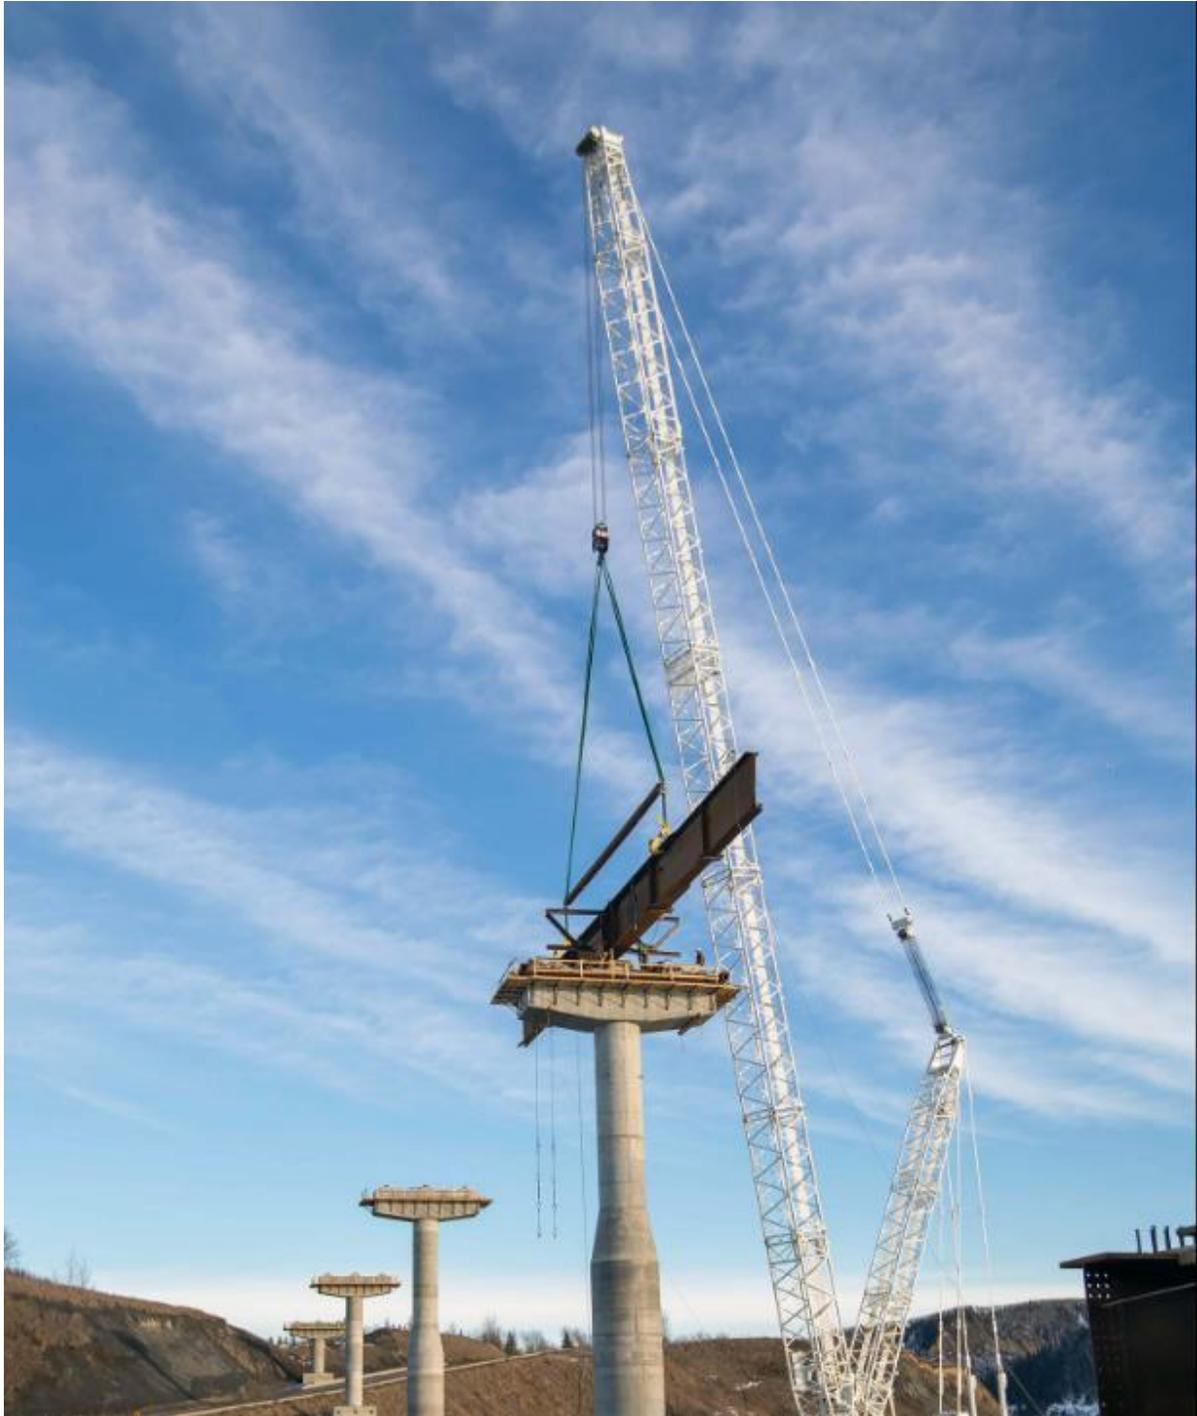
Figure A-3 The first girder is lifted onto a pier on the Farrell Creek Bridge (January 2022)

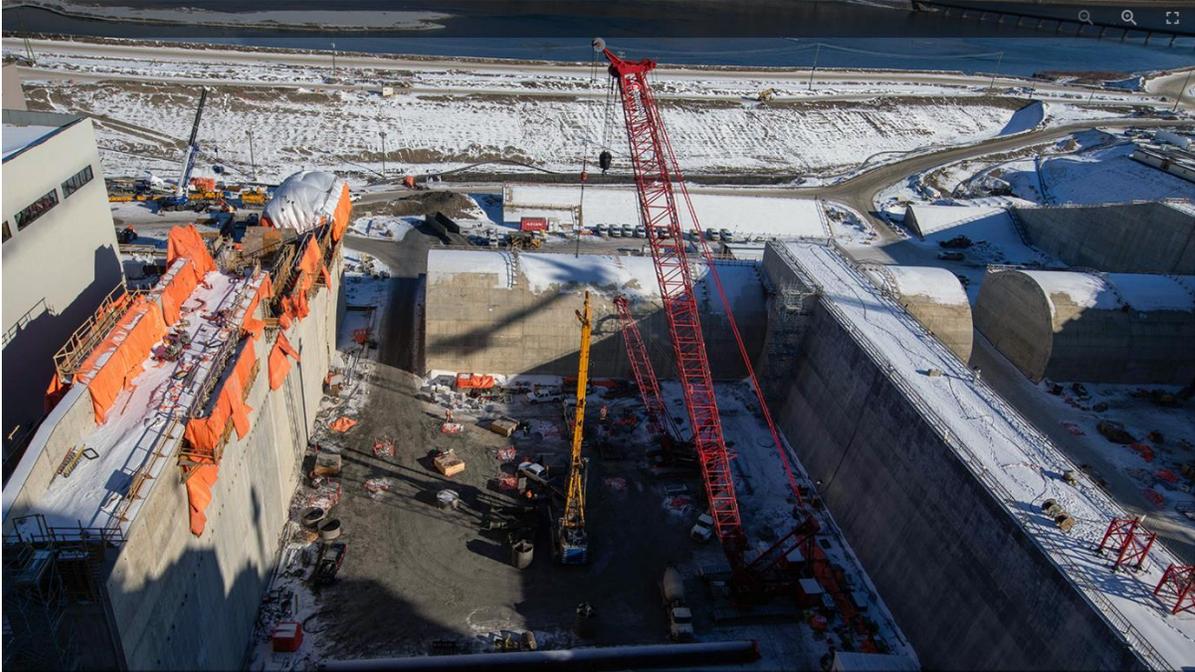
Figure A-4 Pile installation for foundation enhancement on the west spillway stilling basin (February 2022)

15 To reduce the extent of the required excavations downstream of the powerhouse
16 that are necessary to provide access for pile installations, the powerhouse tailrace
17 piling scope has been divided into four phases. Each phase consists of completing
18 bedrock excavations to provide access and a level working surface for the piling
19 equipment to work. Once access is established, the piling equipment will be
20 mobilized into position to drill and install steel piles. After installation, the steel piles
21 will be backfilled with concrete to secure the steel piles into the bedrock foundation
22 below the powerhouse. Once a group of steel piles are concrete backfilled, the tops
23 of the piles will be encased in a large concrete block called a pile cap, which is
24 affixed to and abuts against the powerhouse concrete foundation.

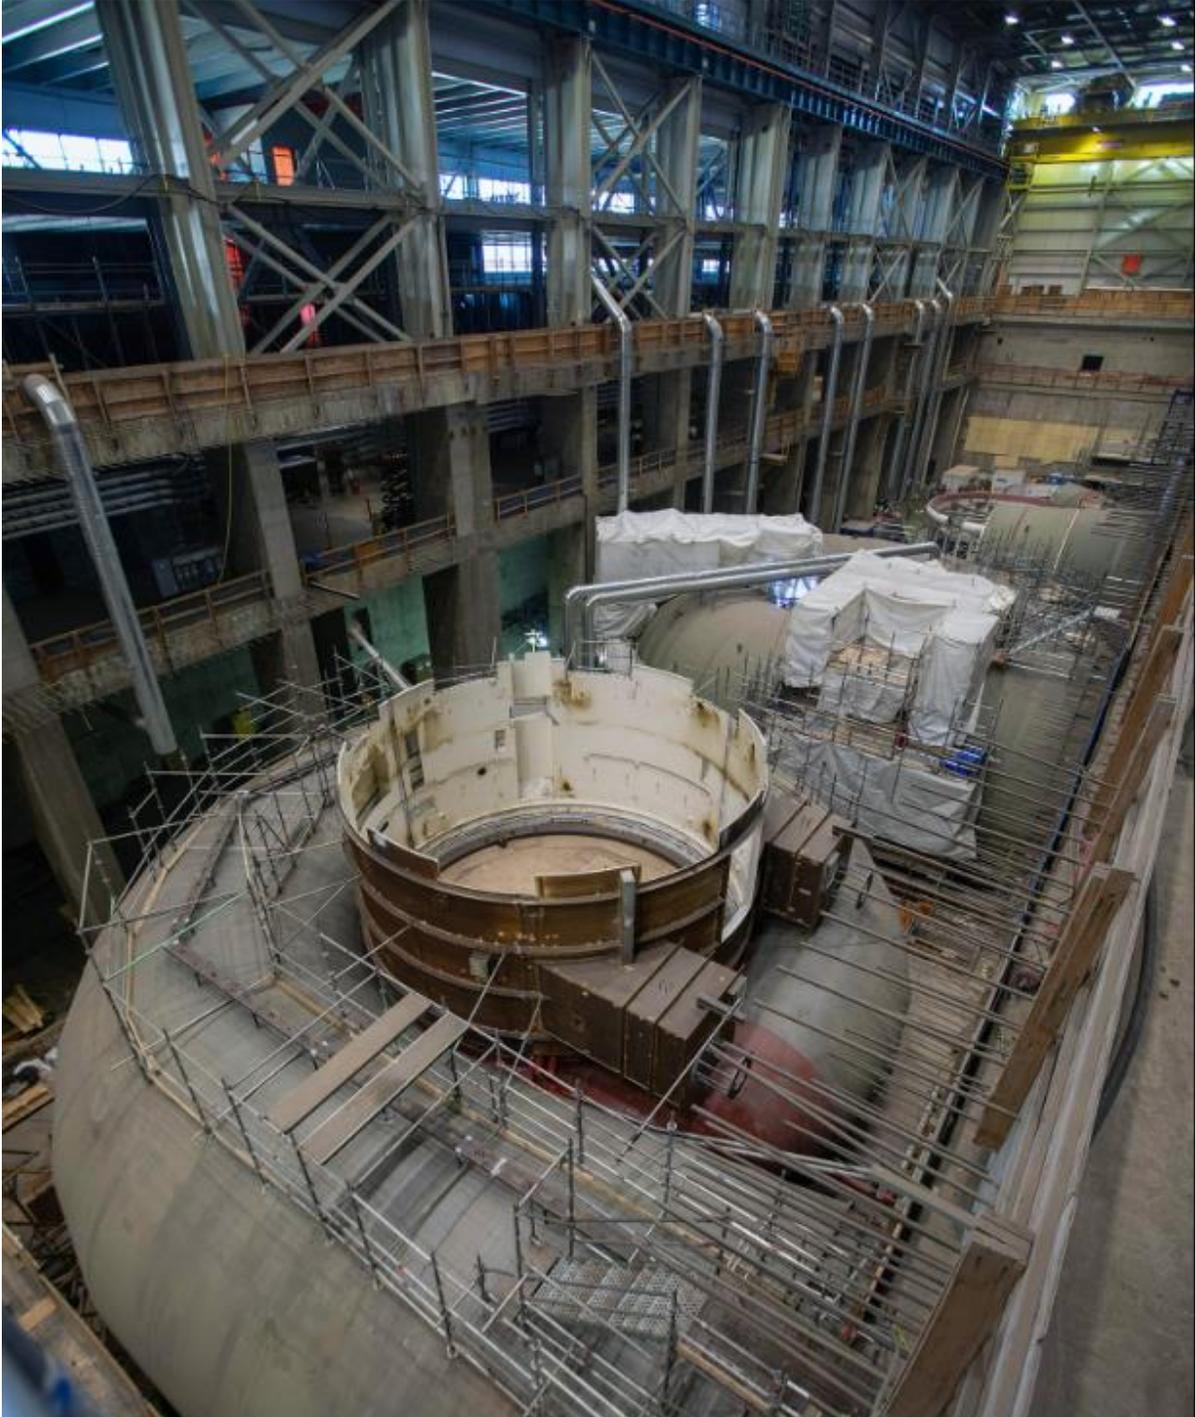
Figure A-5 Inside the powerhouse are six spiral cases at various stages of completion with this photo showing Units 4, 5, and 6 (February 2022)

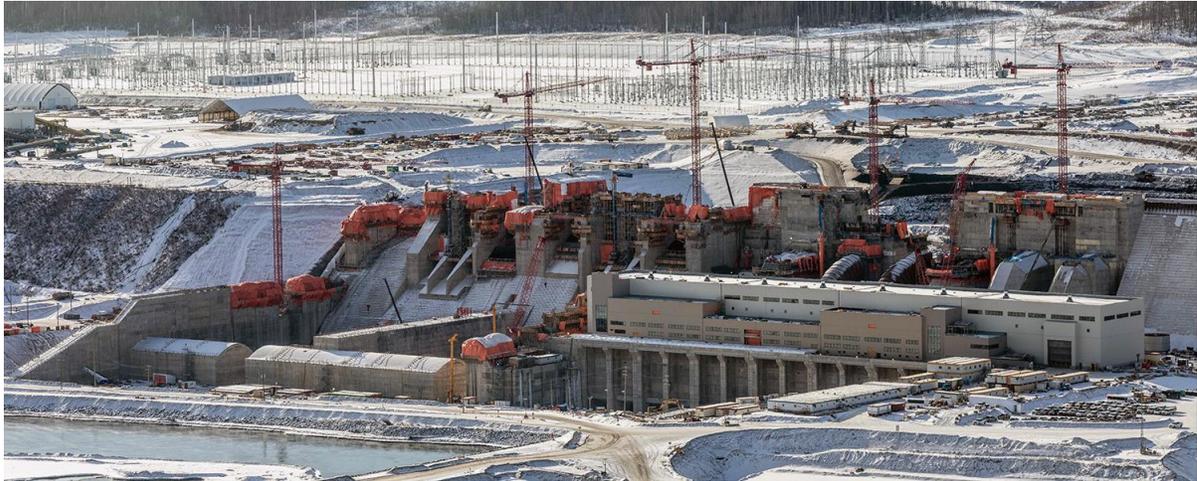
Figure A-6 A winter view of the spillways, penstocks, powerhouse, operations building and tail race (February 2022)

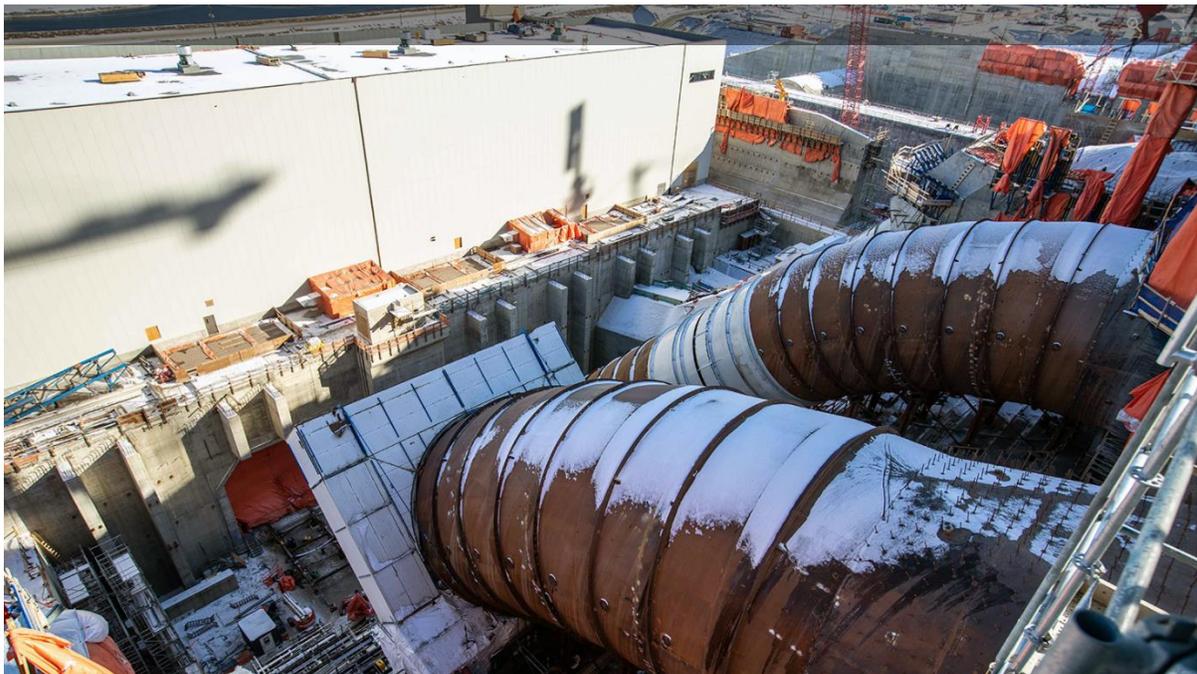
Figure A-7 Penstock Units 4 and 5 (February 2022)

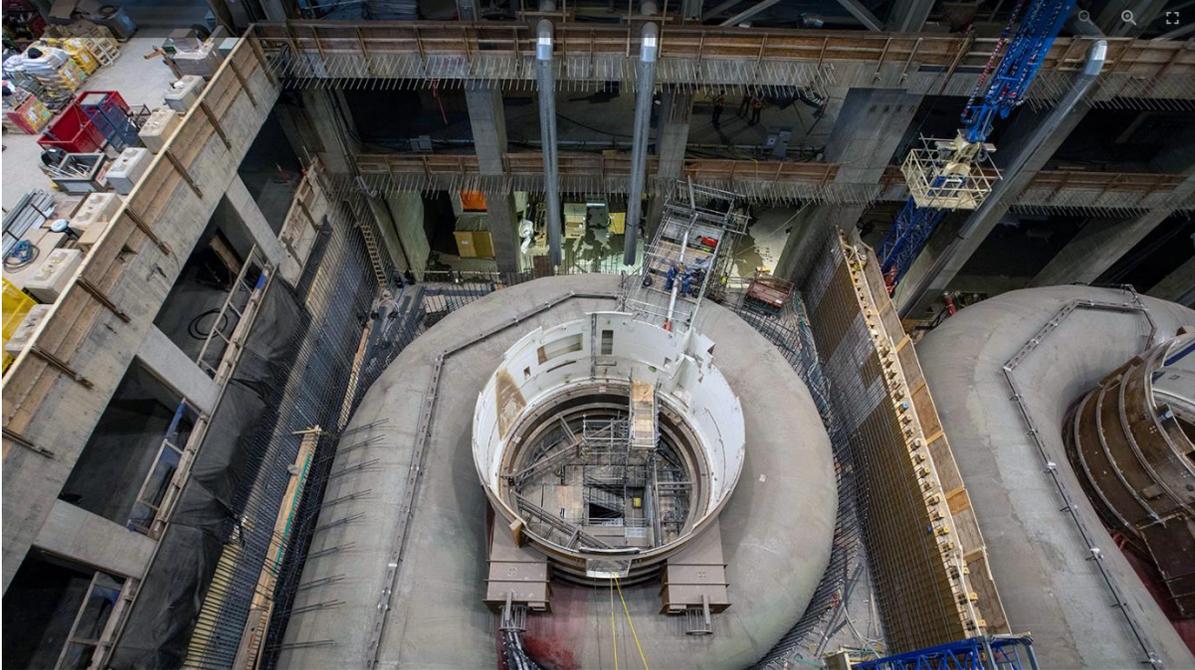
Figure A-8 Preparing embedded piping for a second lift of concrete on spiral case Unit 1 (February 2022)

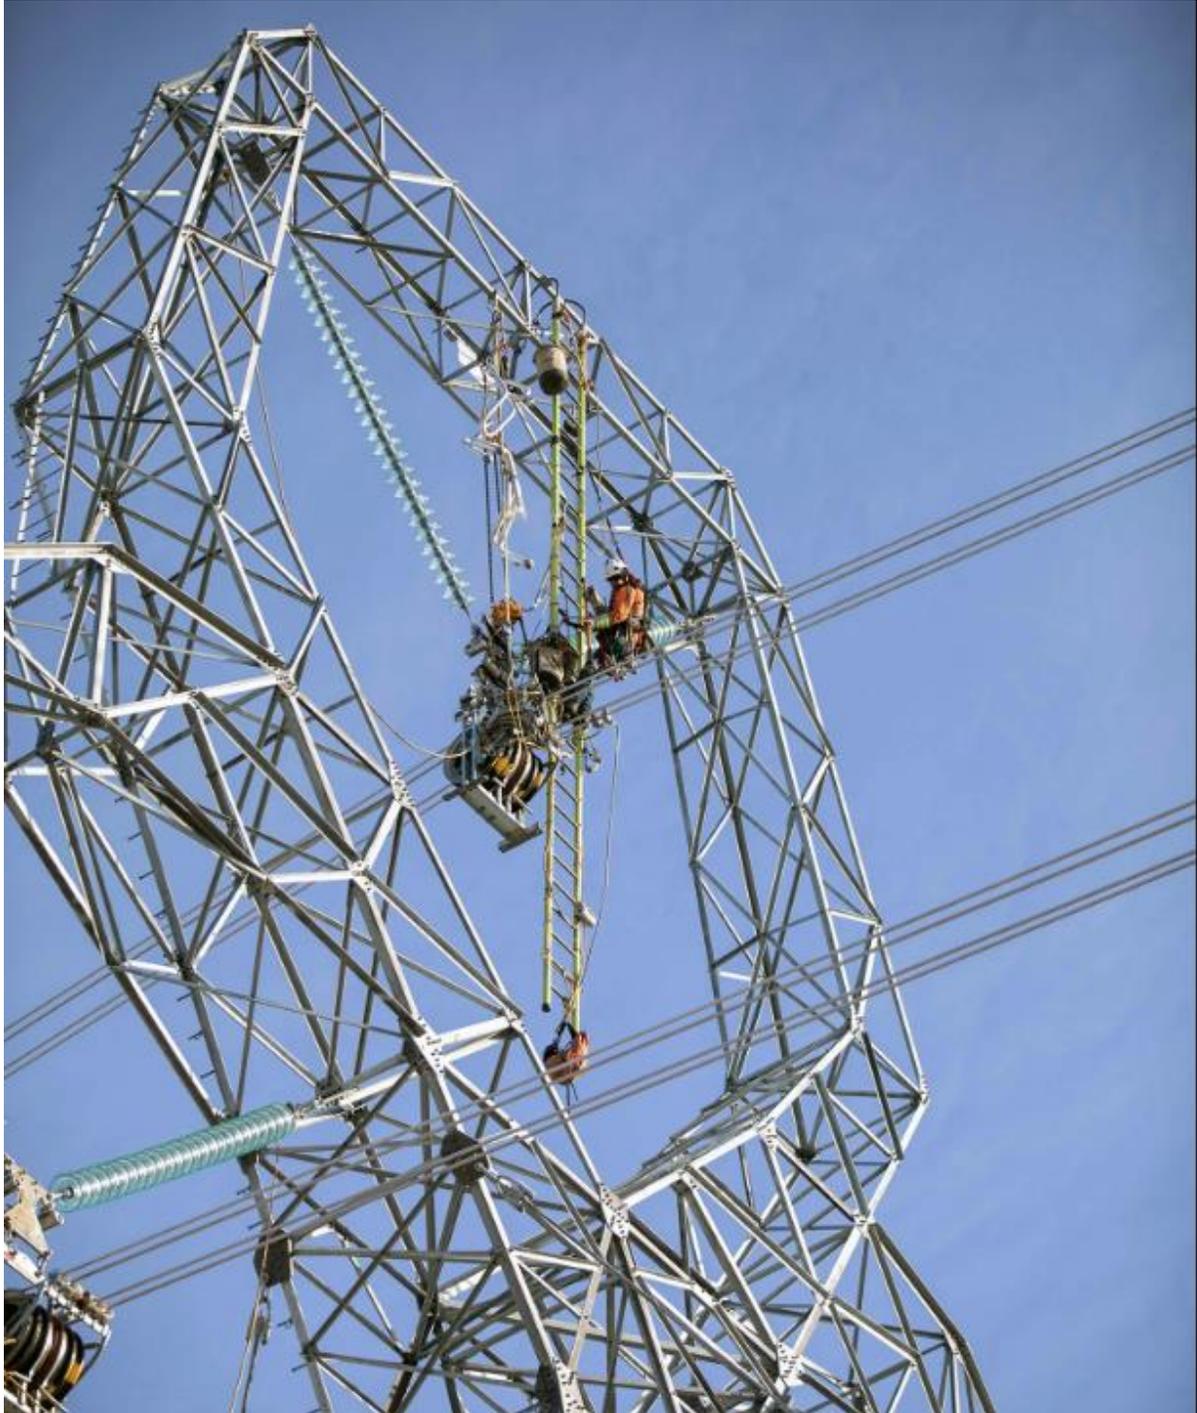
Figure A-9 Attaching the centre-phase conductor and installing corona rings on a transmission tower (February 2022)

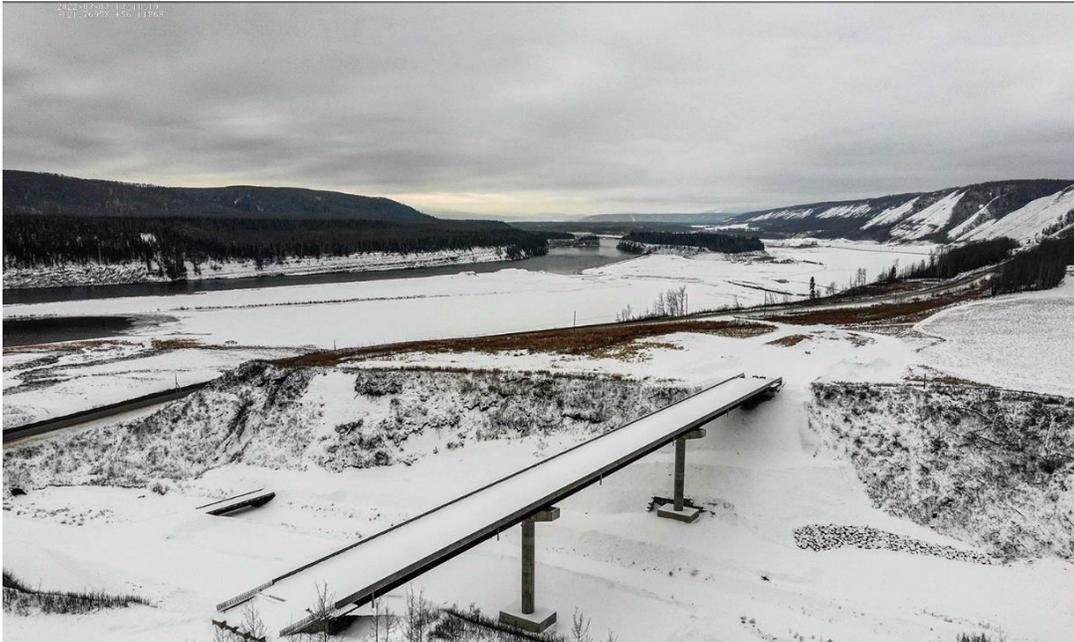
Figure A-10 Dry Creek bridge is complete (March 2022)

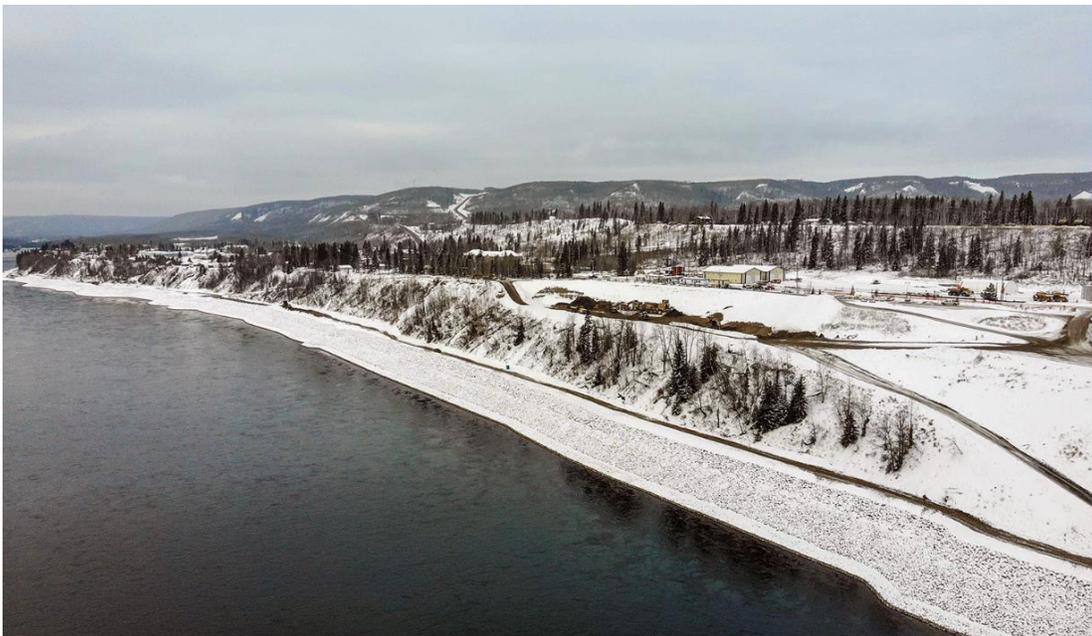
Figure A-11 The Hudson's Hope shoreline protection berm in winter (March 2022)

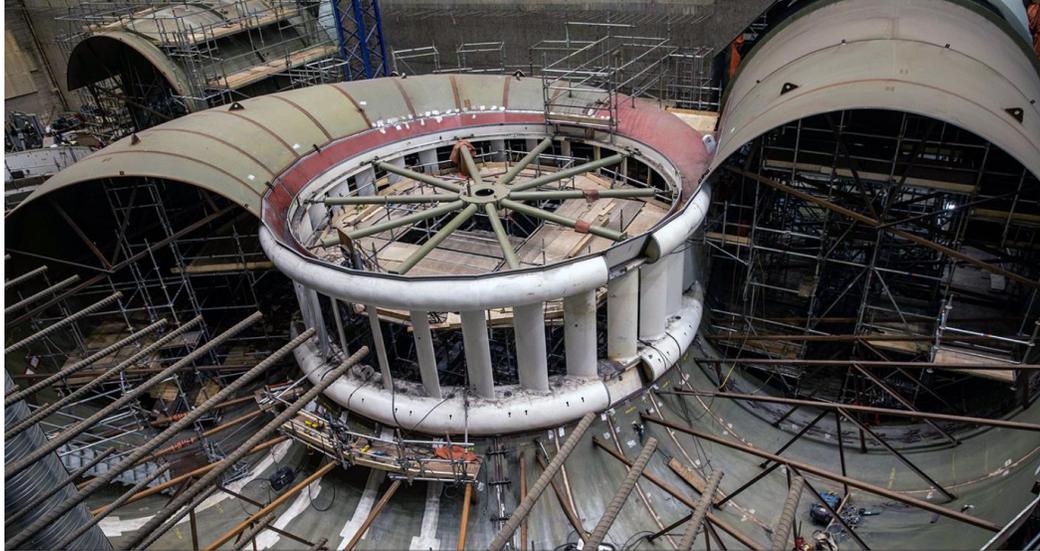
Figure A-12 Progress of a spiral case and stay ring installation (March 2022)

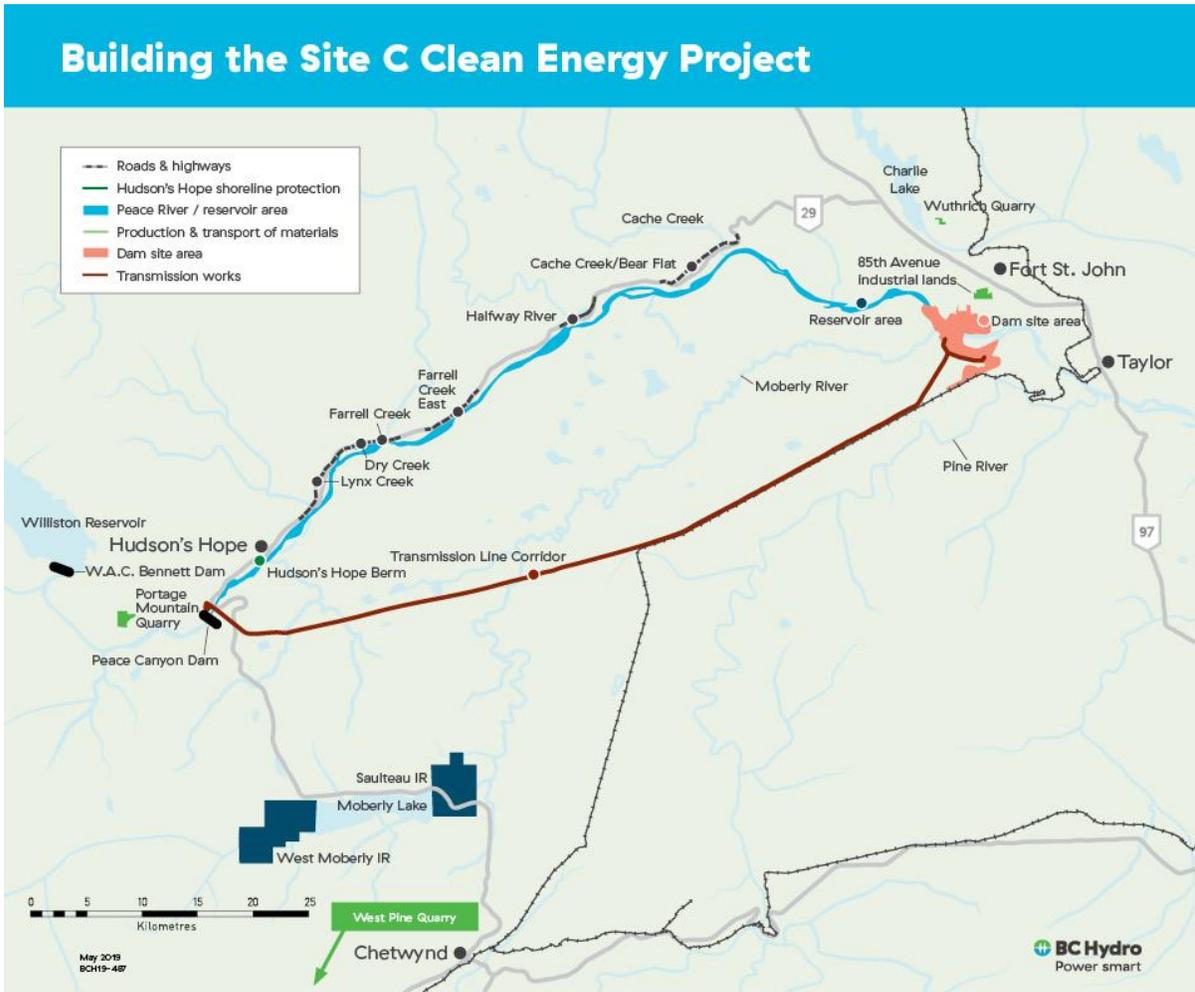
Figure B-1 Site C Project Components
