**RE: British Columbia Utilities Commission (BCUC or Commission)  
British Columbia Hydro and Power Authority (BC Hydro)  
Site C Clean Energy Project PUBLIC Quarterly Progress Report No. 21**

Today, we are filing Site C Quarterly Progress Report No. 21 that covers the period of January 1 to March 31, 2021.

**Site C Clean Energy Project**

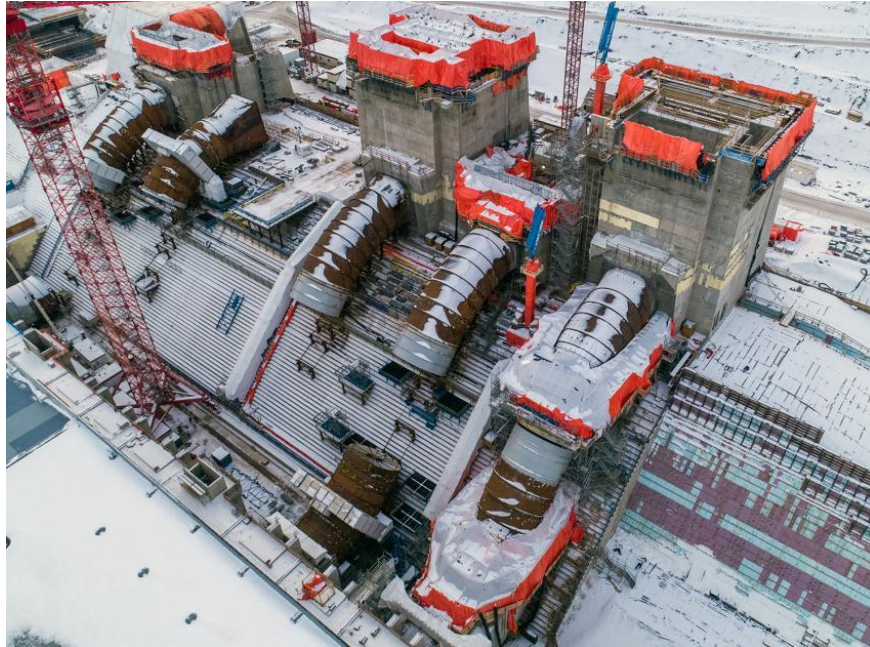
**Figure A-1** An aerial view of the Site C penstocks and intakes under construction (January 2021)

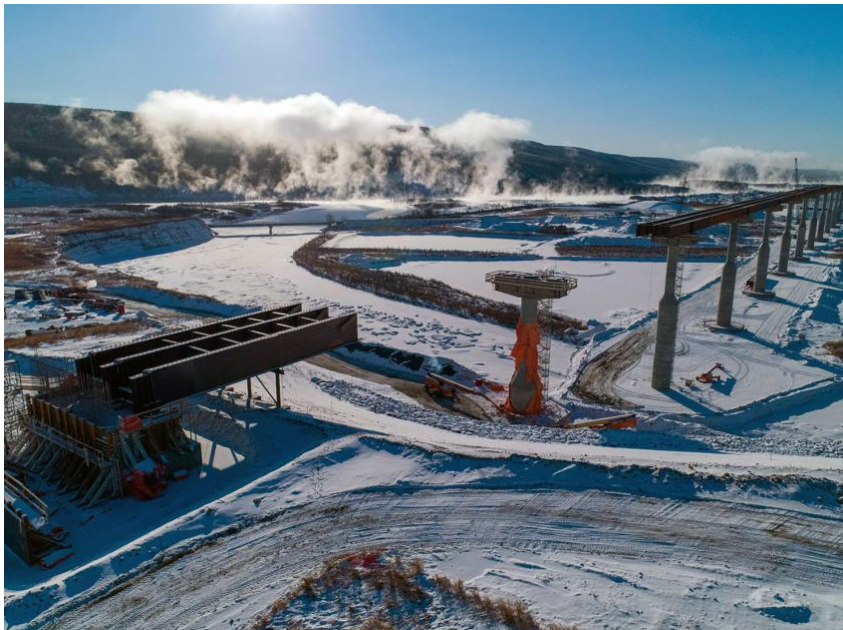
**Figure A-2** Halfway River bridge construction where the final girders will connect pier 12 to the eastern bridge abutment (January 2021)

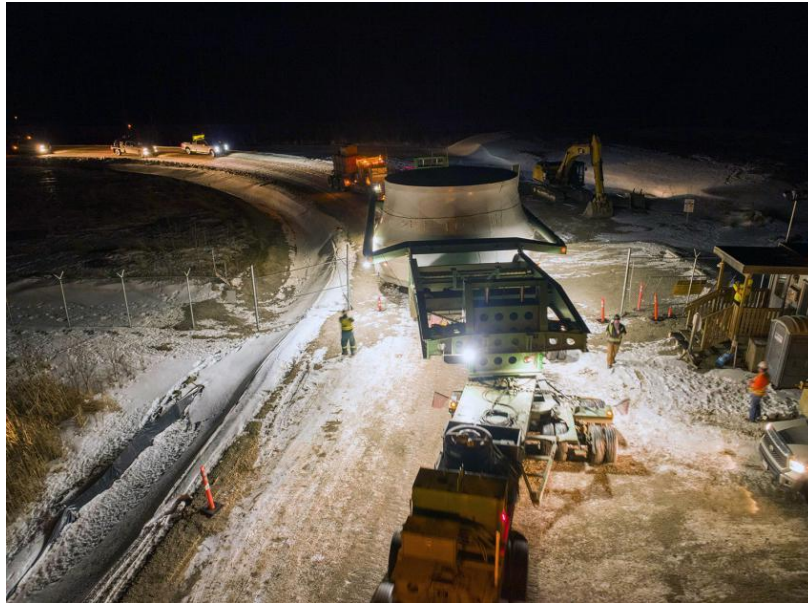
**Figure A-3** Unit 1 turbine runner arrives at Site C after travelling from Sao Paulo, Brazil, by ship to Prince Rupert, and transported on a customized truck to the project site (January 2021)

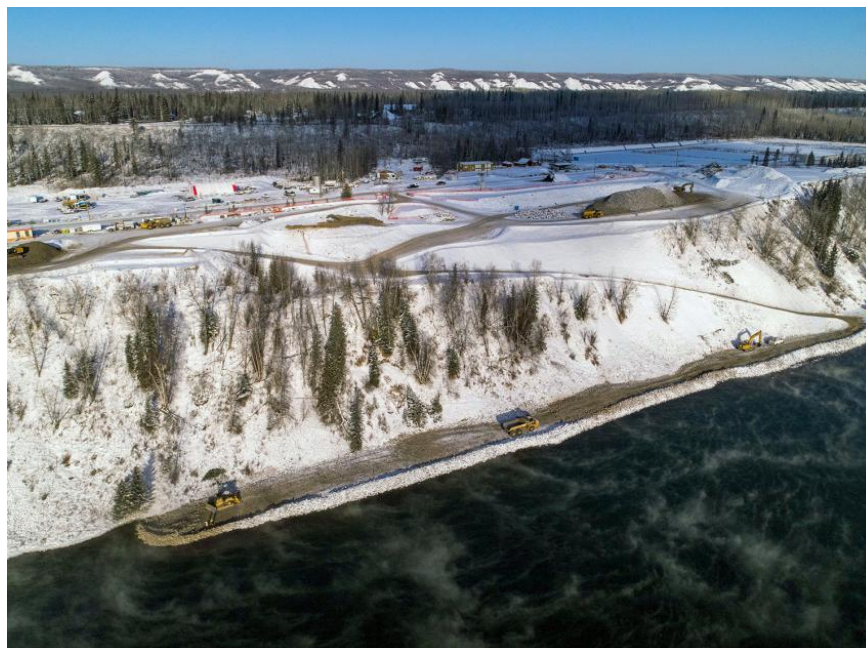
**Figure A-4** Construction of the shoreline protection at Hudson's Hope (January 2021)

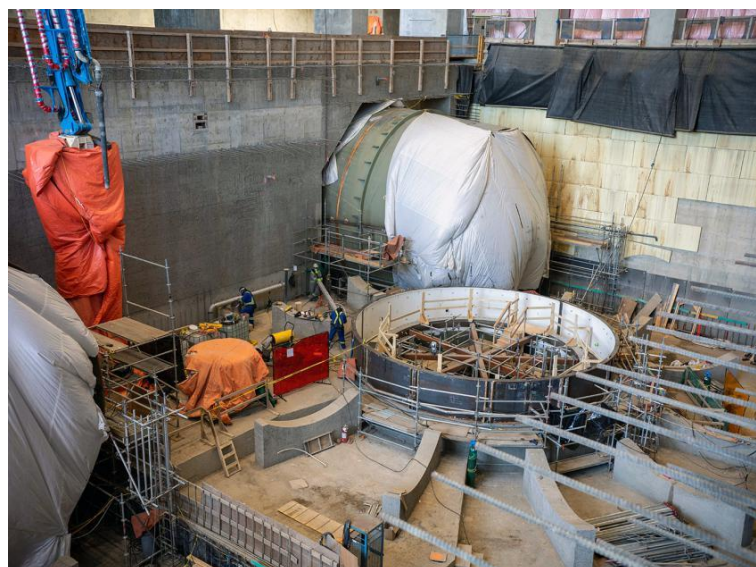
**Figure A-6** Crews have commenced installation of the turbine-embedded components for Units 1 and 2 inside the powerhouse. The Unit 1 draft tube cone and thrust ring are being prepared for installation (February 2021)

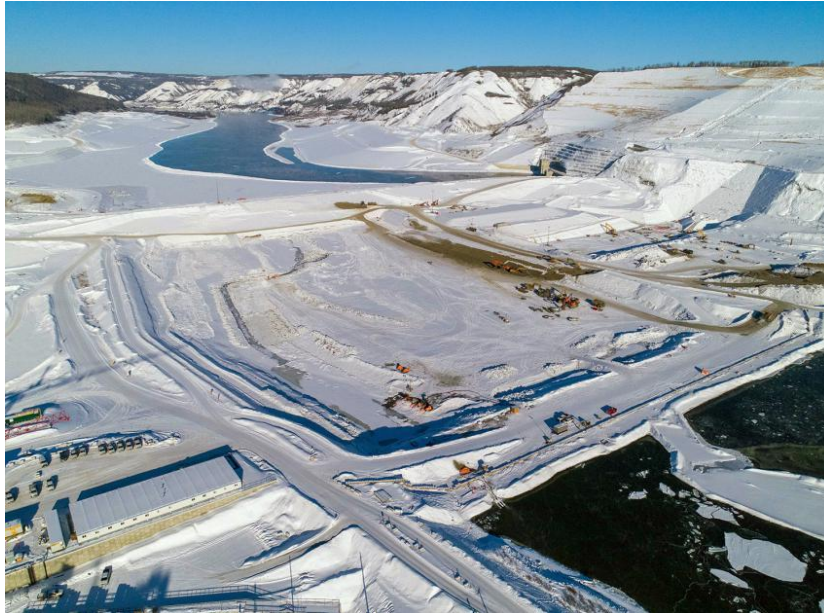
**Figure A-7** The upstream and downstream cofferdams, which divert the Peace River through the two diversion tunnels (February 2021)

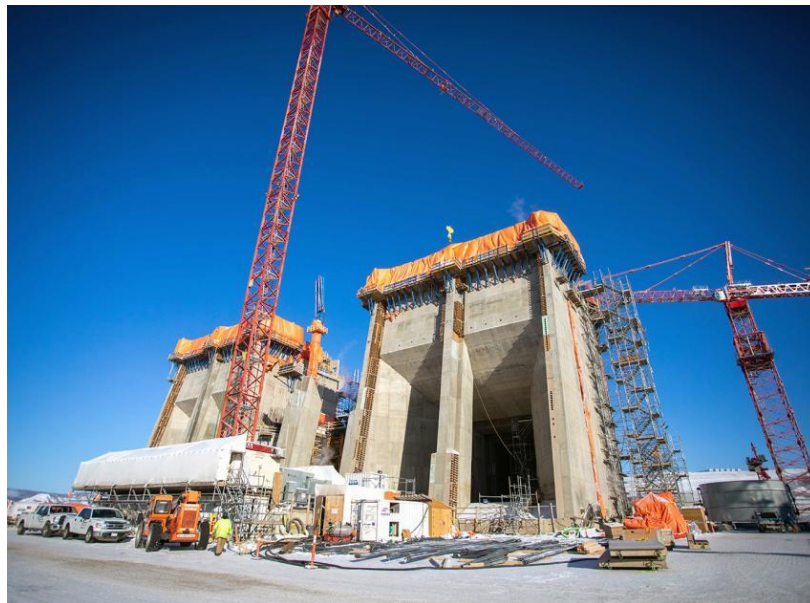
**Figure A-8** Intake Units 1 and 3 are nearing completion as part of the ongoing powerhouse construction (February 2021)

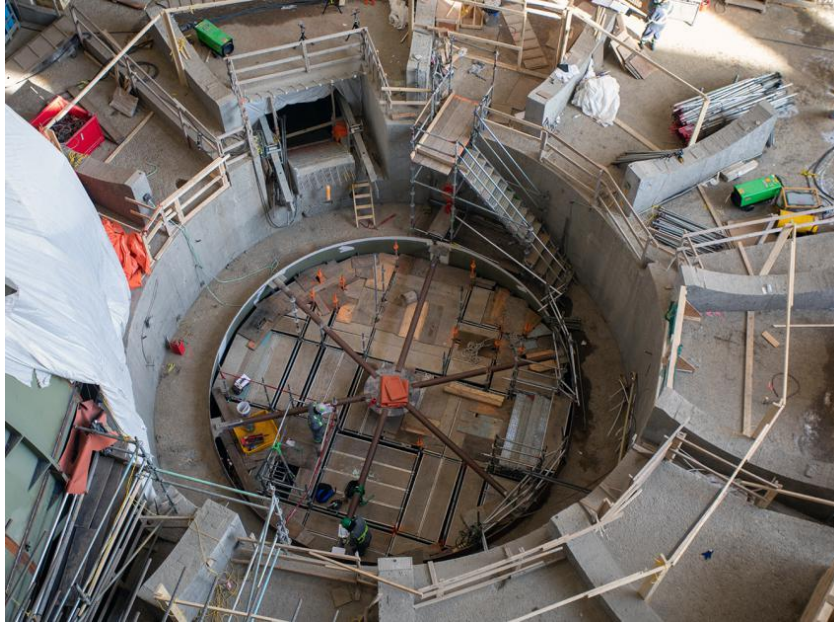
**Figure A-9** Crews install the Unit 2 turbine pit elbow liner (March 2021)

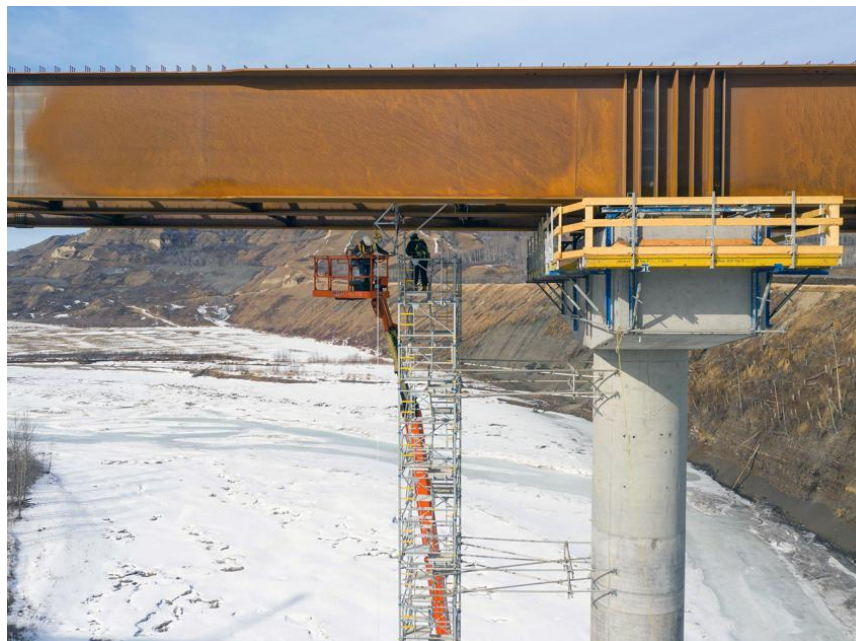
**Figure A-10** Girder installation is complete, and workers remove scaffolding from the Halfway River bridge (March 2021)

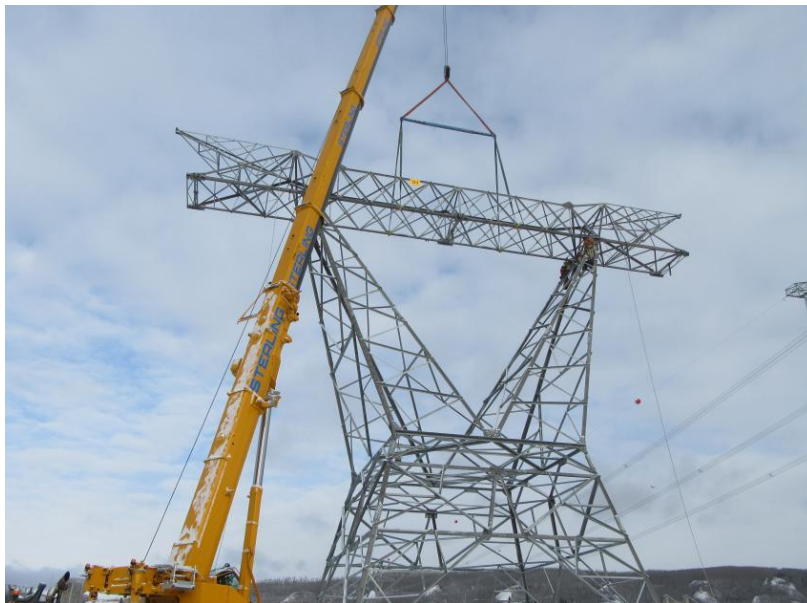
**Figure A-12 The last of 205 transmission towers on the second transmission line was completed at the end of March – eight months ahead of schedule (March 2021)**

Construction of the second 500 kV transmission line continues and as of the end of March 2021, all 205 of 205 foundations had been completed, 205 of 205 towers had been assembled, and 205 of 205 towers had been installed on foundations.
