# Site C Wildlife Mitigation Structures

## *Snake Hibernacula Monitoring 2021*

18113590-010-R-Rev2

19 January 2022

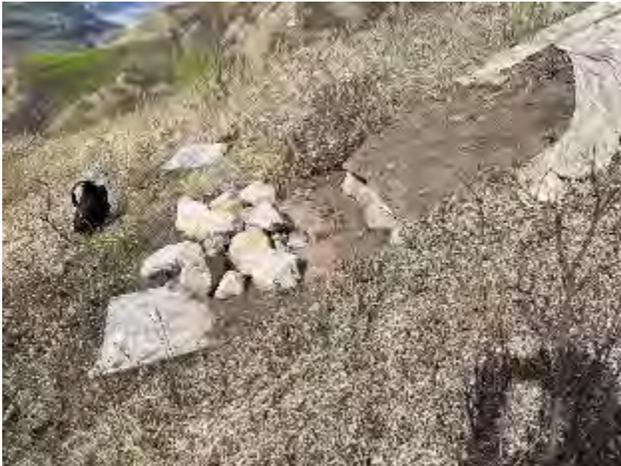
**Photo 1: Snake 21.4 (Dam View) entrance on 12 May 2021.**

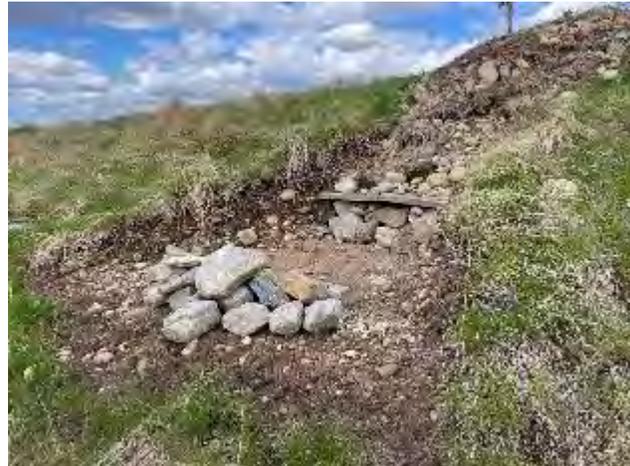
**Photo 2: Snake 48 (Wilder Creek) entrance on 12 May 2021.**

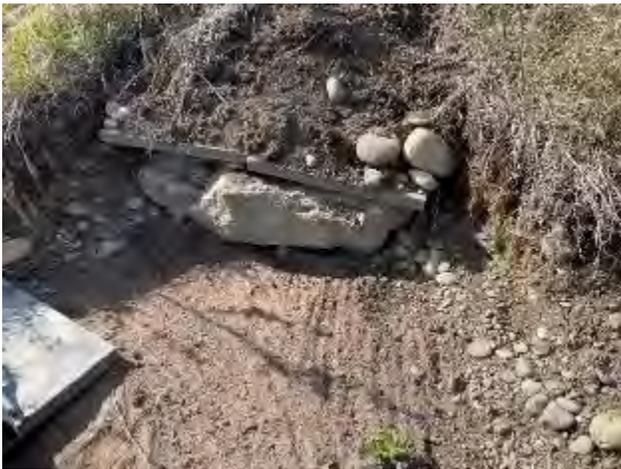
**Photo 3: Snake 134 (Watson Slough) entrance on 12 May 2021.**

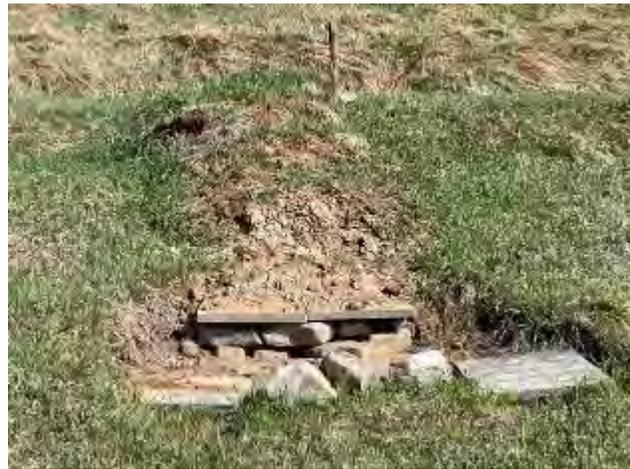
**Photo 4: Snake 153 (Halfway River) entrance on 13 May 2021.**

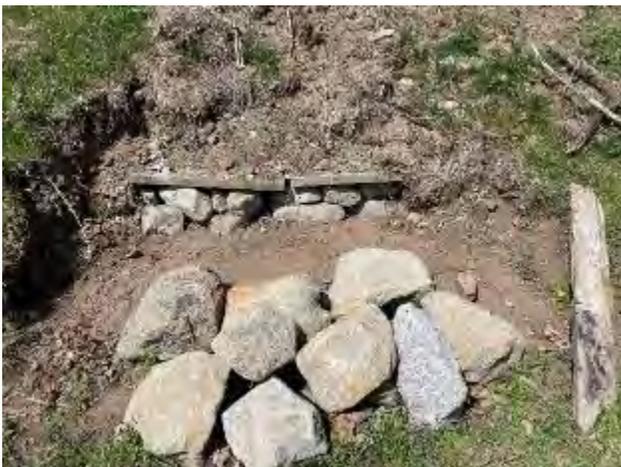
**Photo 5: Snake 326 (Lynx Creek) entrance on 13 May 2021.**

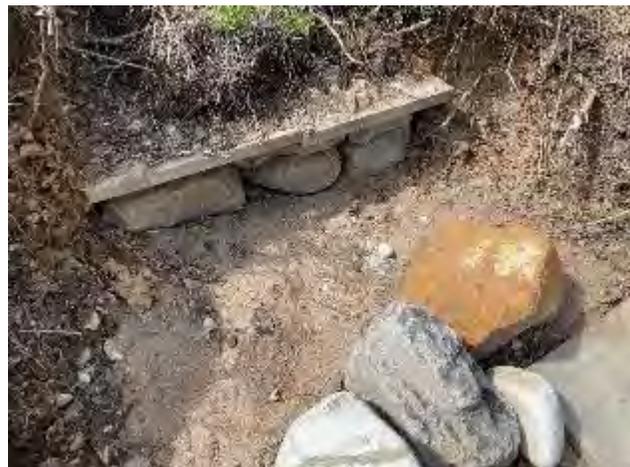
**Photo 6: Snake 272.2 (Peck's) entrance on 13 May 2021.**

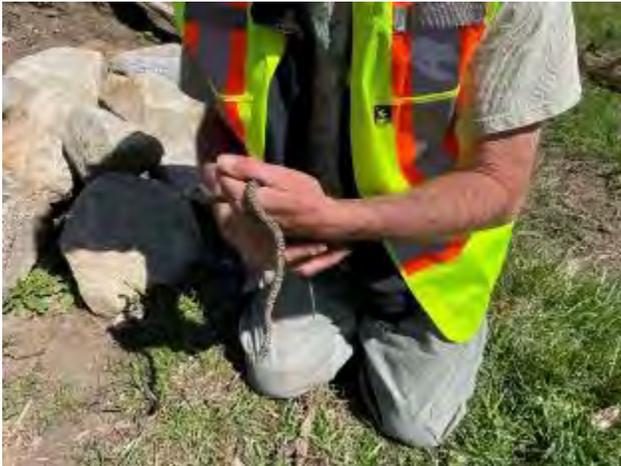
Except for hibernaculum Snake 326 (Lynx Creek), snakes or snake sign were not observed during 2021 occupancy monitoring. On 13 May 2021, two male terrestrial gartersnakes (*Thamnophis elegans*) were observed at Snake 326 (Lynx Creek) under the left (western) cover tile (Appendix A, photo 7). On 11 June 2021, a total of four observations of at least two terrestrial gartersnakes were recorded, with one snake observed under the left (western) cover tile prior to flushing away from the hibernaculum. All other observations occurred in areas adjacent to the hibernaculum. Copies of field datasheets are found in Appendix C.

**Photo 7: Two terrestrial gartersnakes found near the entrance to Snake 326 (Lynx Creek) on 13 May 2021.**

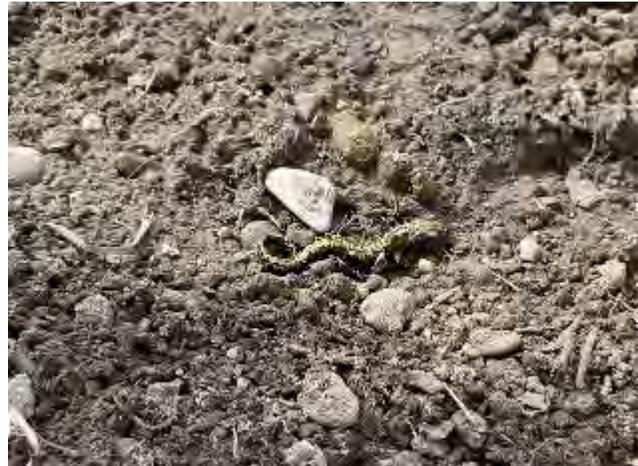
**Photo 8: A long-toed salamander found near the entrance to Snake 272.2 (Peck's) on 13 May 2021.**

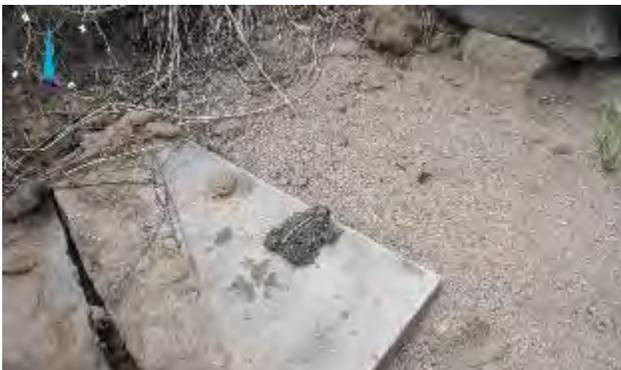
**Photo 29:** An adult western toad near the entrance of Snake 153 (Halfway River) on 10 June.

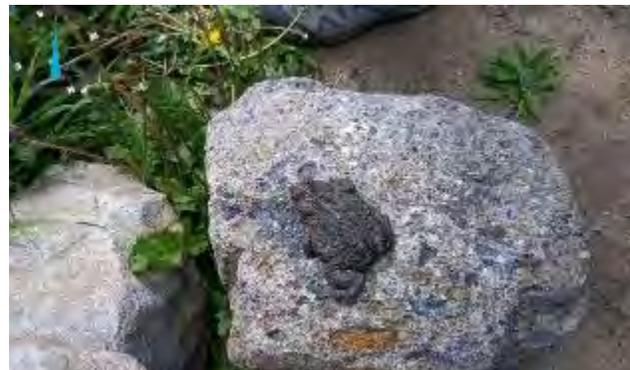
11 June	No	Yes	Terrestrial gartersnake	A minimum of 2 individual snakes observed 4 times; additional soil placed on hibernaculum to attempt to improve its insulation (Appendix B, photos 23 and 24); gaps in hibernaculum entrance plugged using expanding insulating foam, rocks, and concrete/mortar/sand mixture (Appendix B, photos 21 and 22); adult western toad emerged from hibernaculum entrance (Appendix B, photo 30)

**Photo 30:** An adult western toad that emerged from Snake 326 (Lynx Creek) on 11 June.
